CAMBRIDGE HISTORICAL COMMISSION

APPLICATION FOR CERTIFICATE

2. Address of property: 15 Harvard Yard (Holden Chapel), Cambridge, Massachusetts

Holden Chapel – West Pediment Repair and Restoration

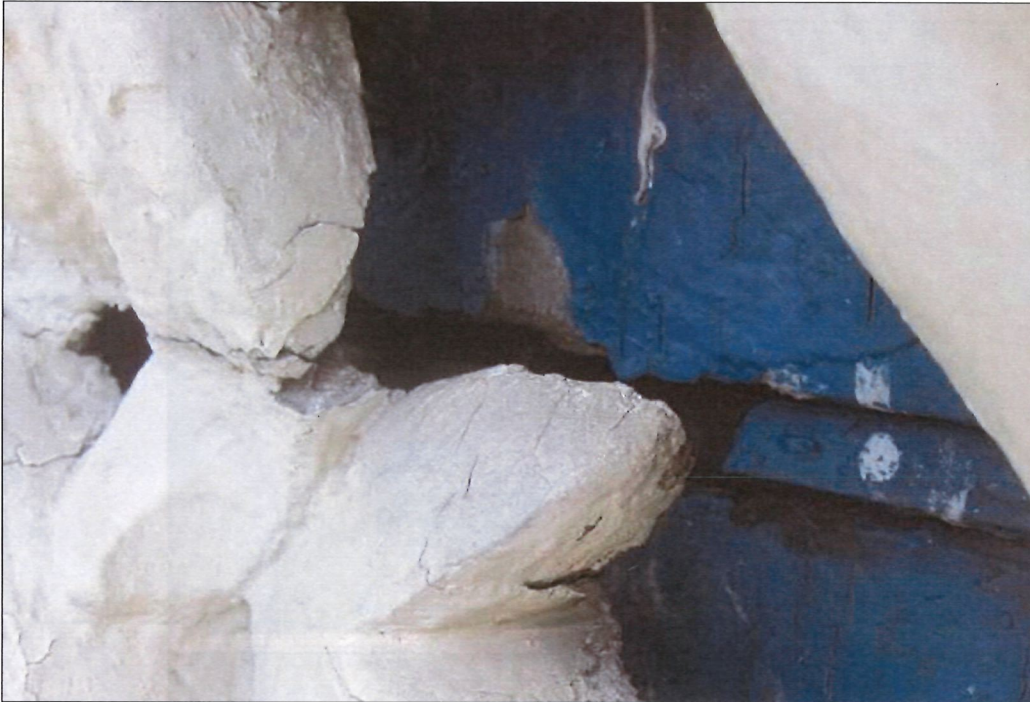
The wood-plank backboards at each location show evidence of extensive deterioration. To appropriately repair these elements, and ensure the long-term structural integrity of the building, the wood sculptures are proposed to be carefully disassembled, removed and the backboards replaced.

West backboards deteriorating and sections are missing

- The backboards will be surveyed, repaired, and re-painted on-site using the same methods and materials as the sculpted sections. This work will include repairing losses at the seams between the boards, filling the gaps between the boards and repairs at the connection points for the sculpture. It will also include removal of a few small boards to permit architectural team access for inspecting the support system. The need for the replacement of damaged and deteriorated backboards will be determined by the project team and reviewed with CHC staff.

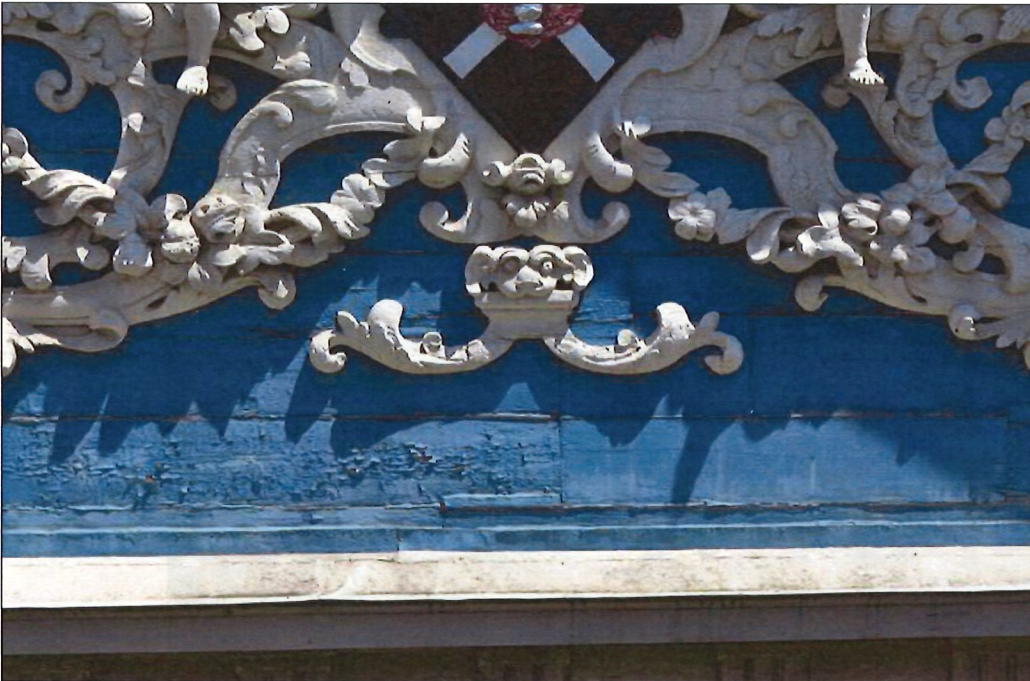
West wood dutchman repairs at backboards

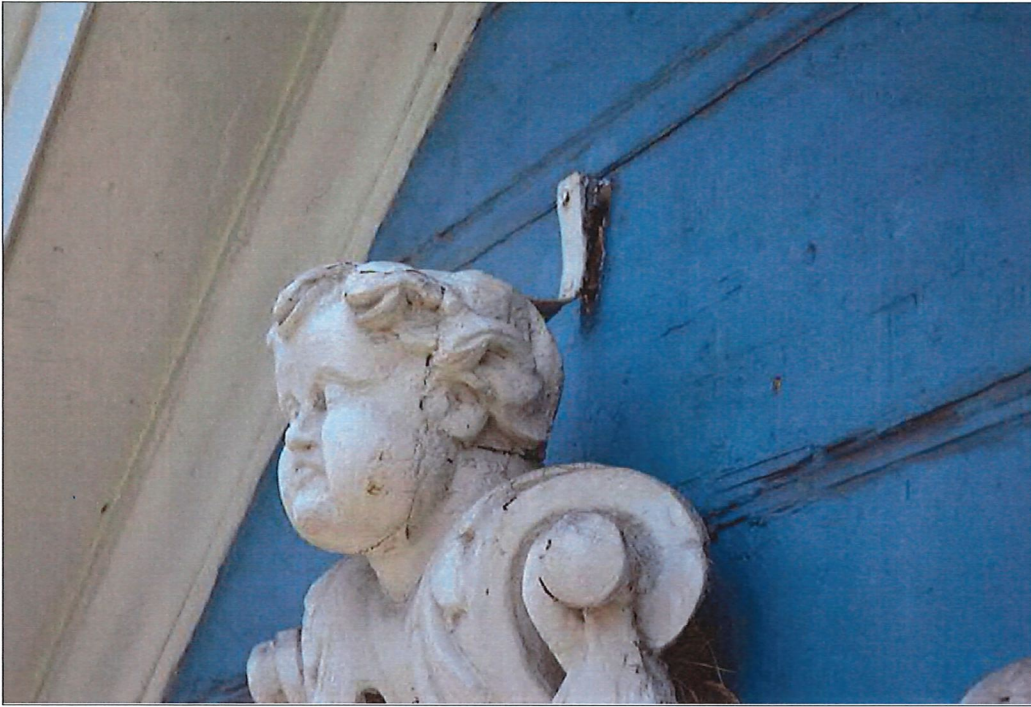
West cherub head with angle attachment to backboards

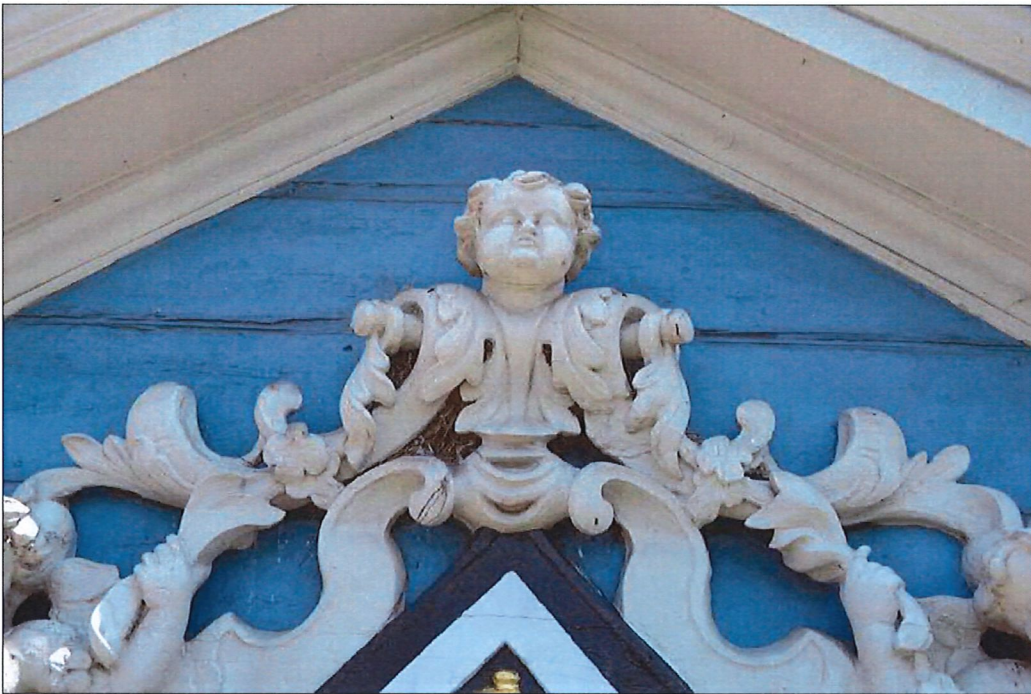
West bird nests to be removed

- Removal of bird nests and debris.
- Gentle cleaning of surface as needed
- Inspection of wood, paint and fasteners for signs of degradation.
- Touch up of paint, filling of cracks and repairs, and re-securing of fasteners as needed.

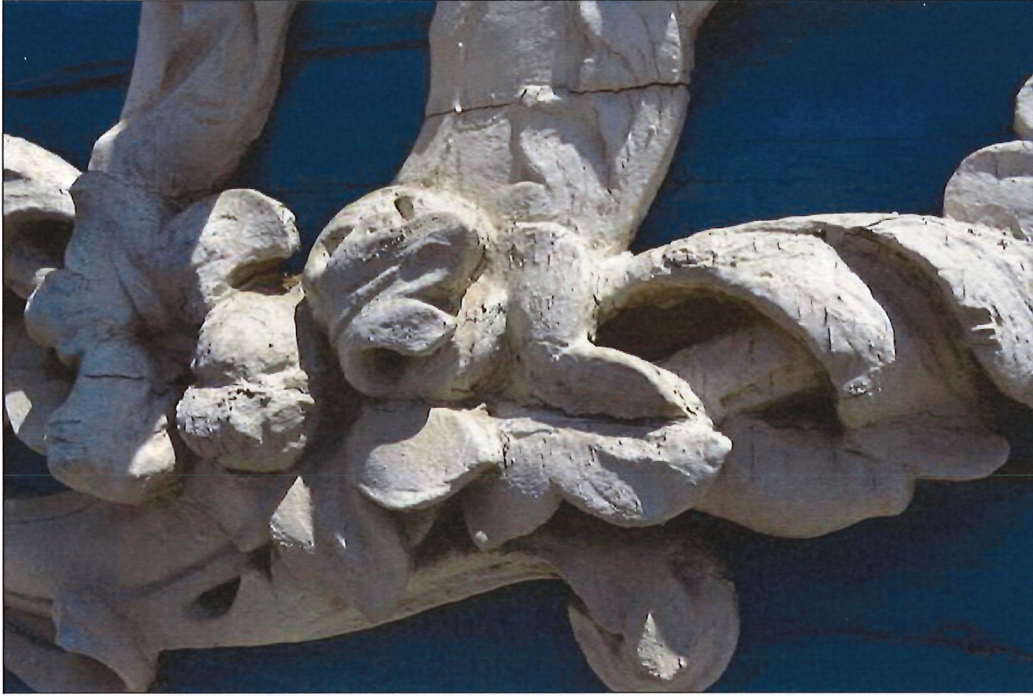
West showing horizontal cracks and location of seam from separate sections of carvings

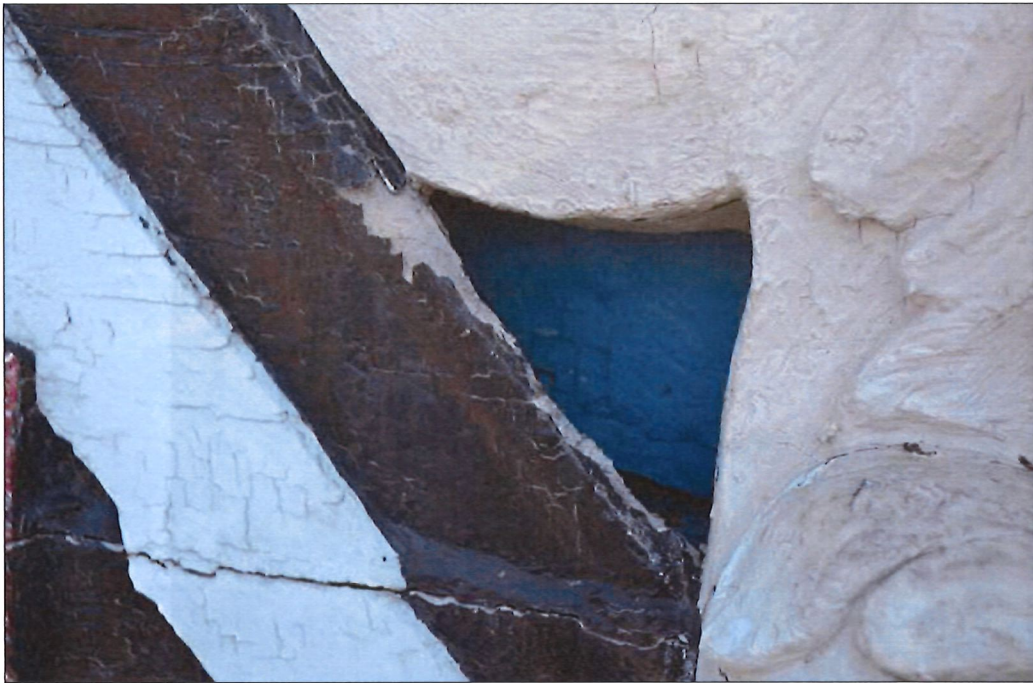
West seam at crest

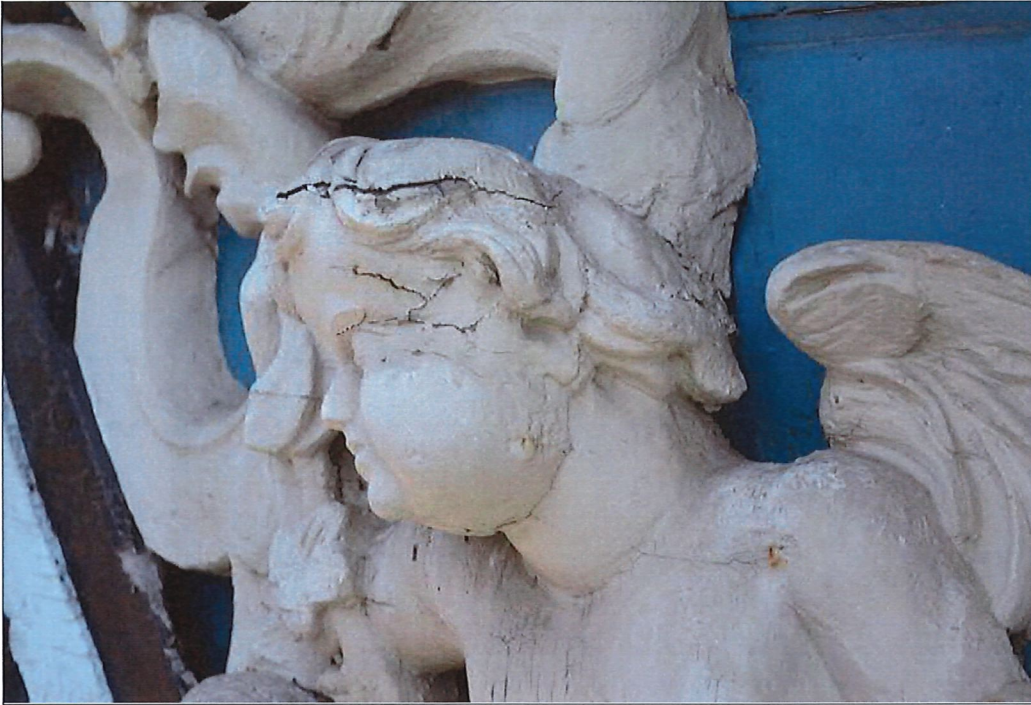
West cherub head with horizontal wood split

- The surface will be repaired using reversible repair materials and are likely to include the use of carved wood dutchman, and traditional wood repair techniques such as dowels and adhesives mixed with wood shavings.

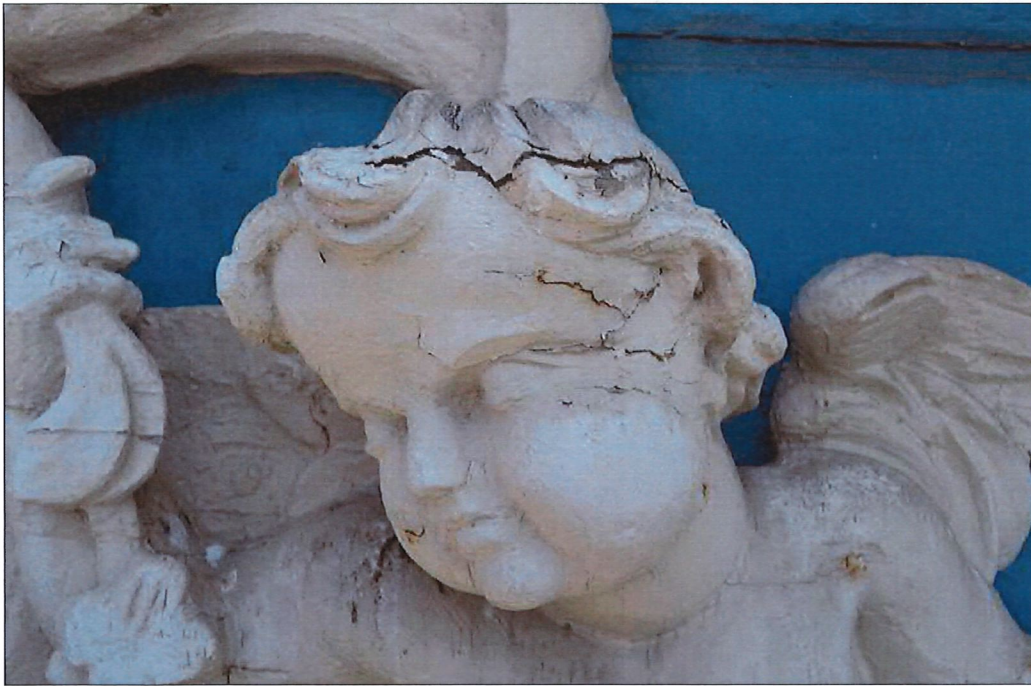
West cherub head with horizontal wood split

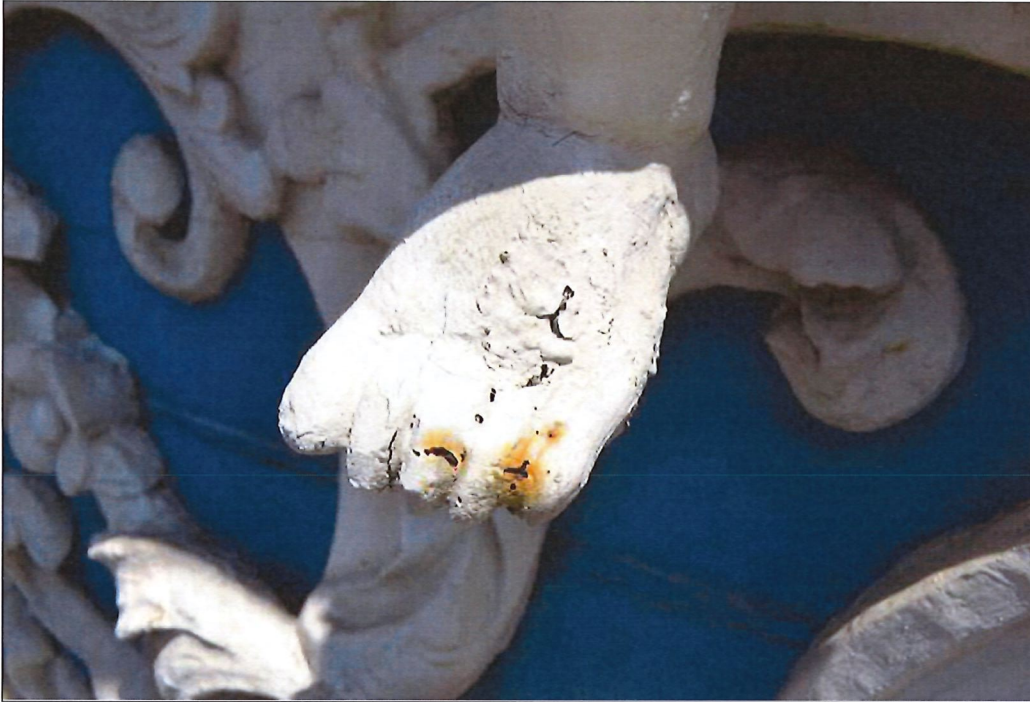
The wood sculptures at both locations, which are comprised of separately carved sections, are generally in fair condition. While the majority of the wood appears to be sound, numerous cracks, checks and loose pieces are present. The elements most susceptible to deterioration are the heads and legs of the cherubs which project out from the soffit above. Ferrous screws are prevalent, causing rust stains and peeling paint.

West cherub foot with ferrous metal fasteners at the toes

- A new mounting system will be fabricated (likely using a stainless-steel framework with accessible screws) which will permit the removal of separate sculpture sections facilitating future maintenance and repair activities. The project team will review the specifications of the new mounting system and its installation with the CHC staff.

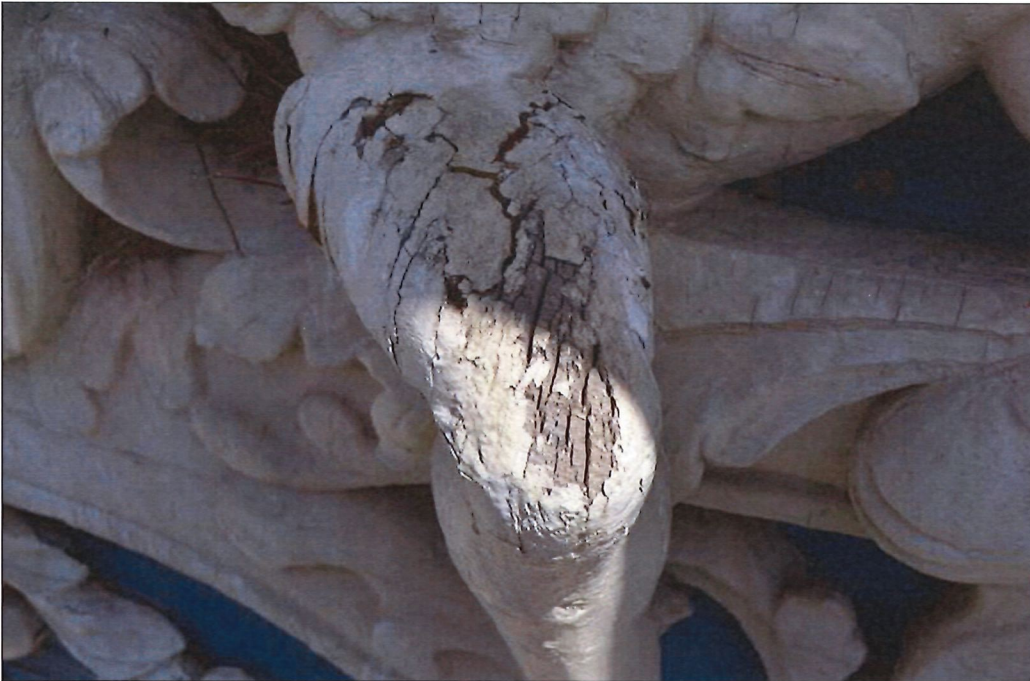
West cherub leg with end-grain exposed
