# Cambridge Historical Commission Review

February 2, 2023

## City Hall Façade Restoration Project

Anticipated Construction  
June 2023 through August 2024

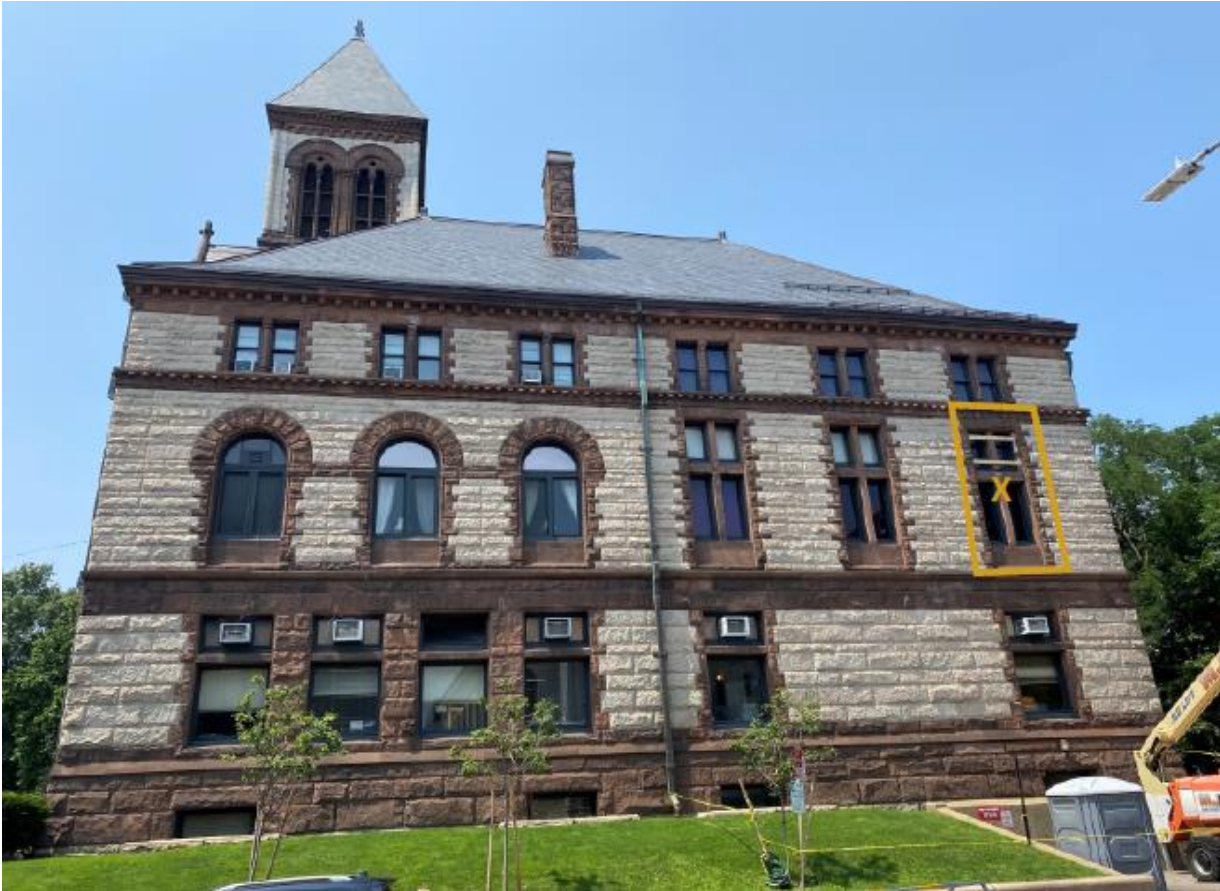
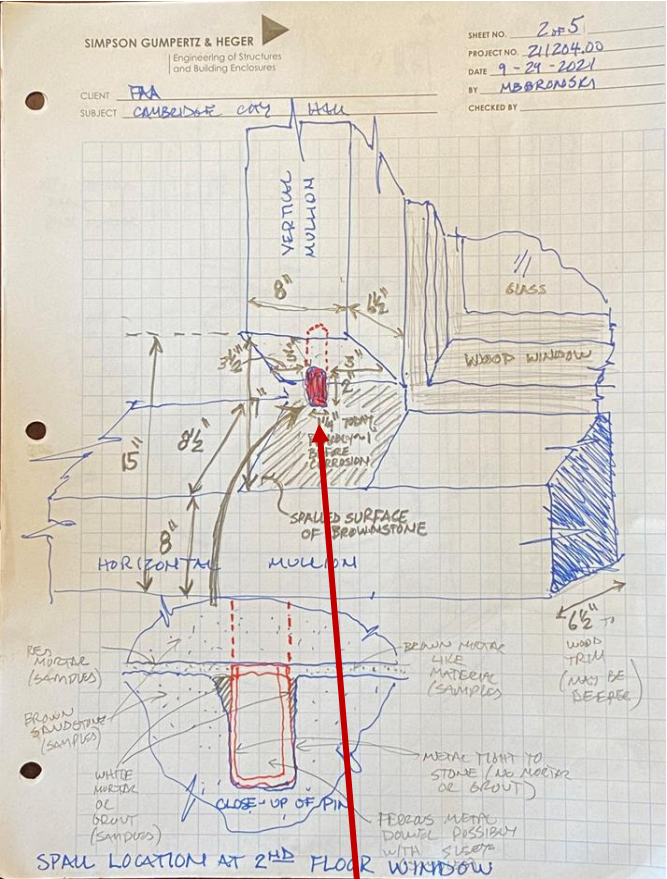
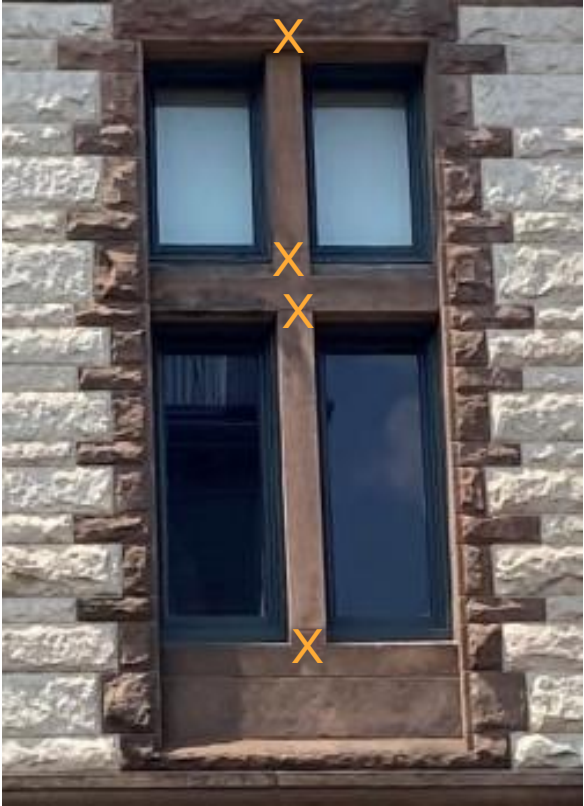
The design team assessed the cause of the spall (detached chunk of stone) that fell from the second-floor window at the north end of the Inman Street in July 2021. The cause of the spall is corrosion-related expansion of the embedded ferrous metal (iron or steel) dowel that connects the sill stone to the vertical stone mullion. The ferrous dowel appear to be original to the 1889 construction.

**The team developed the façade restoration project to replace the dowels, to repair visible spalls and cracks, to redress stone and to repoint in locations as outlined on the elevations next up.**

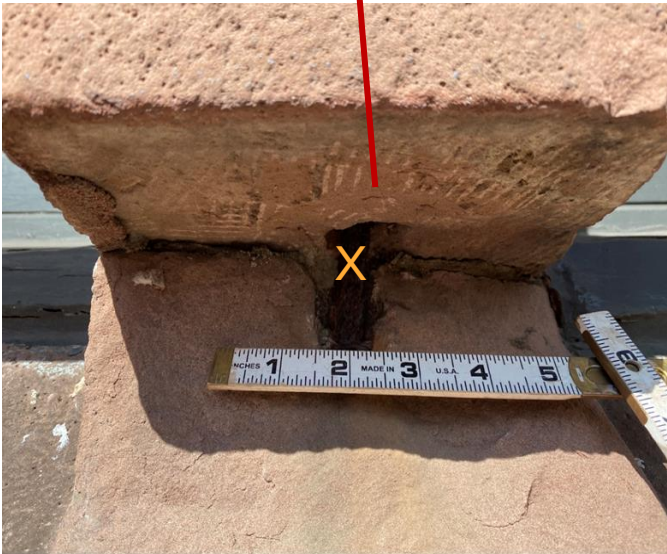
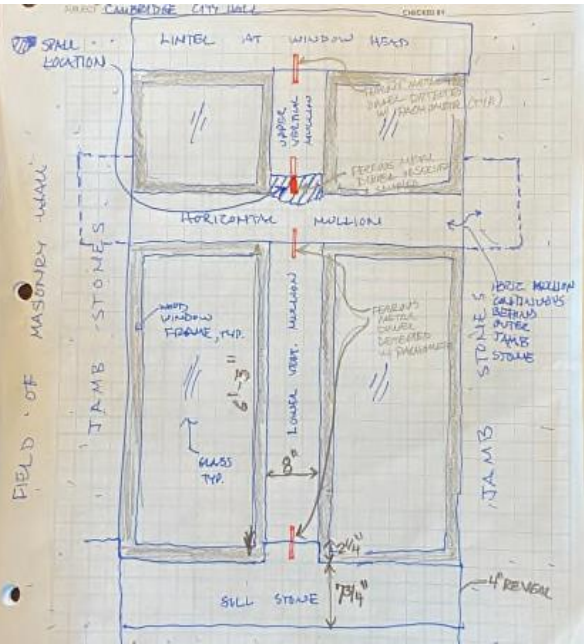
The team concluded that the source of the moisture that caused the corrosion of the ferrous metal dowel was external rain saturating the mortar bed joint between the two stones.

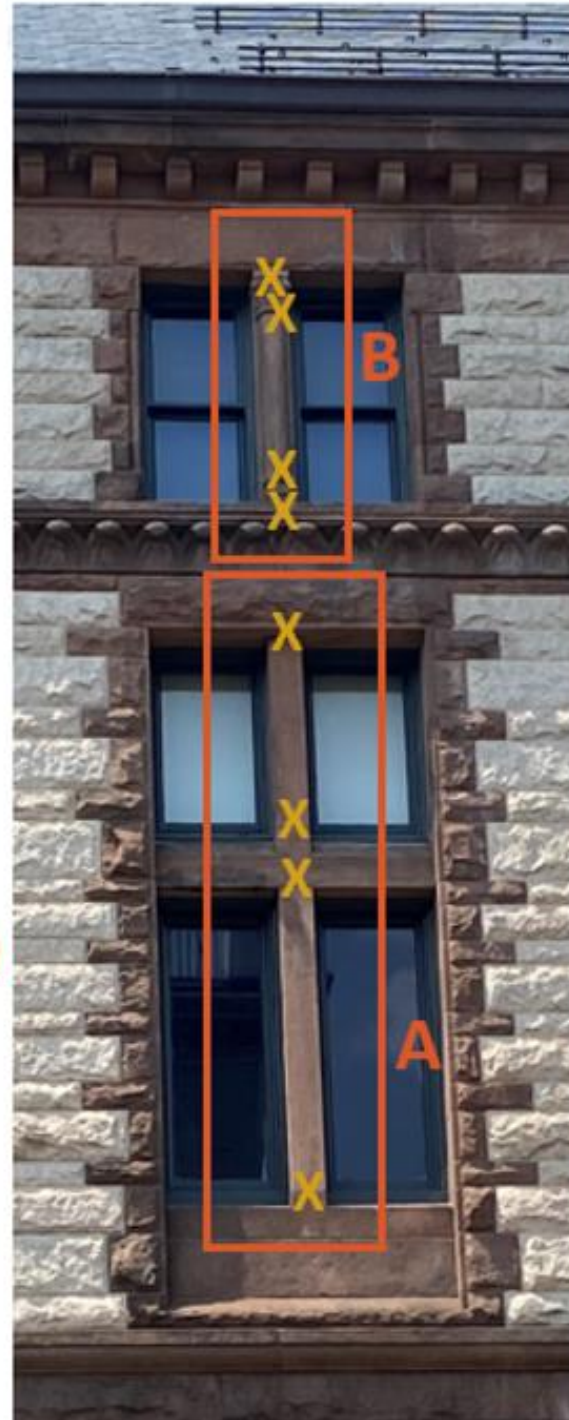
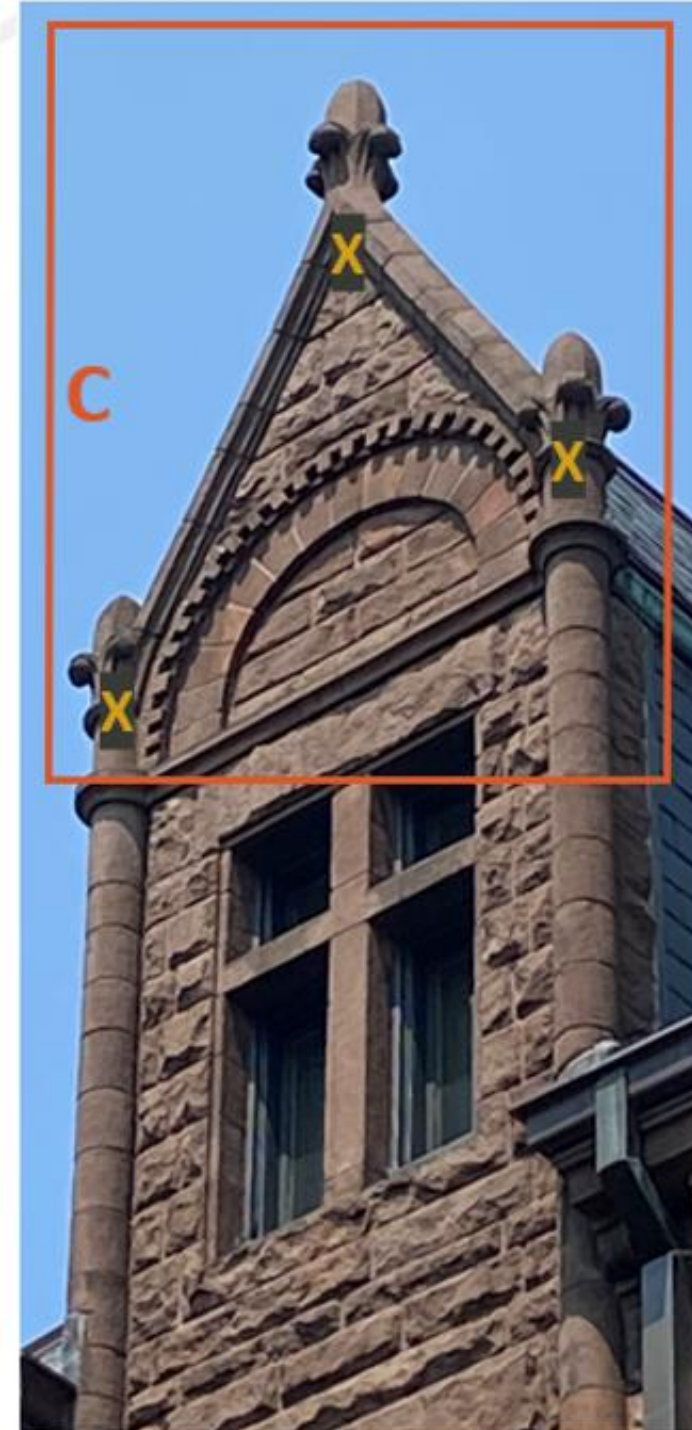
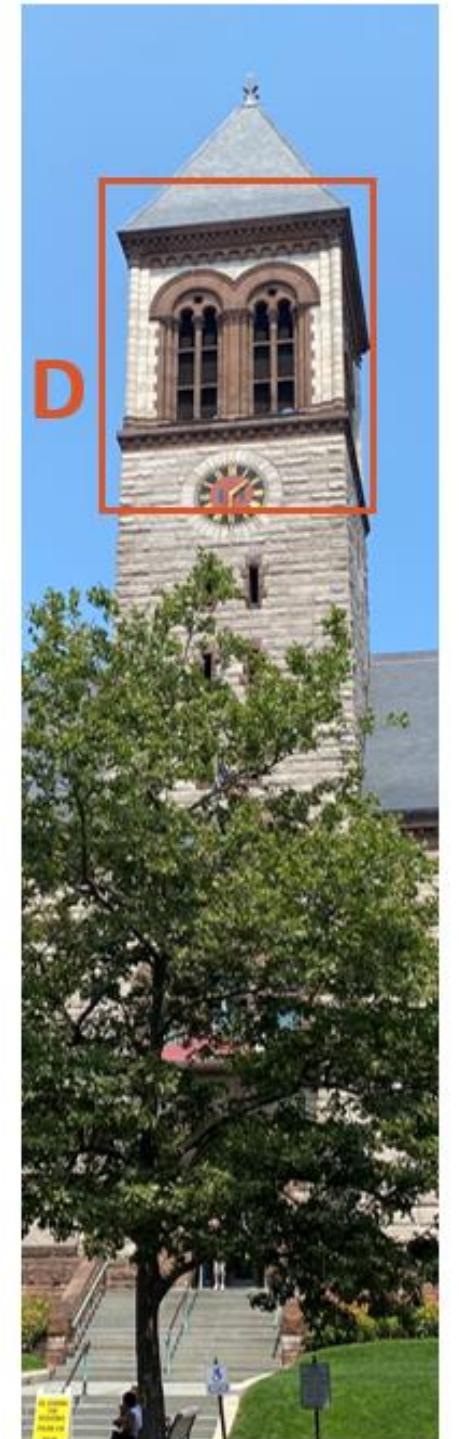
The ferrous metal dowels are present only in specific stones, typically to connect slender, freestanding, or spanning stones:

A. At cruciform mullions, four dowels (yellow X) each location (red box), confirmed via testing.

B. At column-like vertical mullions, four dowels (yellow X) each location (red box), confirmed via testing.

C. Likely at the stone finials atop dormers, likely one dowel (yellow X) at each finial.

D. At column-like vertical mullions in the tower (from survey inside tower).

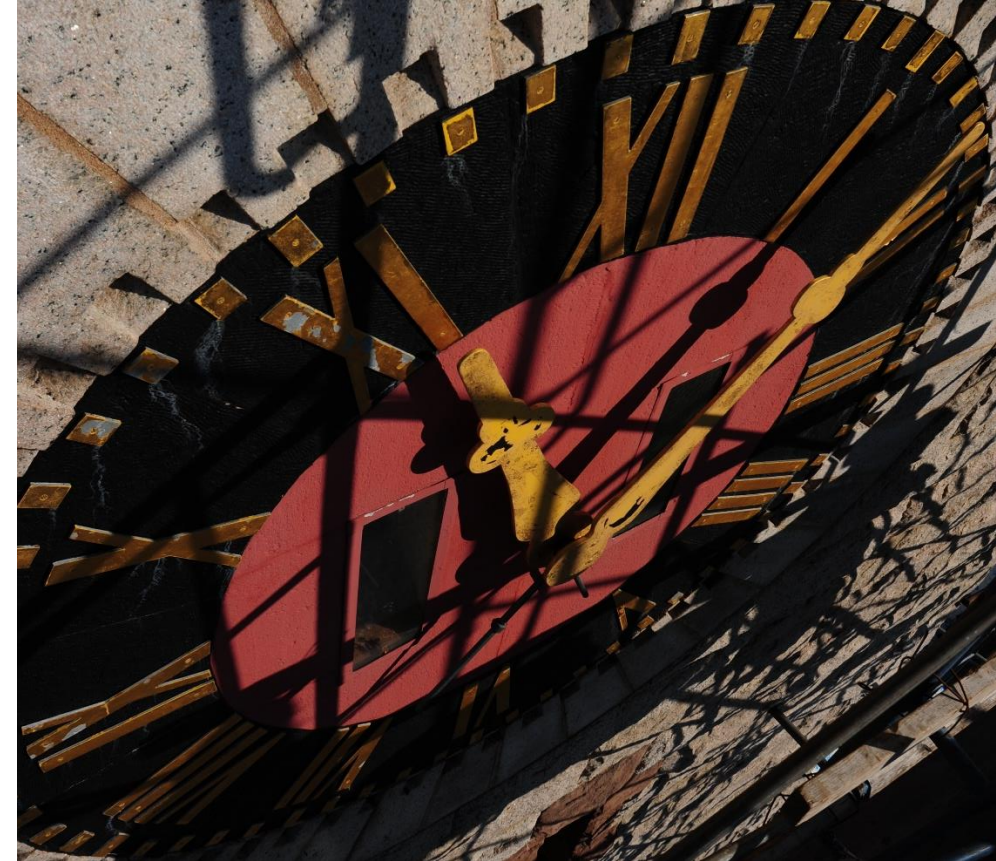
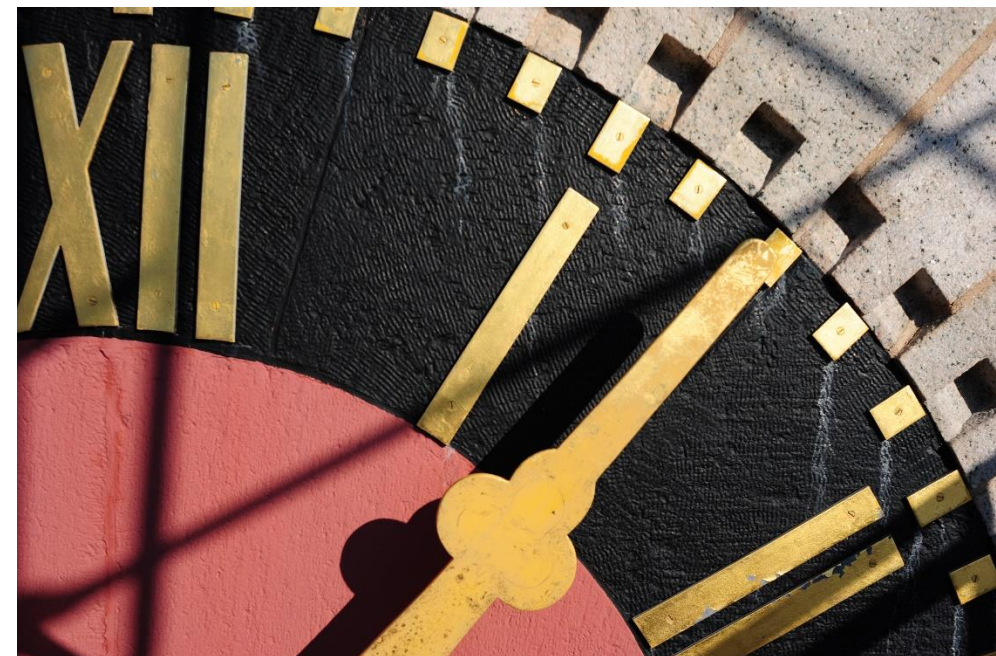
## Existing

Clock hands, numerals, and markers were last restored 20 years ago. This project will regild those same components.

Specialty Clock Technician to Carefully Remove All Clock Hands, Clock Numbers, Second Markers, and Mounting Hardware. Clock Technician to Hand Over Clock Hands, Clock Numbers, Second Markers, and Hardware to Specialty Gilding Contractor Retained by the Painting Contractor for Restoration of Ornamental Metal and Gilding. Once Gilding is Complete, Gilding Contractor to Hand Over the Clock Hands, Clock Numbers, Second Markers, and Hardware for Re-Installation by Specialty Clock Technician.

Painter to Touch Up Paint, Repair Damage, and Restore Finish at Clock Face, Typ.

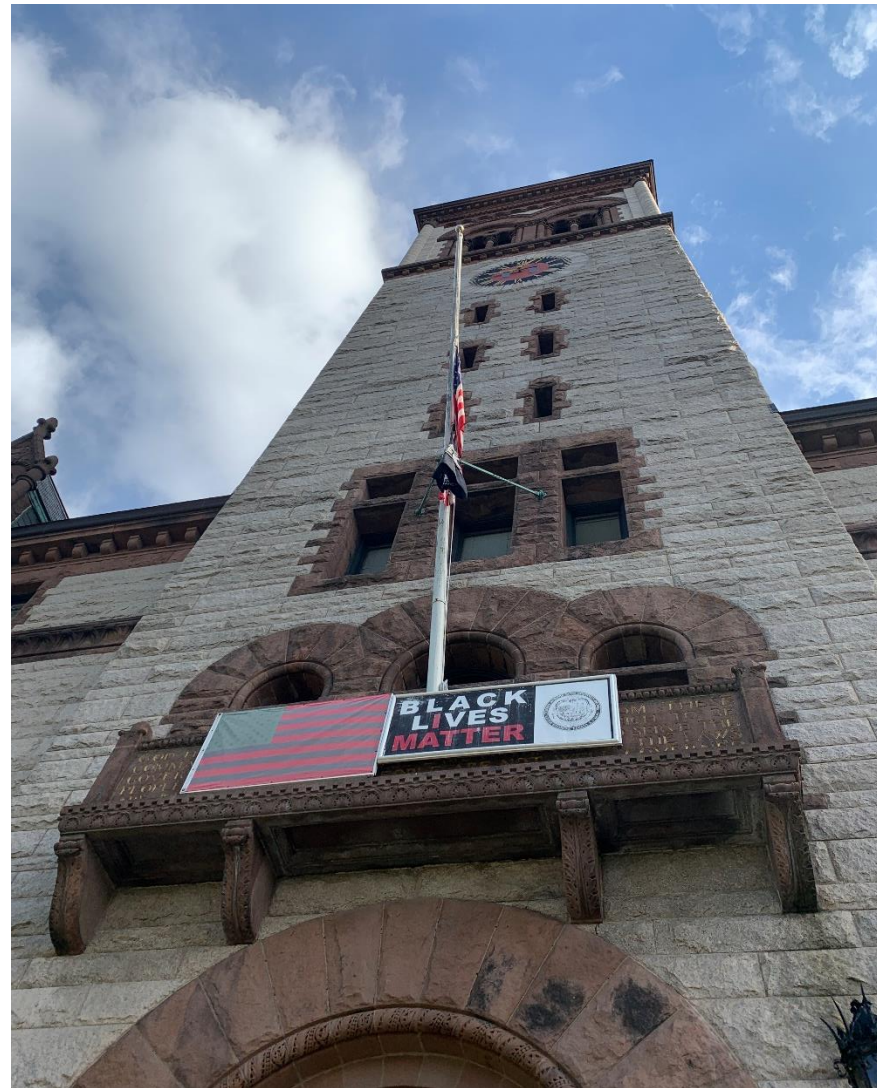
Existing Signage at Front of Balcony

The signs mounted on the balcony will be removed during the construction to allow for the restoration work; proposed relocation of signage to the building facade.

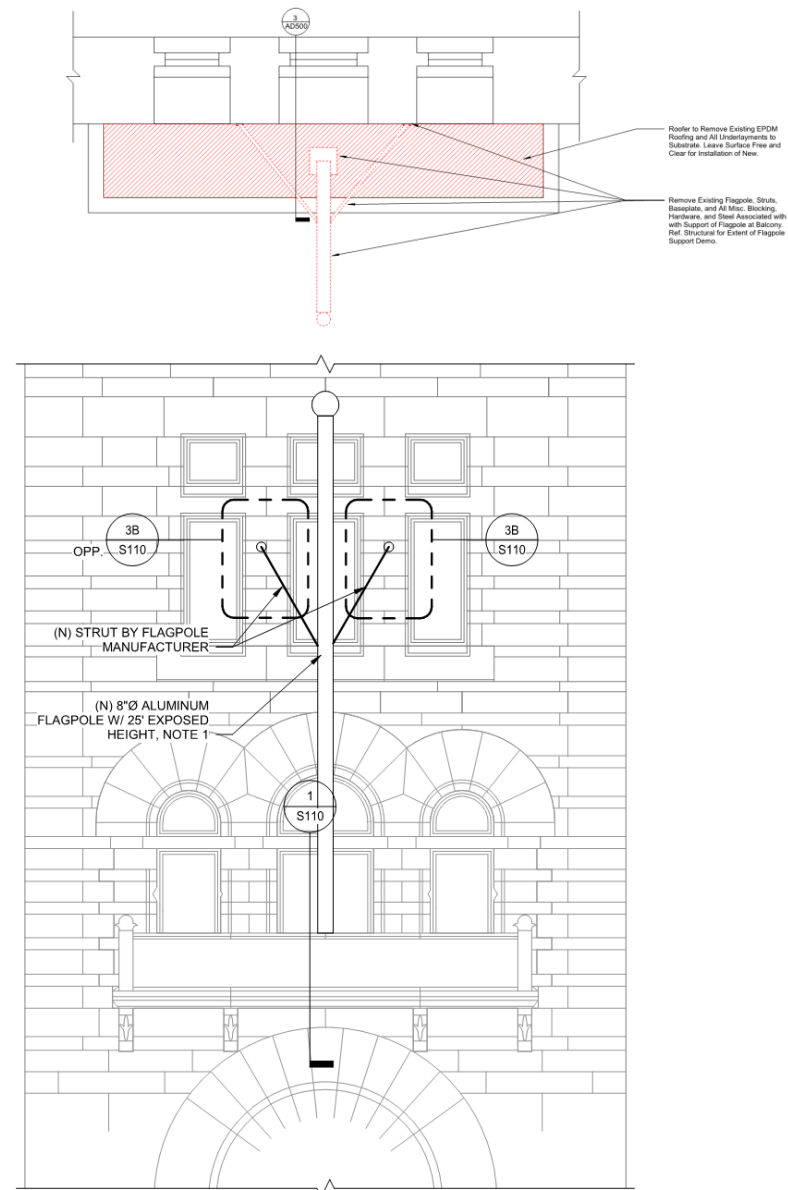
2 ENLARGED SOUTH ELEVATION - BALCONY  
1/4" = 1'-0"

The existing wood flagpole will be replaced to address issues with the supporting base detail, the finial, and the flag tangling.

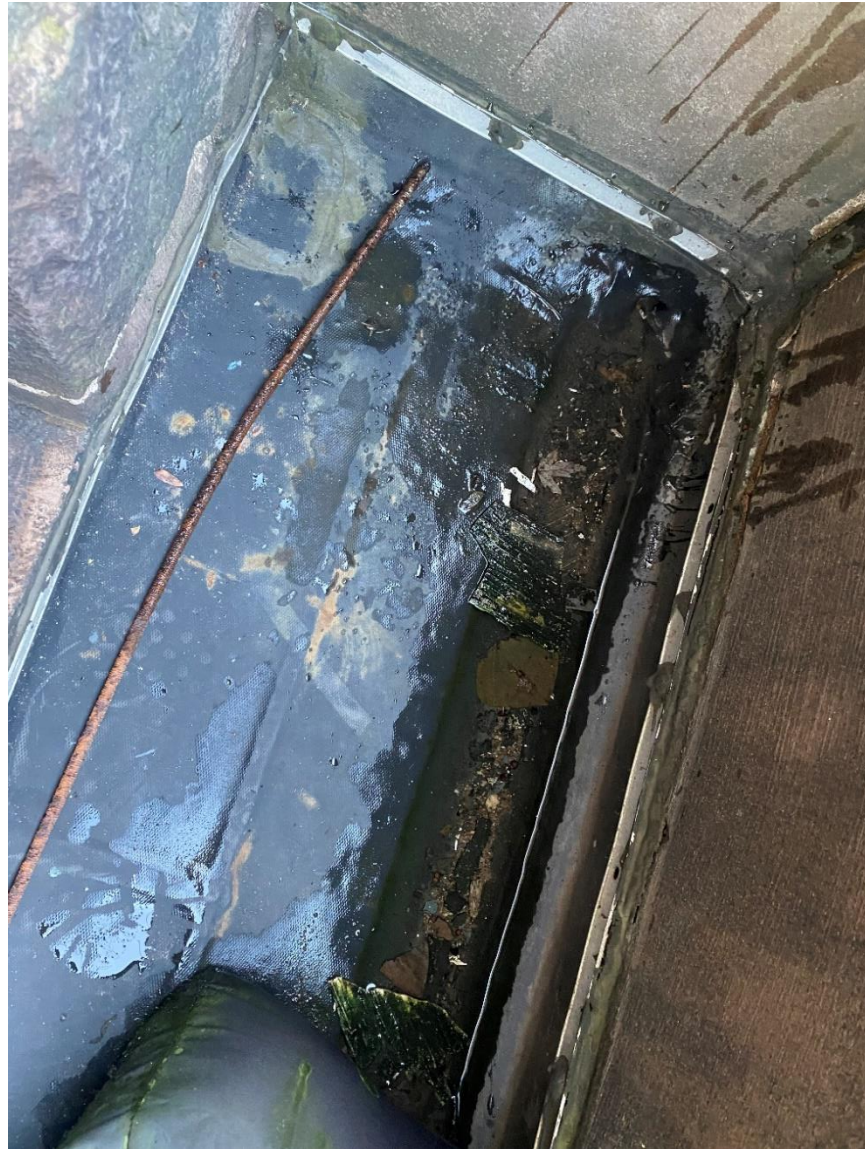
Existing

The balcony drainage is insufficient and frequently clogs. A new scupper will be added in the same location as the existing outlet to address the issue.

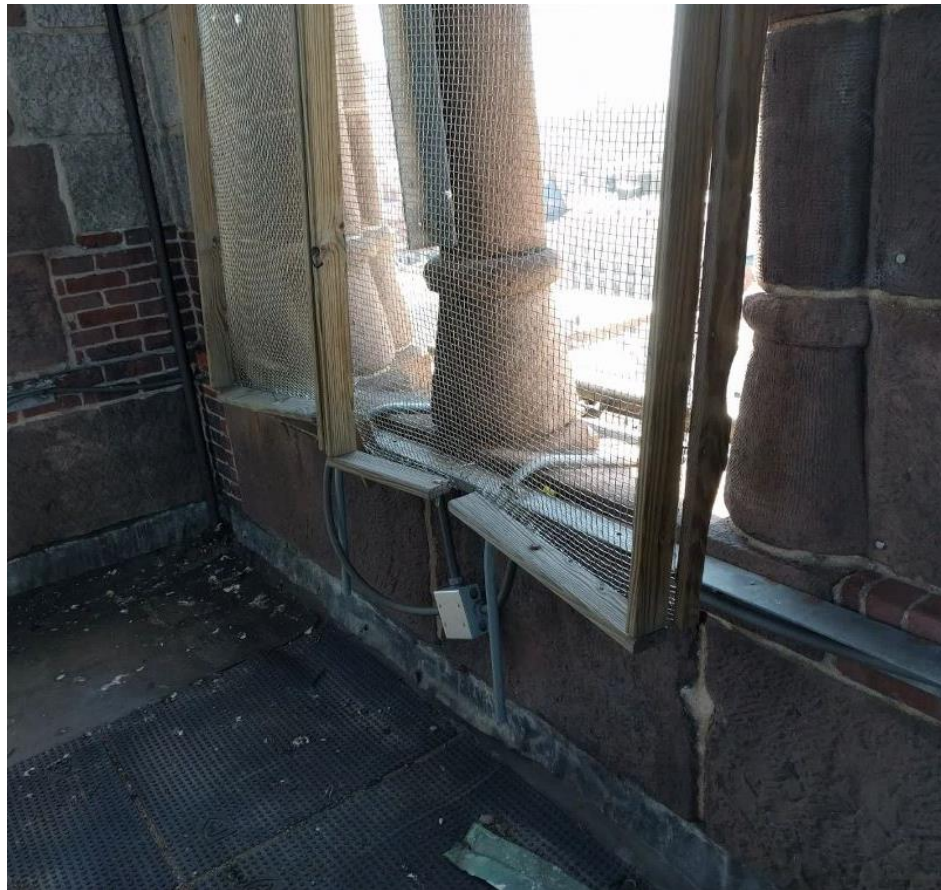
## Existing Deterrent at Tower

REPAIR SPRINGUARD

PERMANET GRANITE  
TO REPAIR/REPLACE

PERMANET GRANITE  
MISSING - REPLACE

INSTALL NEW SS  
PERMAMESH OVER  
GUTTER

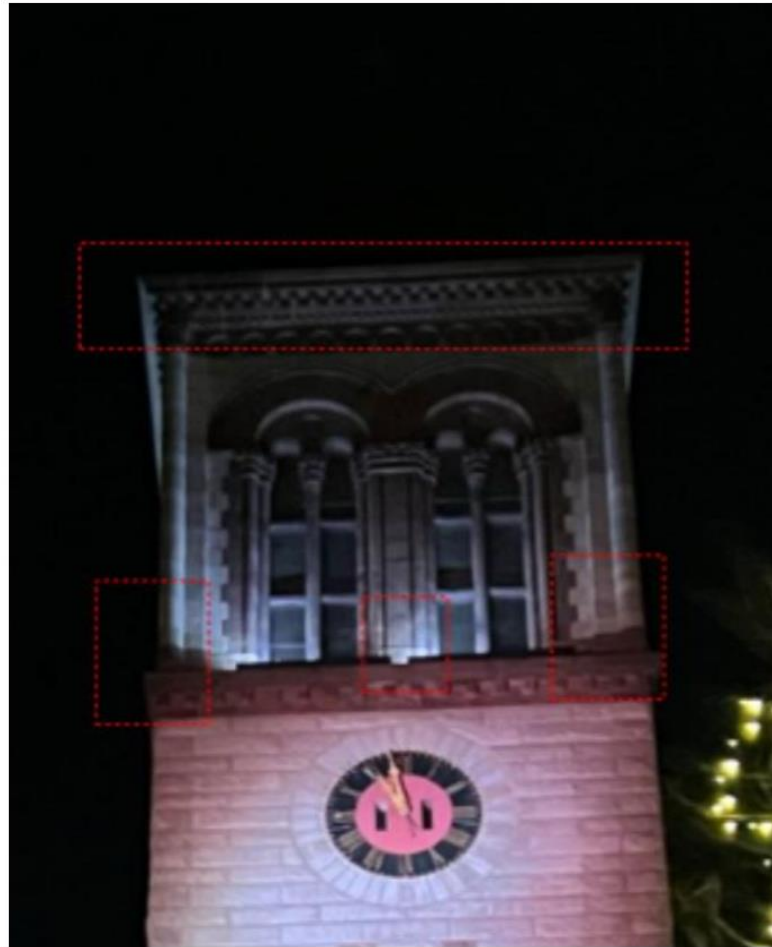
Existing Lighting at Tower

The existing tower lighting fixtures were at one time retrofitted with LED fixtures, but the system was not upgraded to match the remainder of the façade lighting. The current tower lighting provides uneven illumination, with noticeable hot spots and dark spots.
