## **TOBIN MONTESSORI AND VASSAL LANE UPPER SCHOOL**

Cambridge, Massachusetts

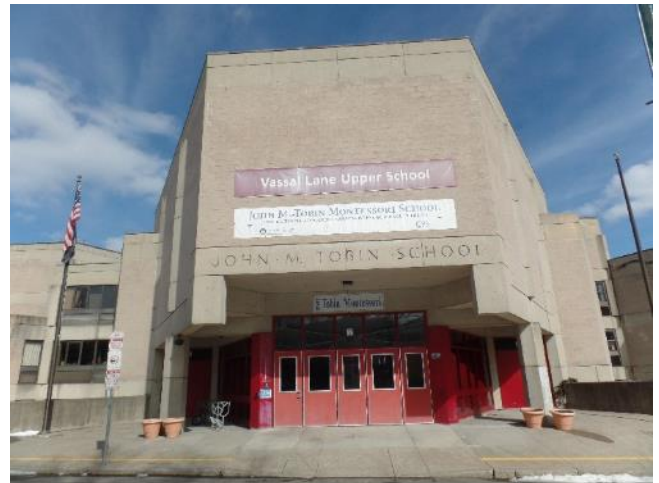
The Tobin Montessori and Vassal Lane Upper School is located at 197 Vassal Lane in Cambridge.

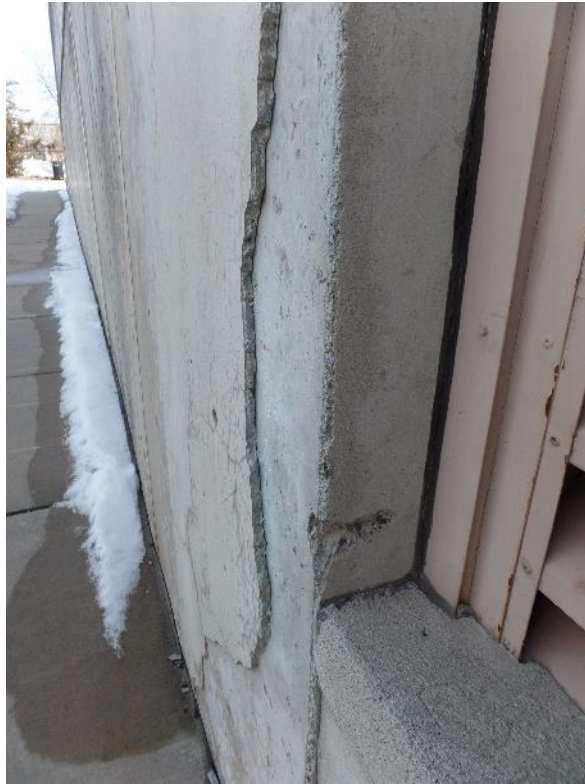
**Photo 1:** Debonded Parging

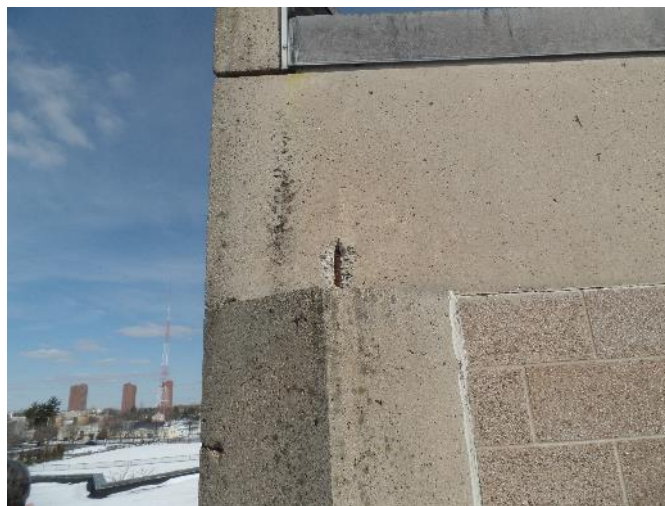
**Photo 2:** Corroded Reinforcing/Spalled Concrete Cover

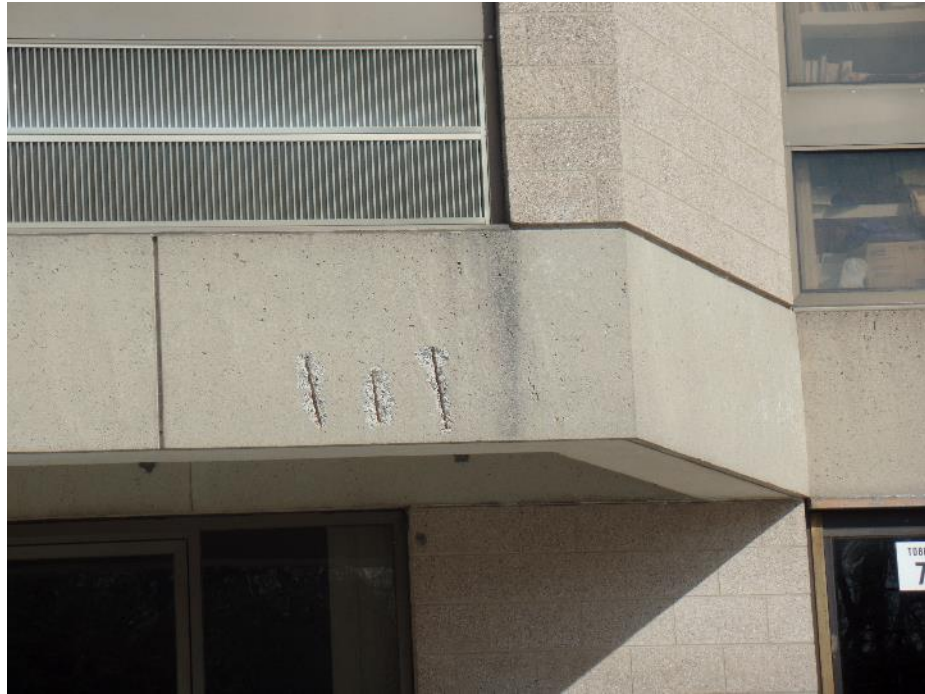
**Photo 3:** Corroded Reinforcing/Spalled Concrete Cover

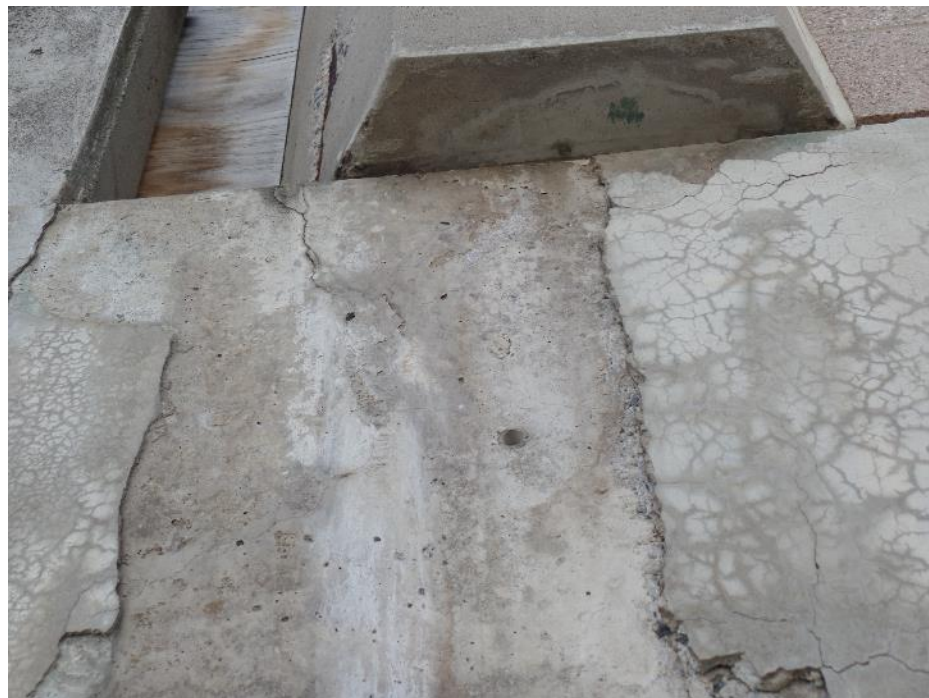
**Photo 4:** Corroded Reinforcing/Spalled Concrete Cover and Surface Deterioration

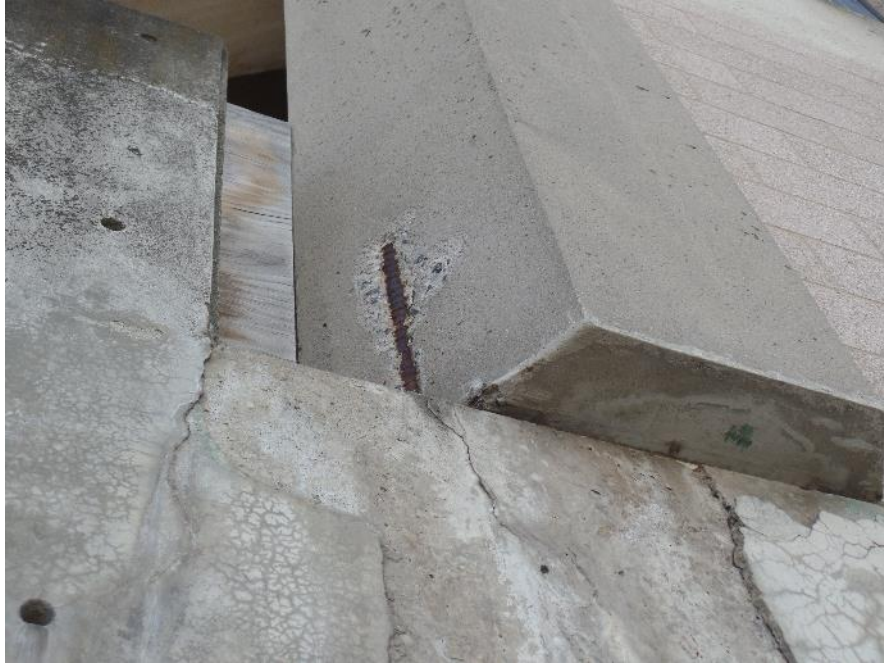
**Photo 5:** Corroded Reinforcing/Spalled Concrete Cover

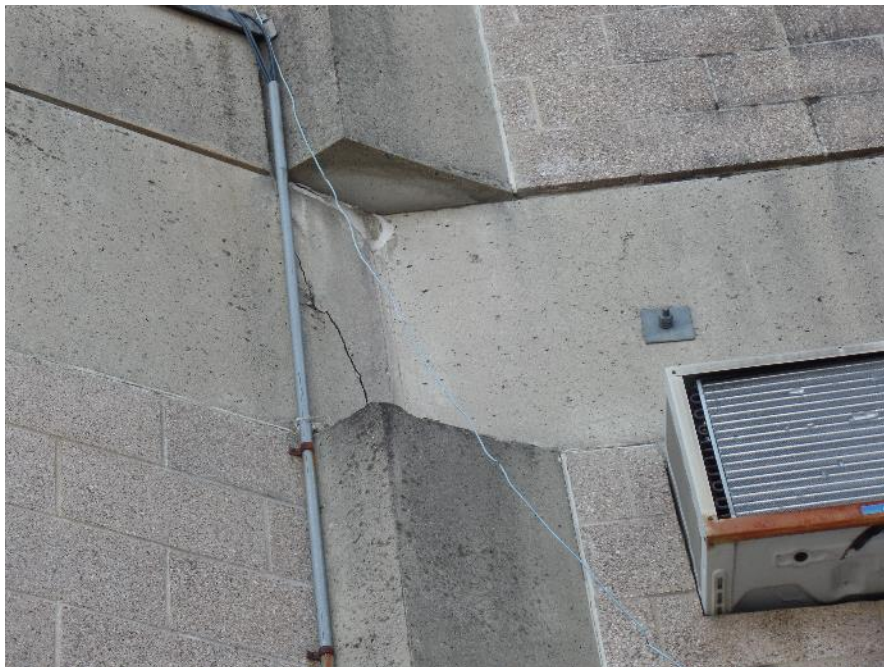
**Photo 6:** Crack in Concrete Spandrel Beam

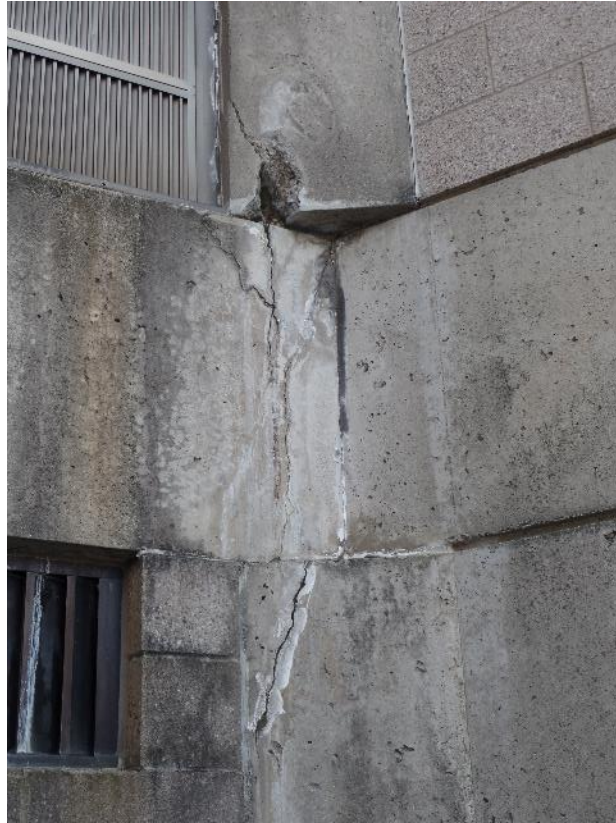
**Photo 7:** Corrosion/Spalled Concrete Cover and Cracking/Deterioration

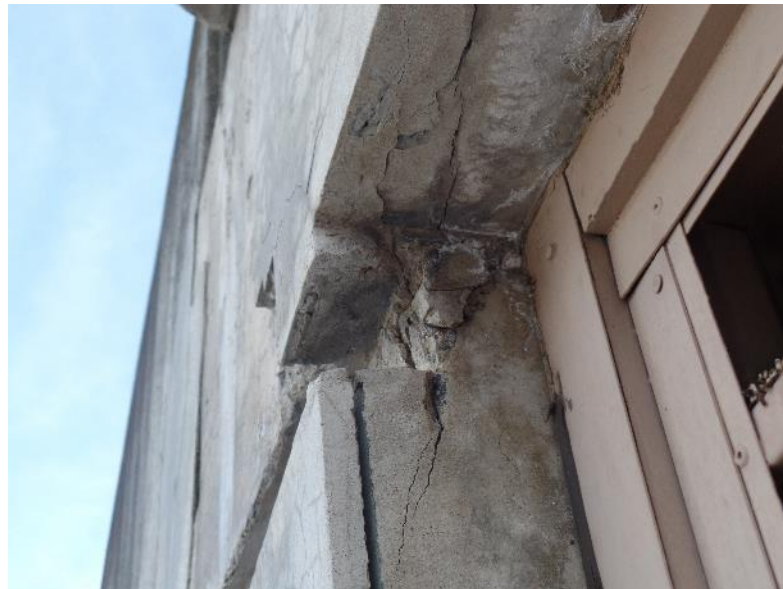
**Photo 8:** Corrosion/Spalled Concrete Cover and Cracking/Deterioration

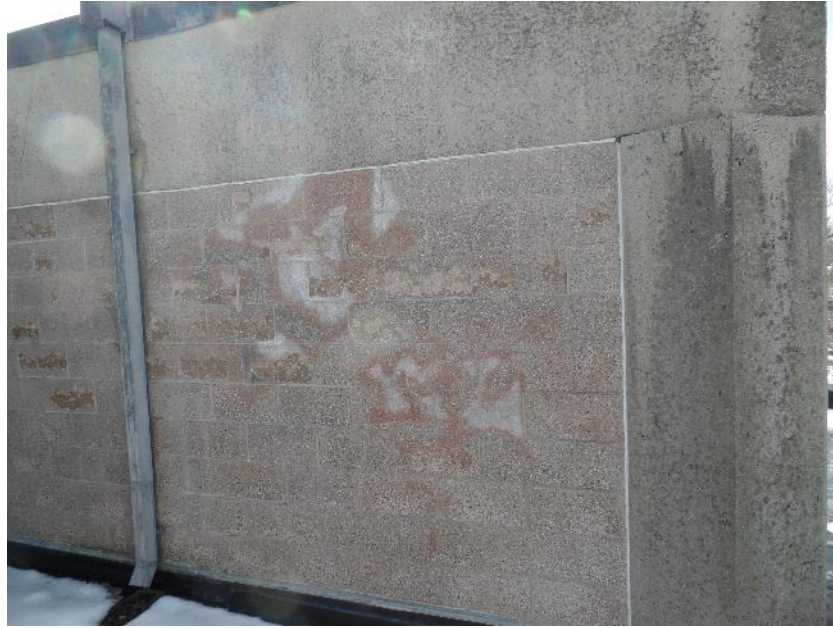
**Photo 9:** Exterior Masonry Wall - Moisture Damage

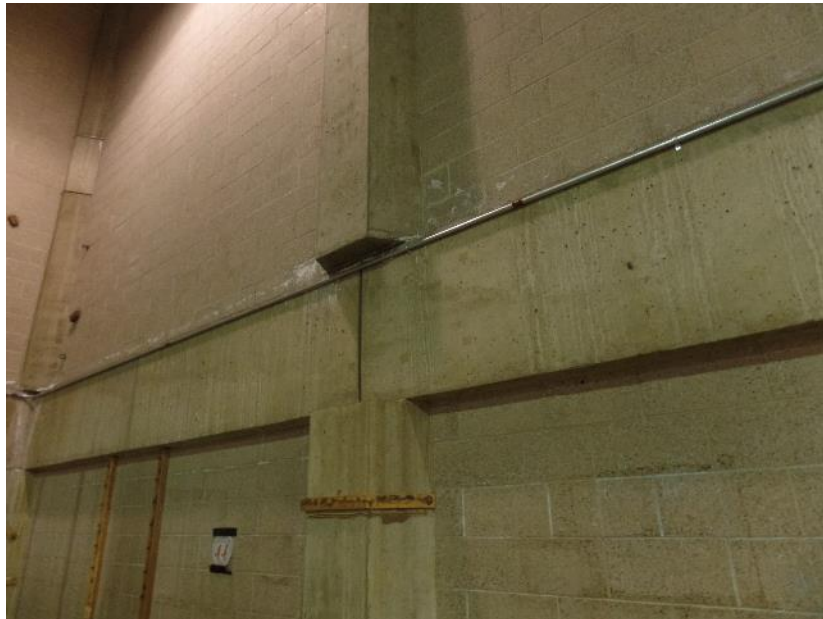
**Photo10:** Efflorescence on Interior Face of Exterior Wall

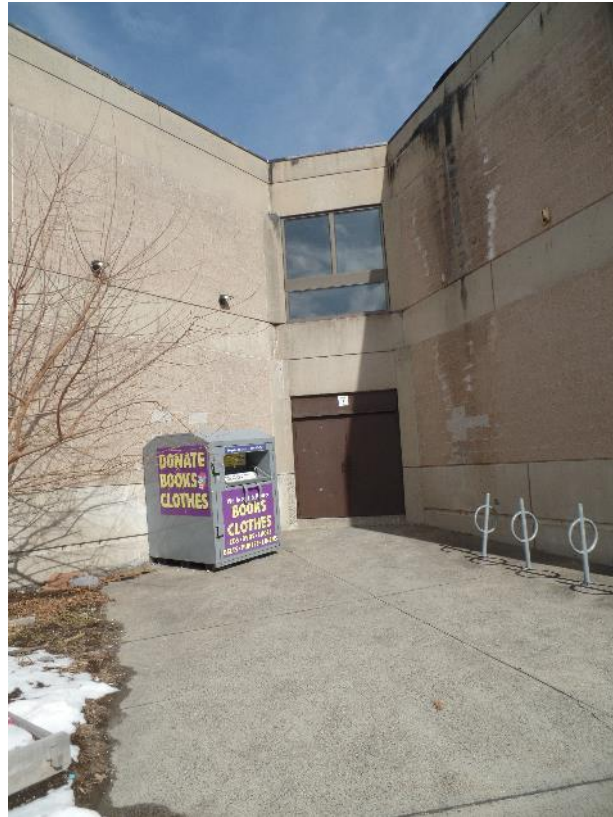
**Photo 11:** Exterior Masonry Wall - Moisture Damage

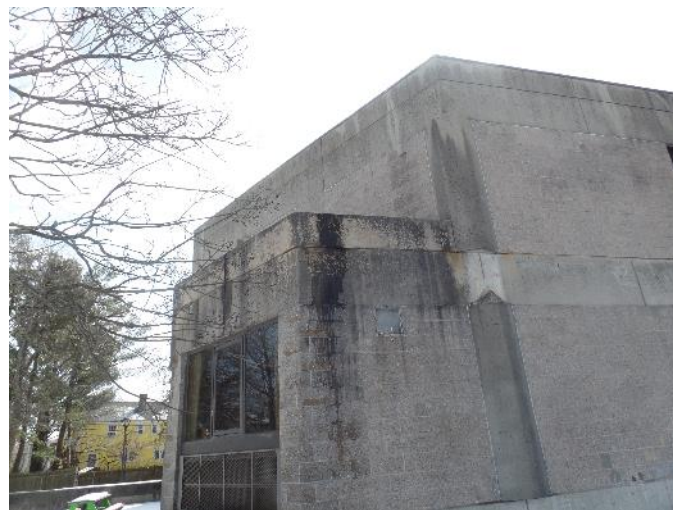
**Photo 12:** Exterior Masonry Wall -Moisture Damage

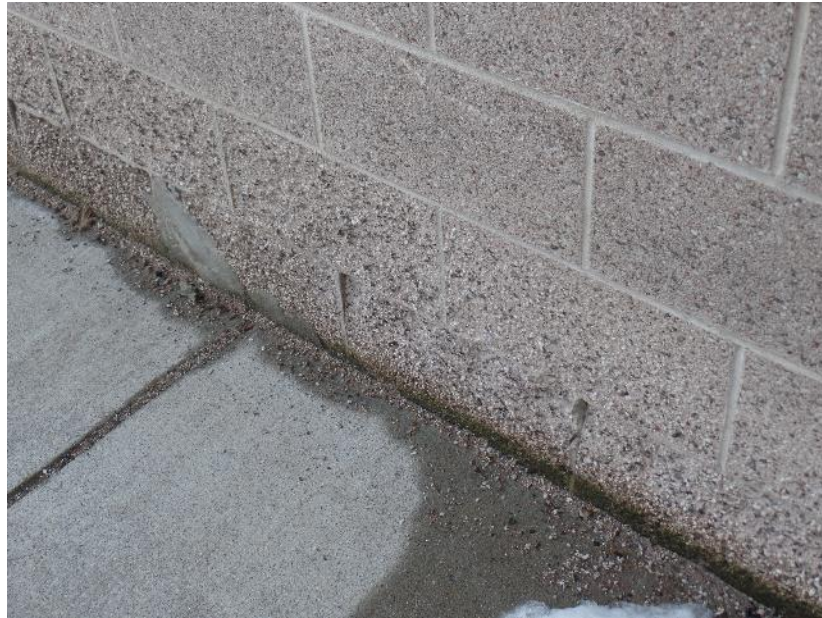
**Photo 13:** Exterior Masonry Wall - Surficial Damage at Walkway

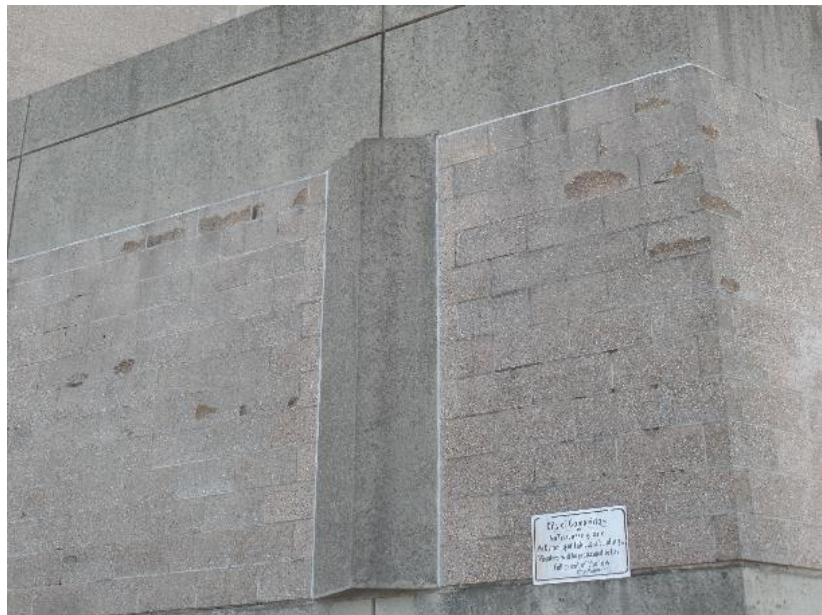
**Photo 14:** Exterior Masonry Wall - Surficial Damage

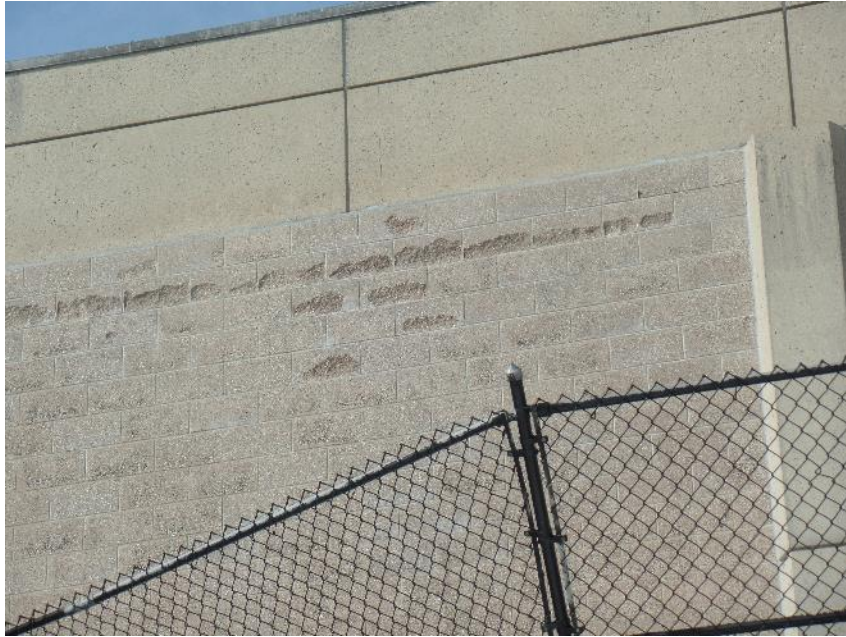
**Photo 15:** Exterior Masonry Wall - Surficial Damage

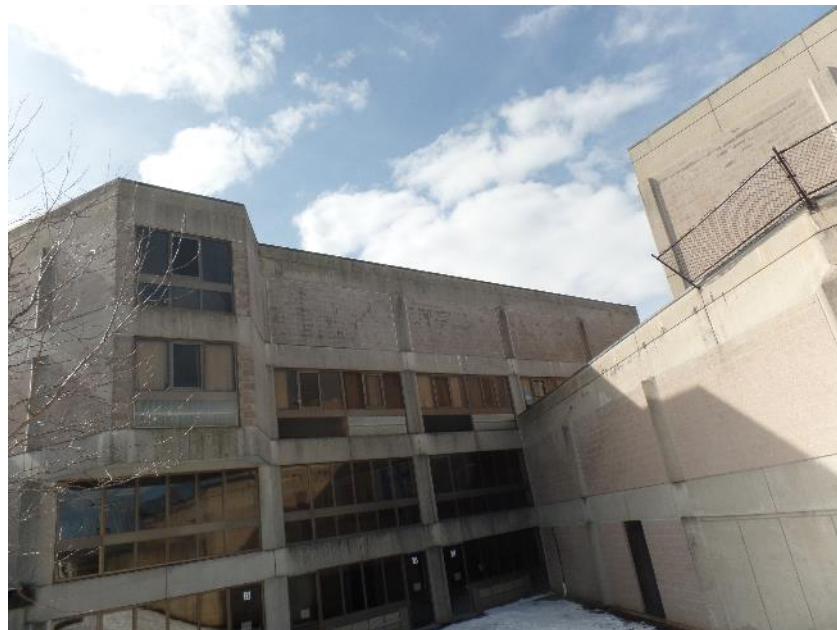
**Photo 16:** Exterior Masonry Wall - Surficial Damage

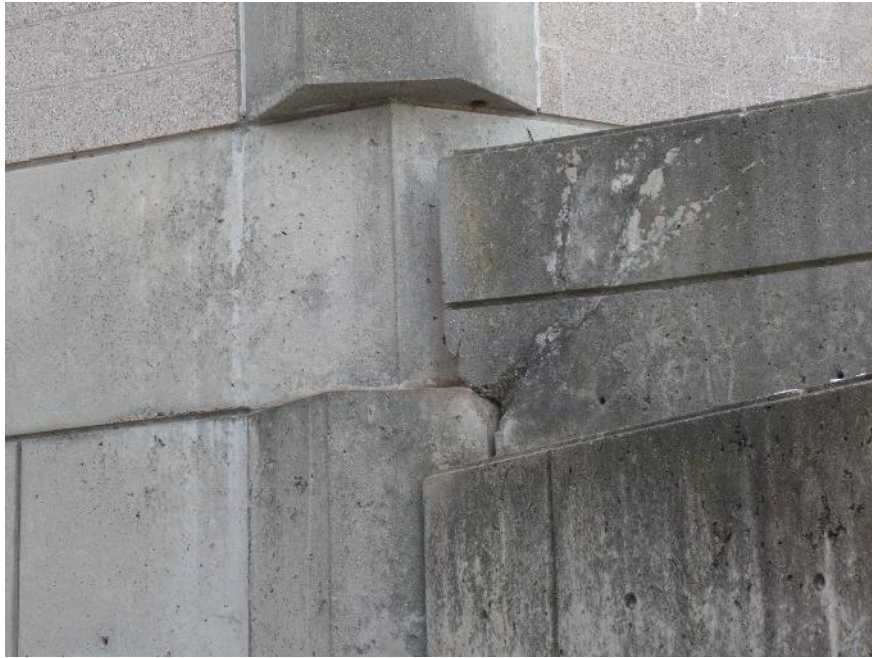
**Photo 17:** Expansion Joint South of the Gymnasium

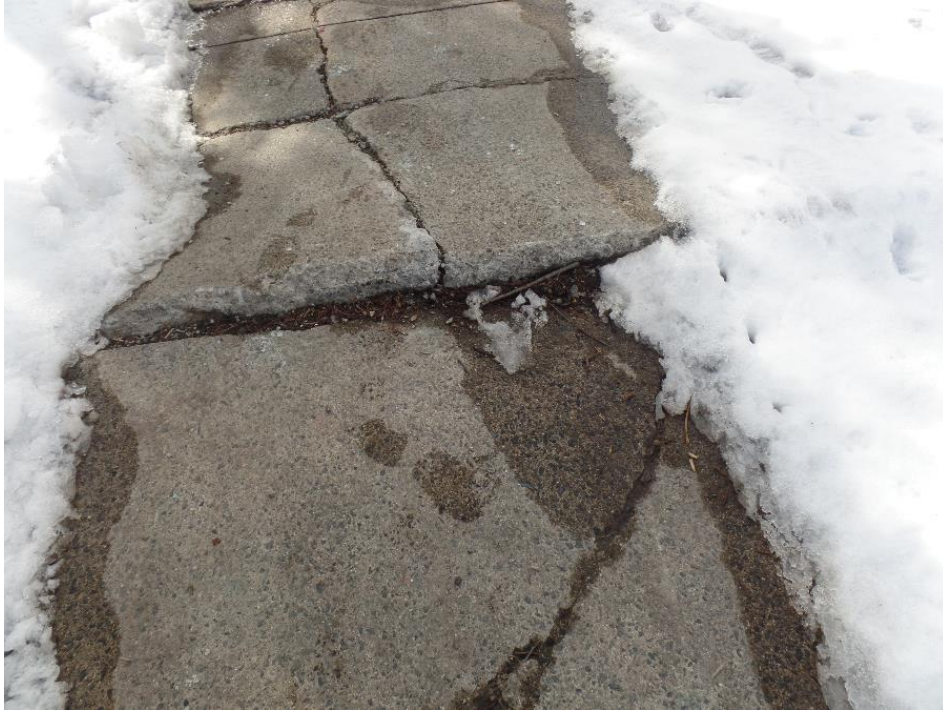
**Photo 19:** Cracked/Frost-Heaved Sidewalk
