# THE COLLECTION AT HARVARD SQUARE

April 11, 2017

HARVARD SQUARE, CAMBRIDGE, MA

**The Collection at Harvard Square**  
**HISTORIC COMMISSION**

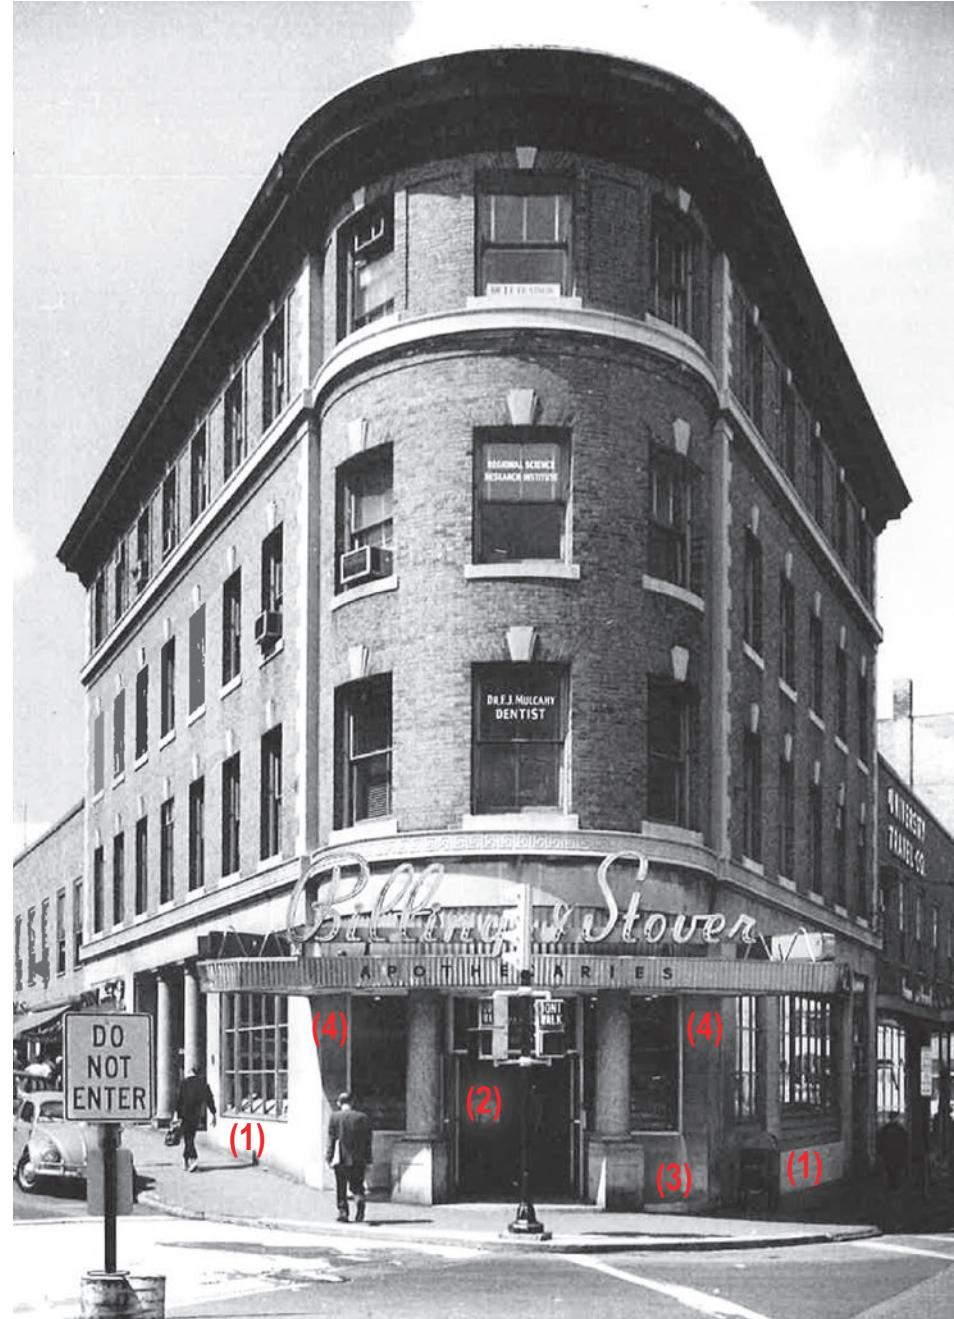
**NOTED CHANGES**

- (1) LIMESTONE INFILLS AT WINDOW OPENINGS
- (2) OPENING RECONFIGURED IN 1948. FLAT WALL AND DOOR RECESSED IN CURVED FACADE
- (3) GRANITE CURBS REMOVED
- (4) LIMESTONE INFILL PIERS FLANKING NEW ENTRANCE COVER PILASTERS

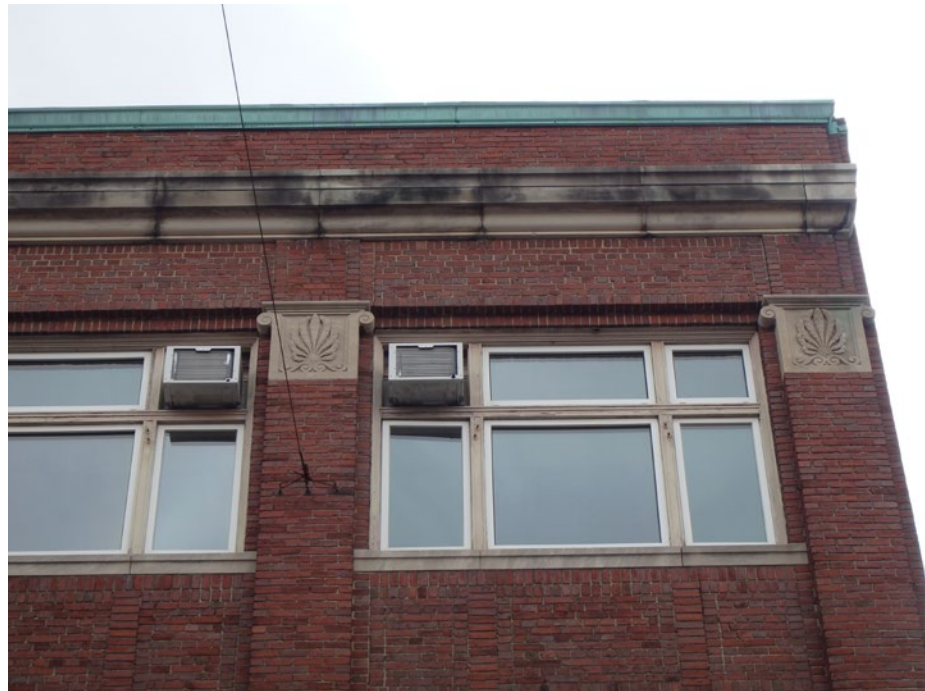
TYPICAL LIMESTONE AND BRICK SOILING

- Clean brick and limestone using gentlest means possible to remove atmospheric soiling and staining.
- Repoint all open brick and limestone mortar joints. Use mortar that matches existing in color, texture and composition.

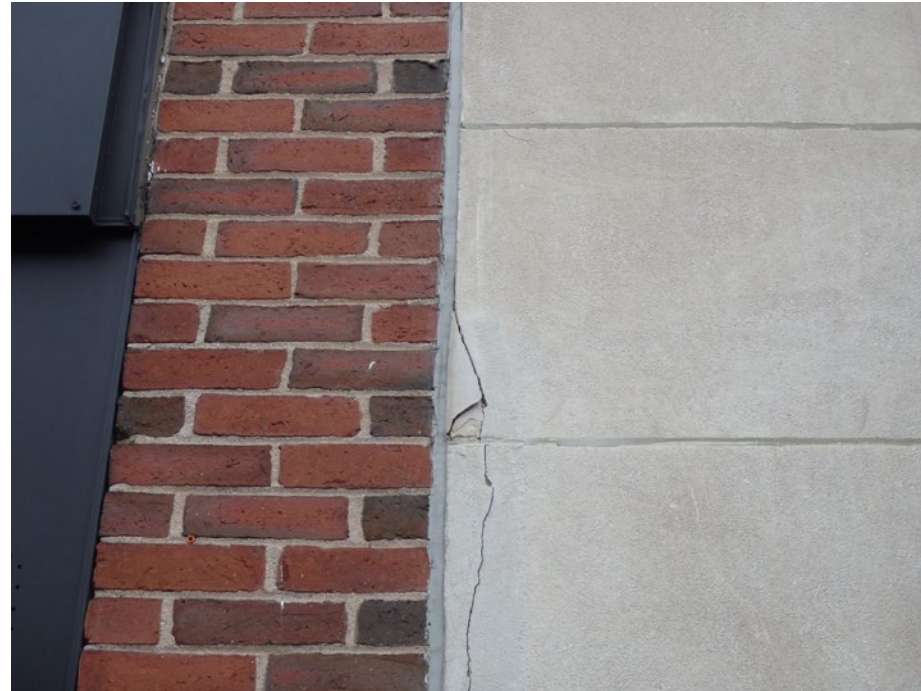
CRACK IN LIMESTONE TO BE REPAIRED WITH PINS AND GROUT

- Replace any cracked brick with new brick matching existing in color, texture and composition.
- Repair cracks in limestone with stainless steel pins and patching material.

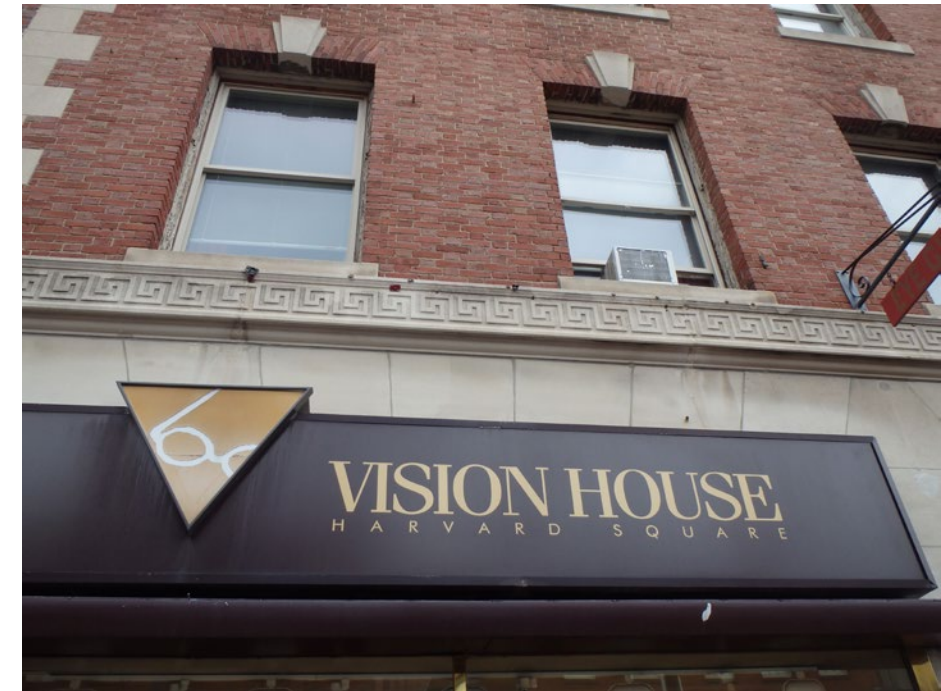
FERROUS ANCHORS, CONDUITS, AND ATTACHMENTS TO BE REMOVED AND RESULTING HOLES PATCHED

- Remove all ferrous anchors, conduits and attachments. Patch resulting holes in brick and limestone with cementitious patching material (<1" diameter); or Dutchman (>1" diameter).

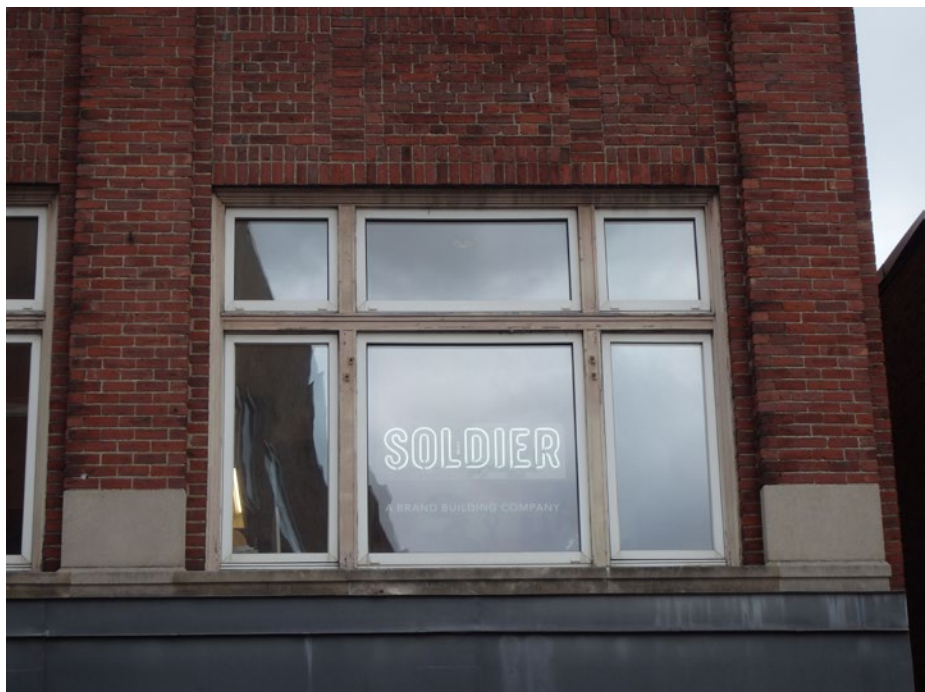
WOOD WINDOW FRAMES TO BE RESTORED. WOOD WINDOW SASH TO BE REPLACED TO MATCH ORIGINAL PROFILES AND CONFIGURATION.

- Furnish and install new wood windows to match historic profiles.
- Restore existing wood frames and trim.

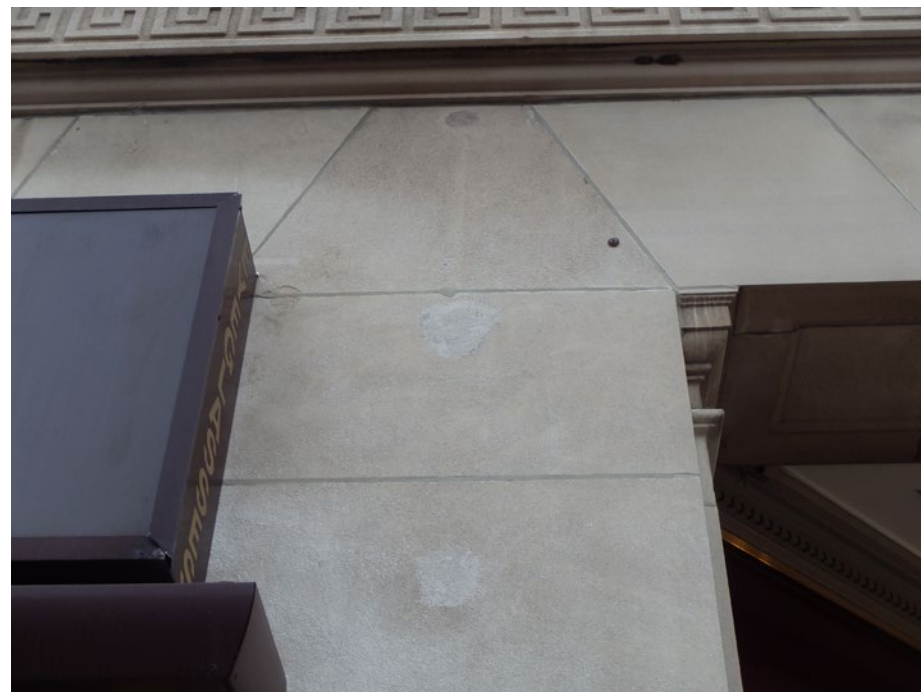
PREVIOUS LIMESTONE PATCHES TO BE REMOVED AND NEW PATCHES INSTALLED TO MATCH SURROUNDING STONE

- Remove all previous limestone patches that are failing, or do not match surrounding in color or texture. Patch resulting voids with cementitious patching material (<1" diameter); or Dutchman (>1" diameter).

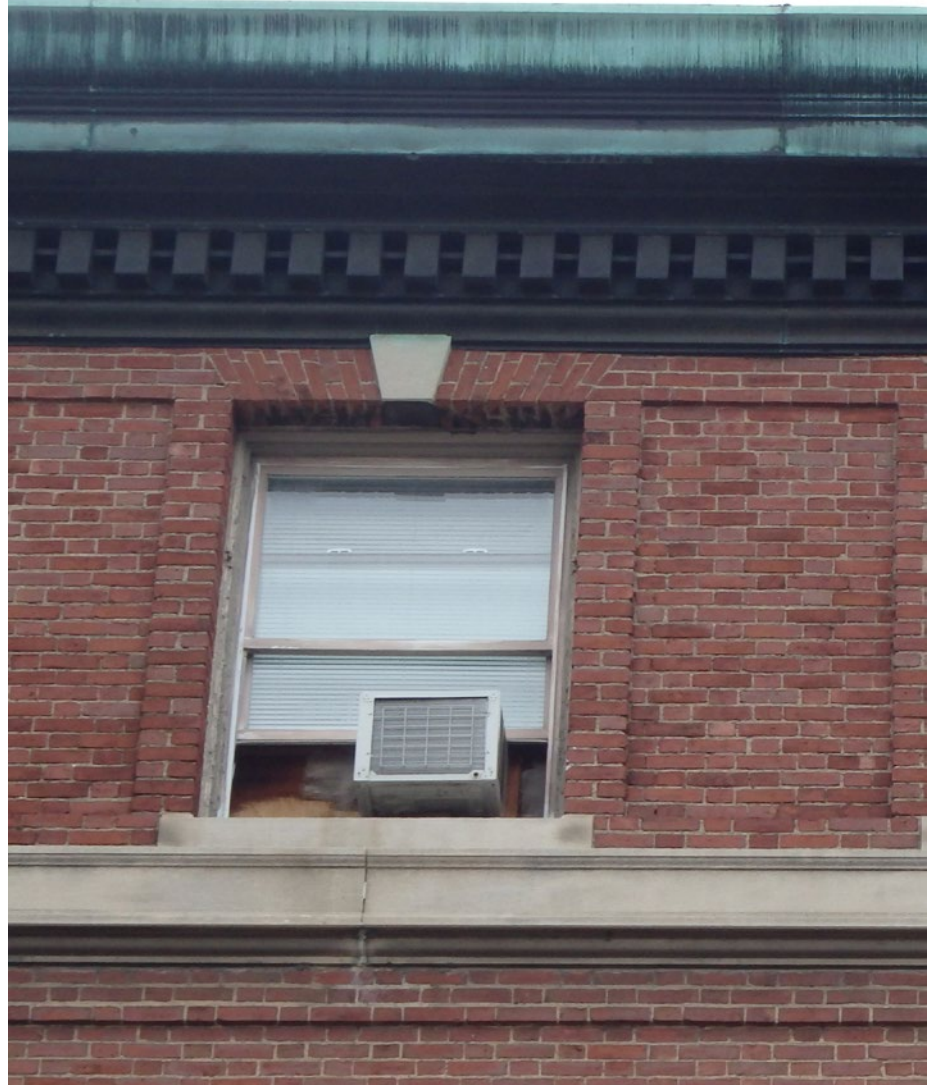
OPEN JOINTS AT LIMESTONE BELT COURSE. COPPER CORNICE TO BE INSPECTED
