# Hobbs Brook Dam Repairs

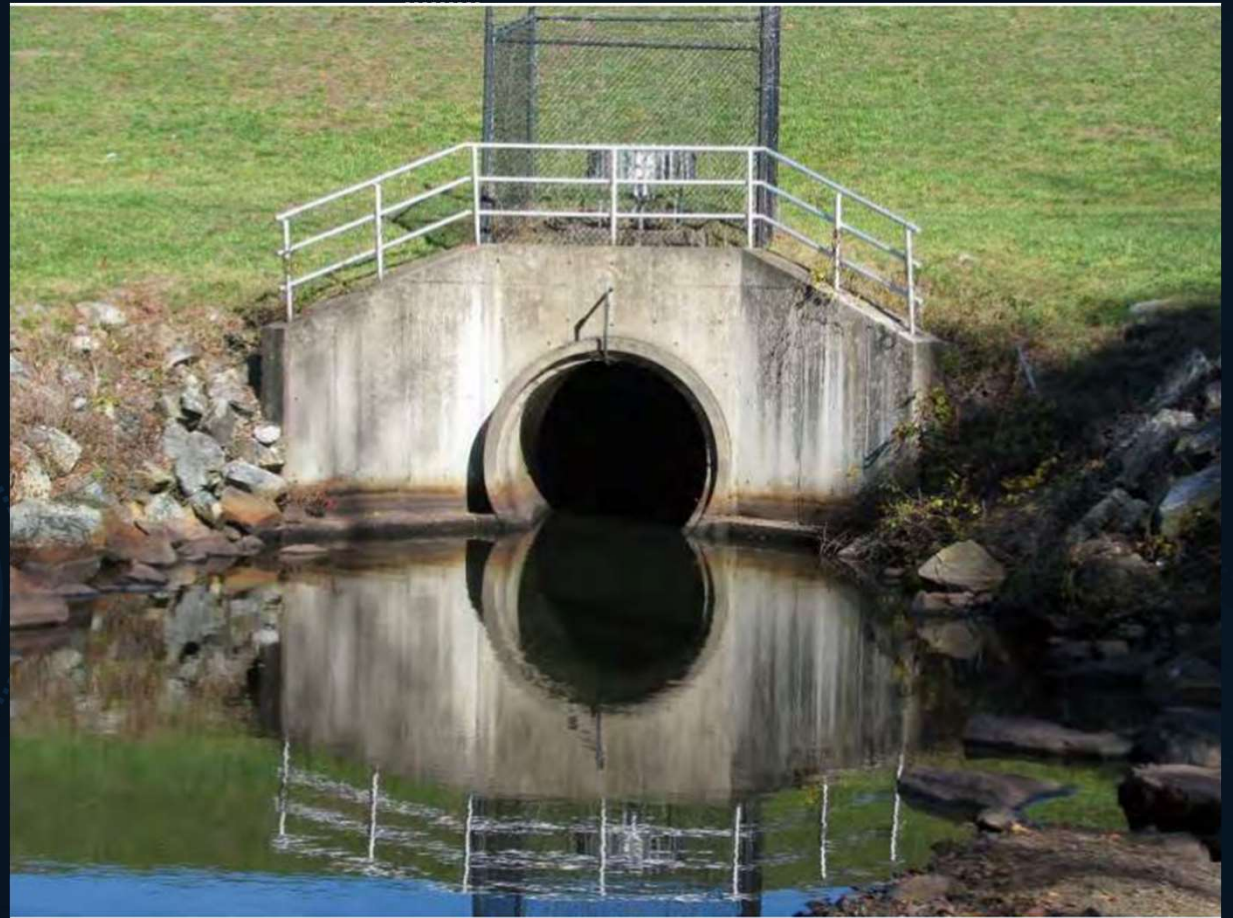
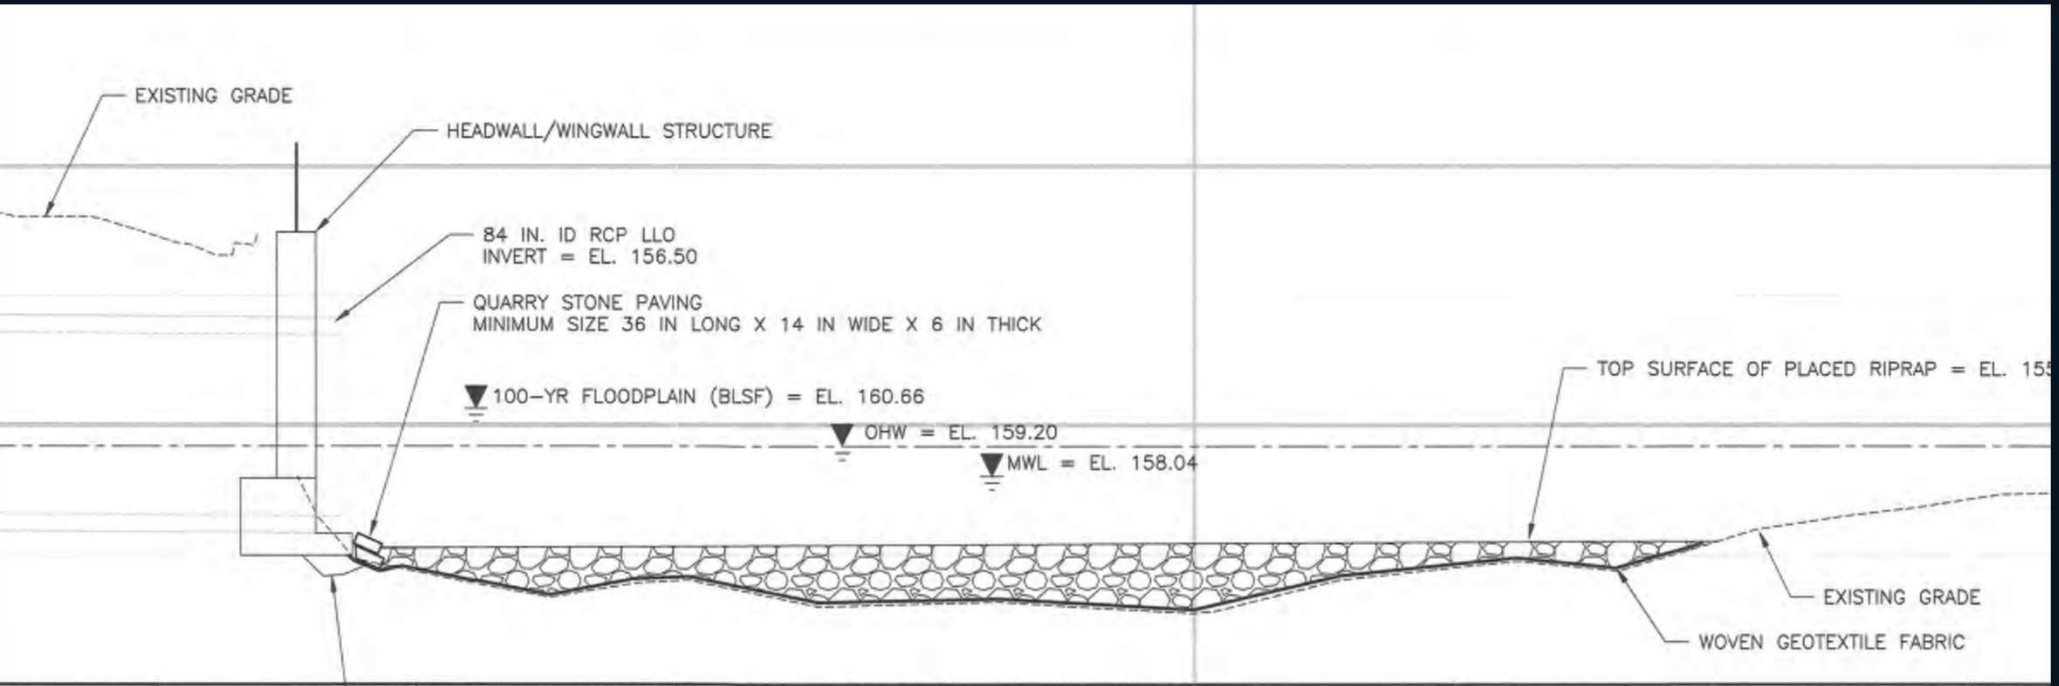
# Downstream Outlet

VOID BENEATH HEADWALL FOOTING TO RECEIVE UNDERWATER GROUT AND GROUT-FILLED BAGS
