Willard Street Drainage Improvements Project

Community Meeting #1

March 30, 2017

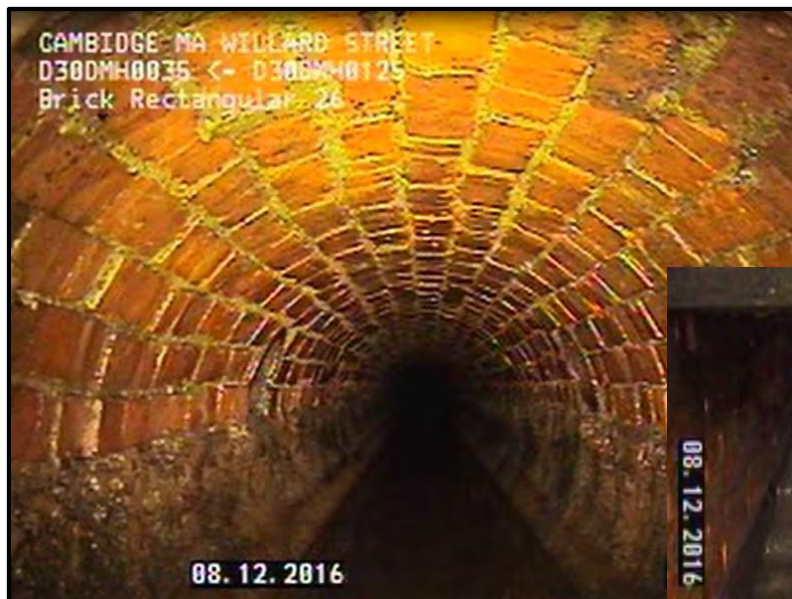
24"x 26" Brick sewer ↗

↖
Wood and slate in structure at Willard/Foster Street manhole

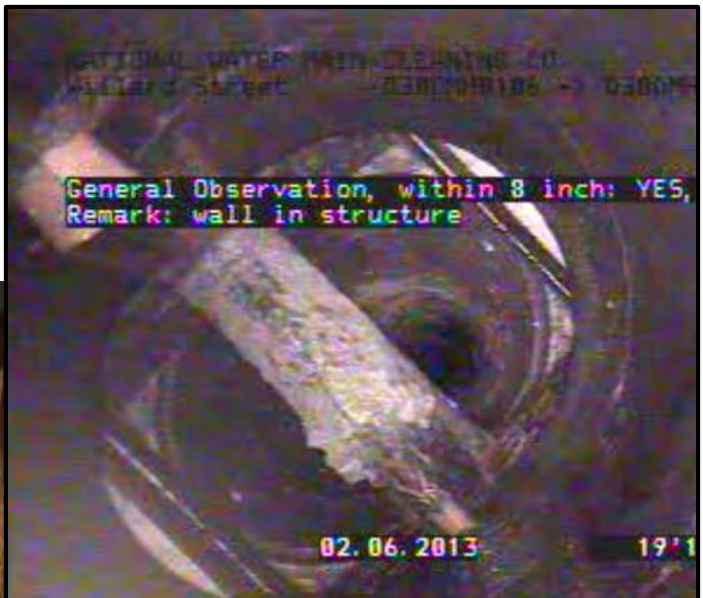
↖
Bulkhead and pipe redirecting flow to access structure (from 2013 inspection)

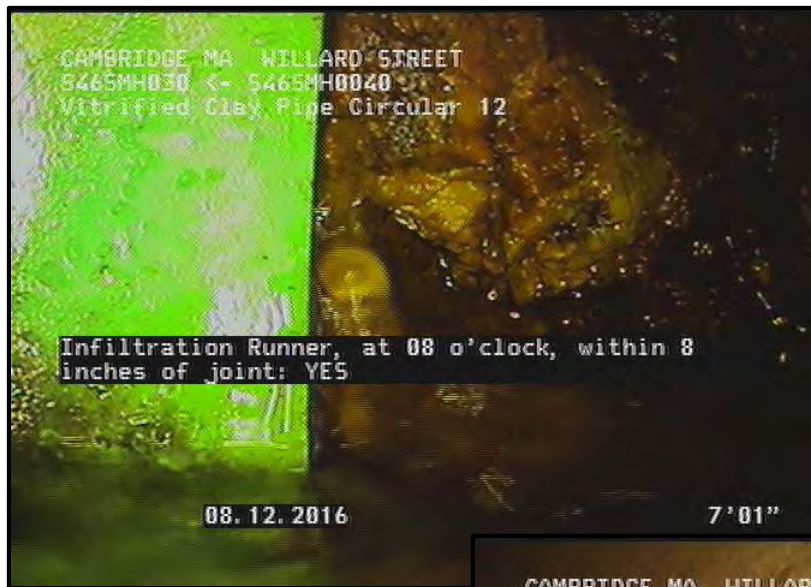
Example of infiltration (at joint)

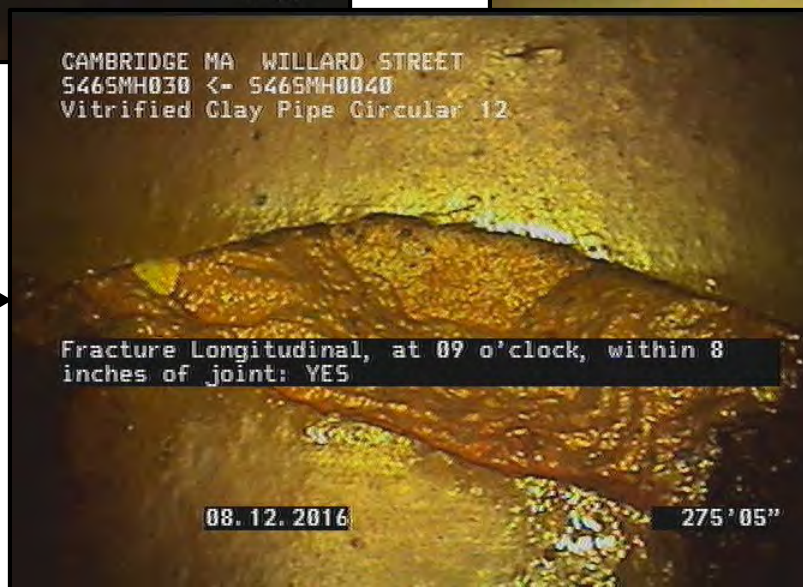
Example of fracture

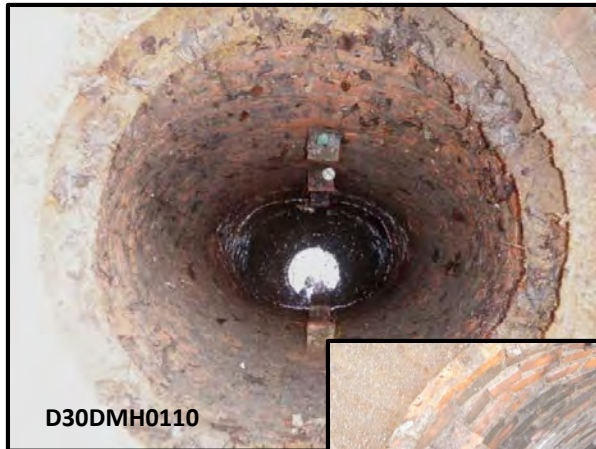
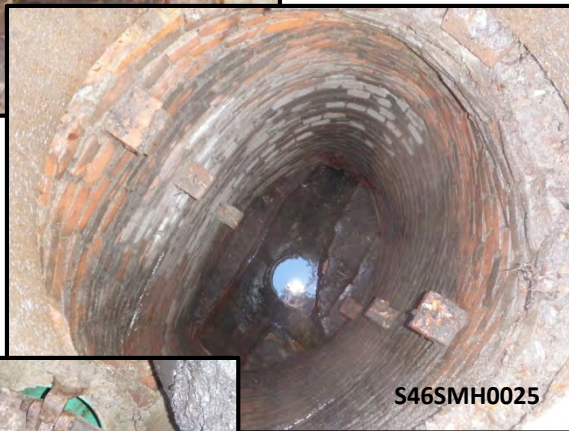
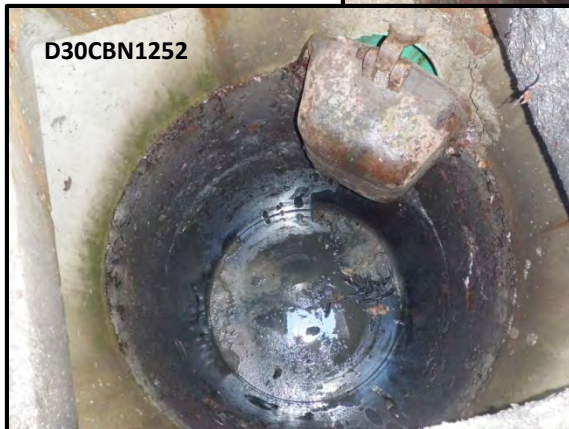
- **Materials:**
 - brick (MHs, some CBs)
 - concrete (CBs)
- **Condition:** fair to good
- **Initial findings:**
 - A couple MHs have missing bricks/mortar
 - Moderate amount of debris (leaves, dirt, etc.) in catch basins (all CBs required cleaning)
 - Many CBs have hoods on outlet pipes

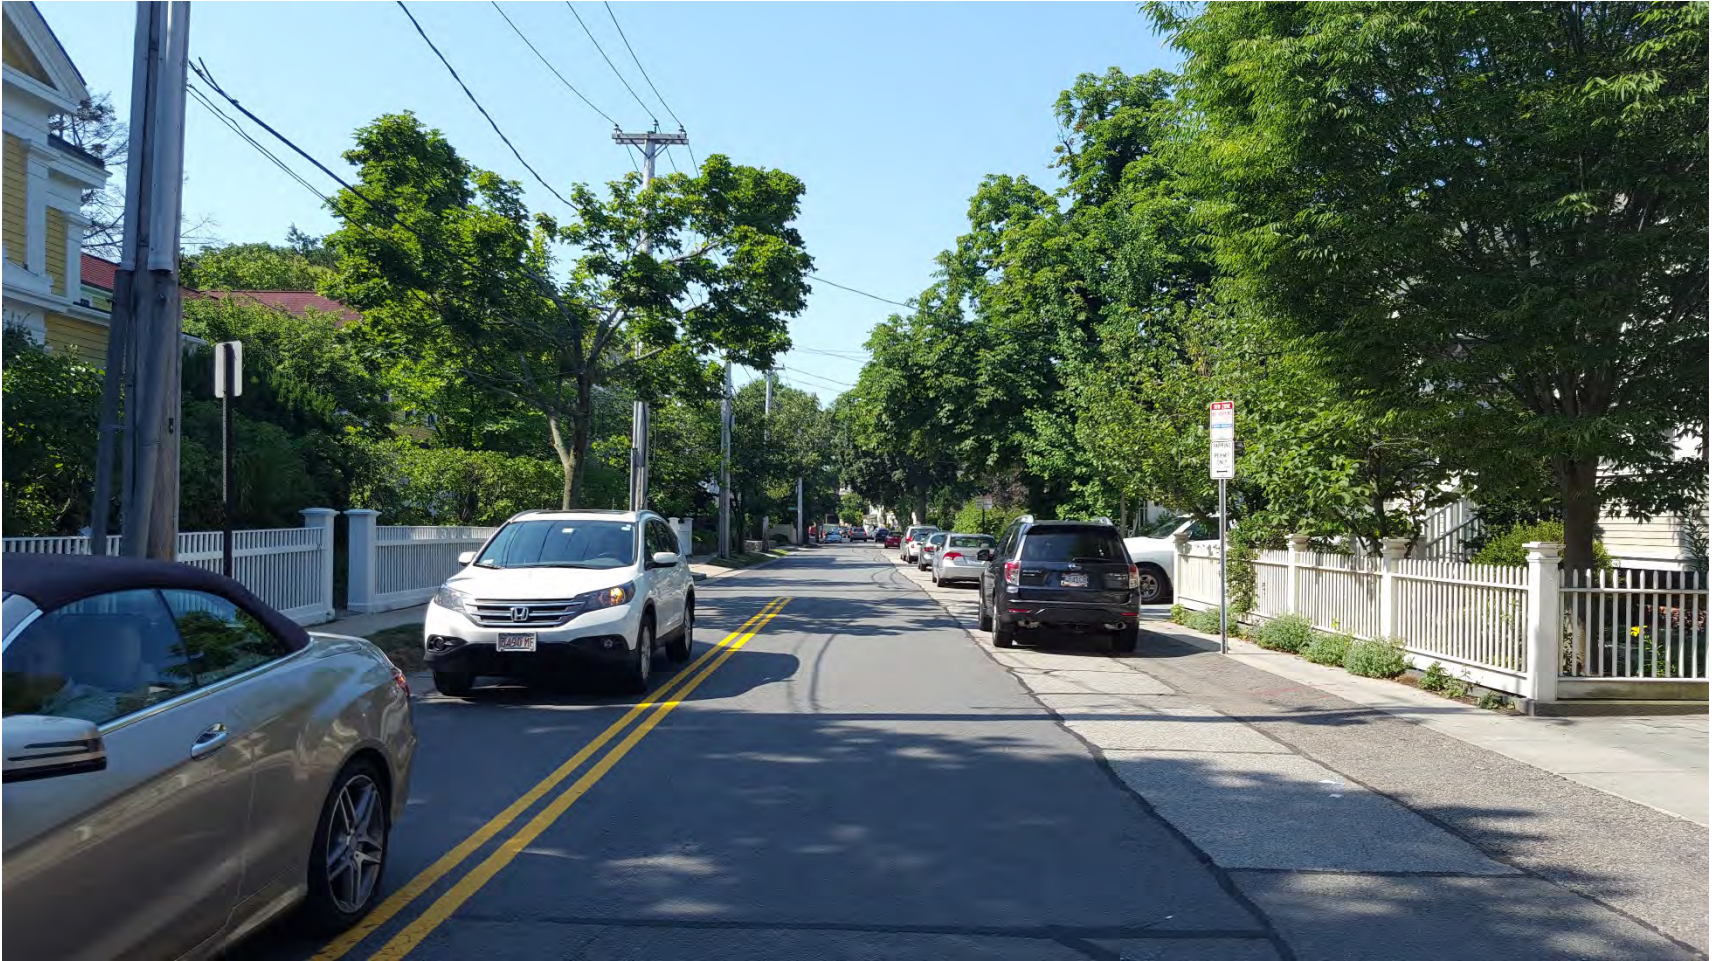
Current Conditions - Looking South (from Brattle end)

- **Parking West Side**
- **10' Travel Lanes**
- **Narrow/Obstructed Sidewalks**

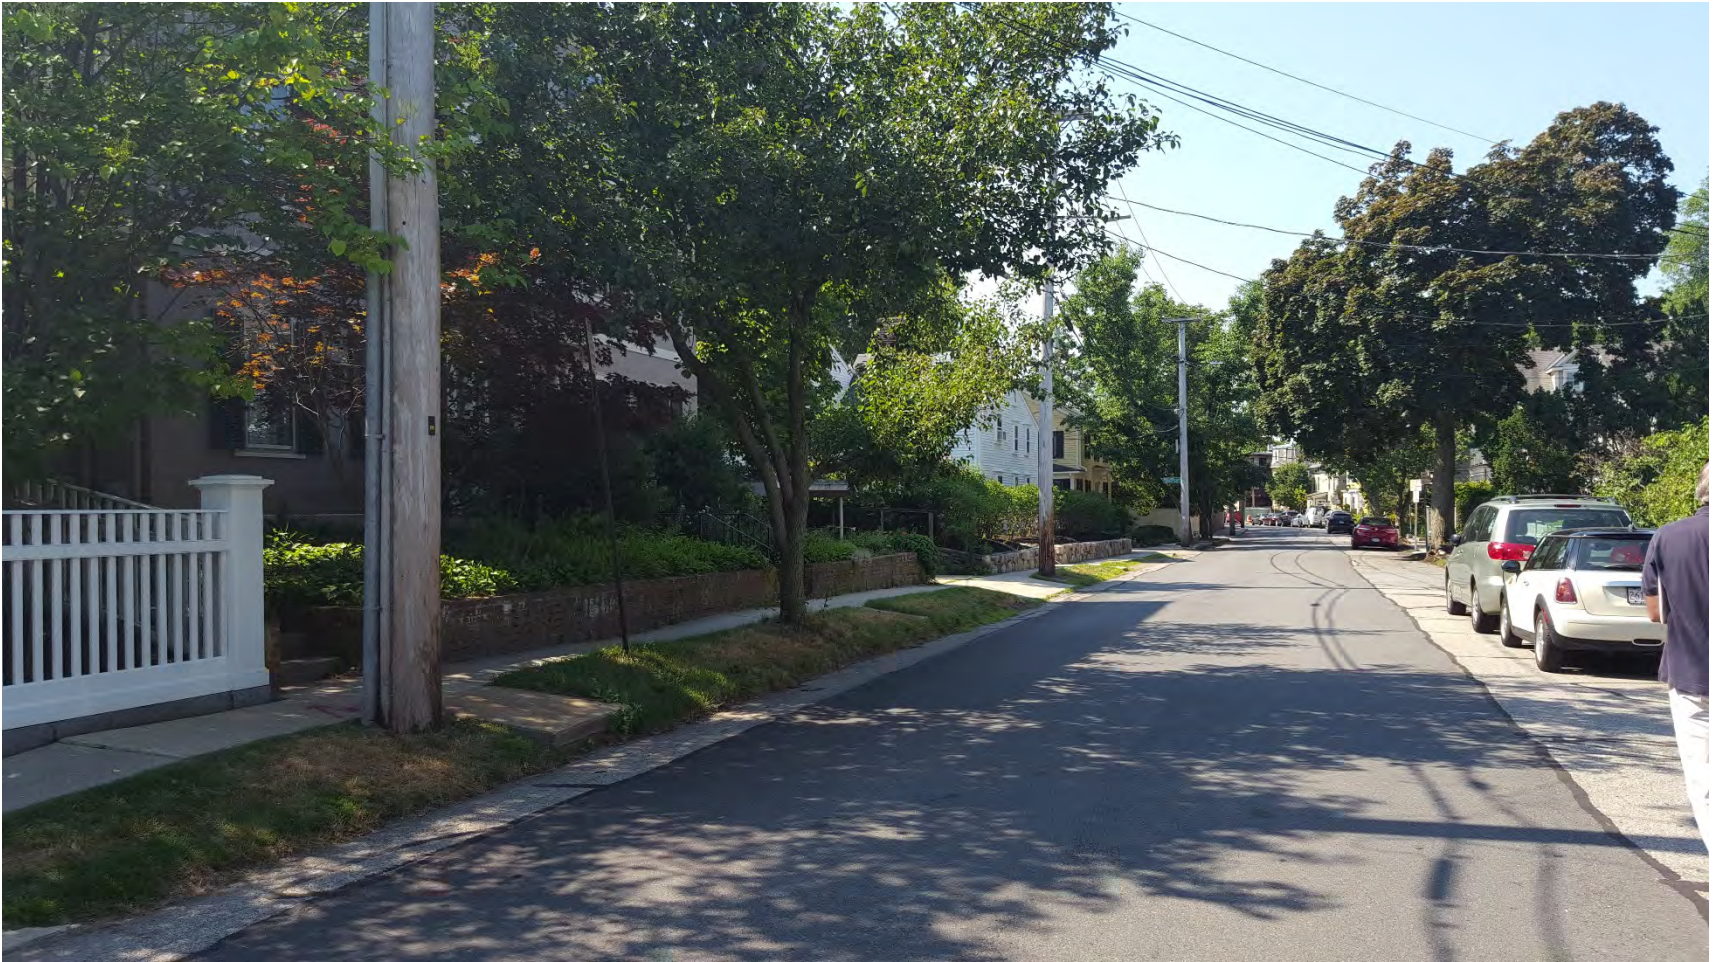
Current Conditions - Looking South (from Brattle end)

- **Parking West Side**
- **Overhead Utilities/Lighting**
- **Narrow/Obstructed Sidewalks**

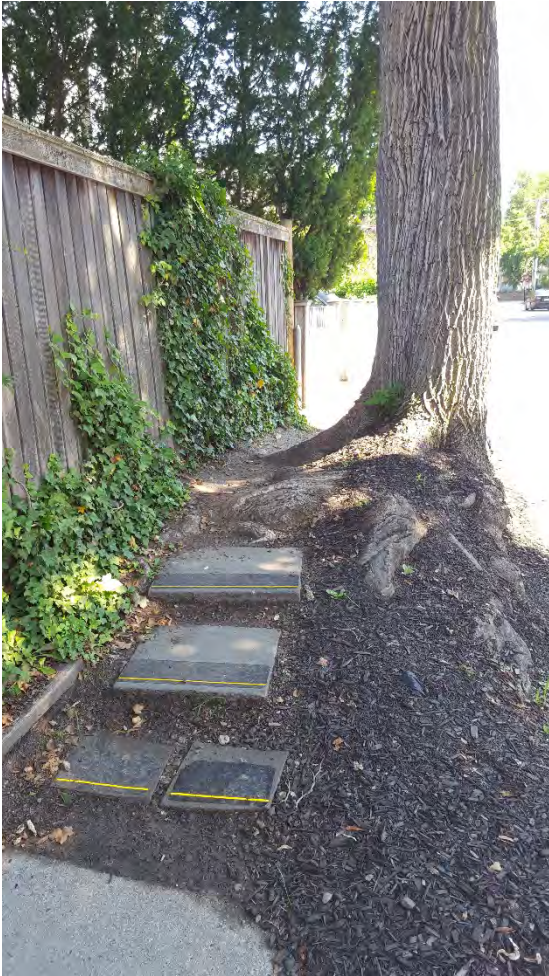
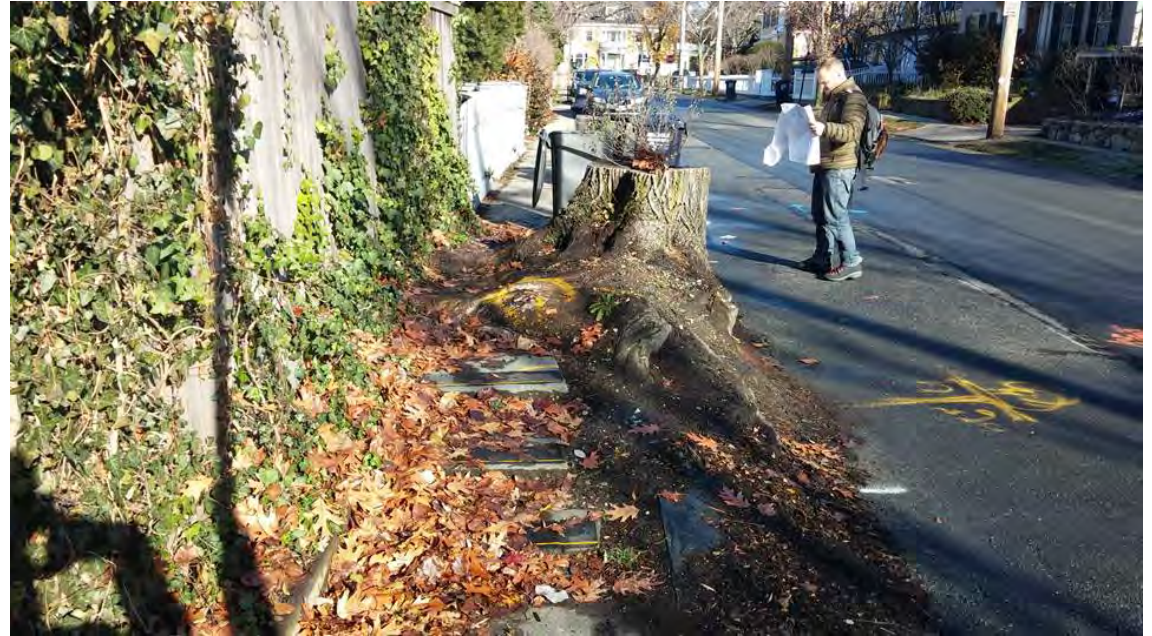
Current Conditions - Looking West (#11-#15 Willard)

- **Narrow/Obstructed Sidewalks**
- **ADA Accessibility Issues**

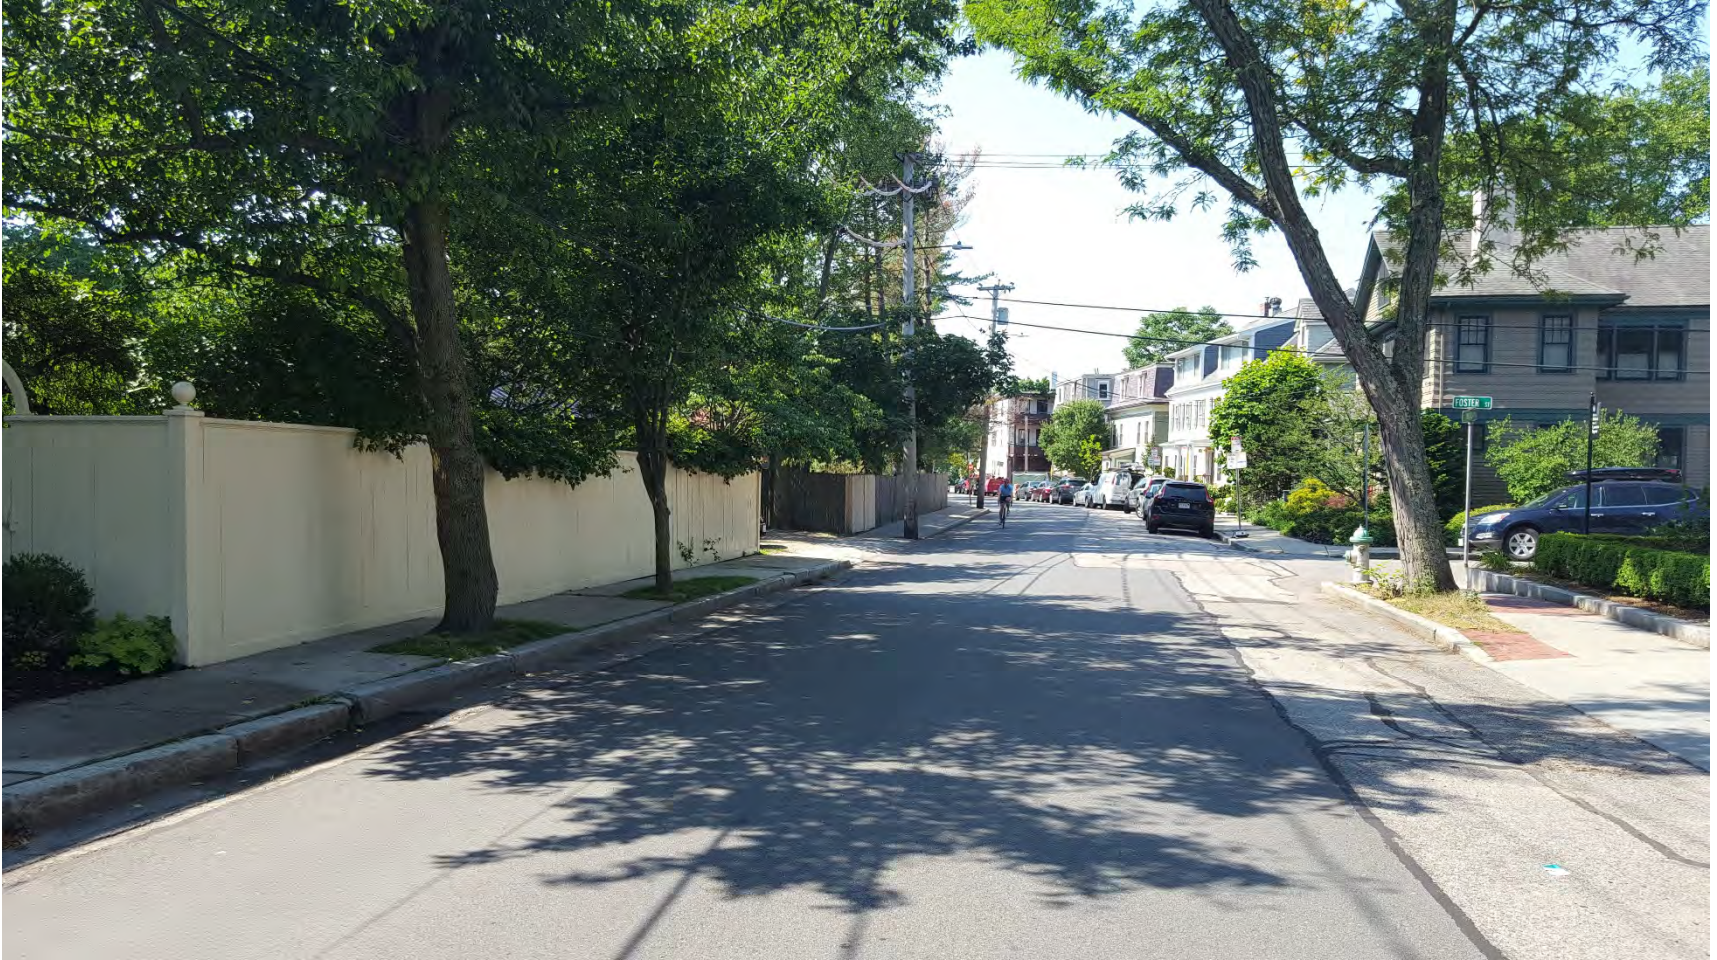
Current Conditions - Looking South (at Foster Street)

- **Parking West Side Only**
- **Limited opportunity for street trees**
- **Narrow/Obstructed Sidewalks on both sides**

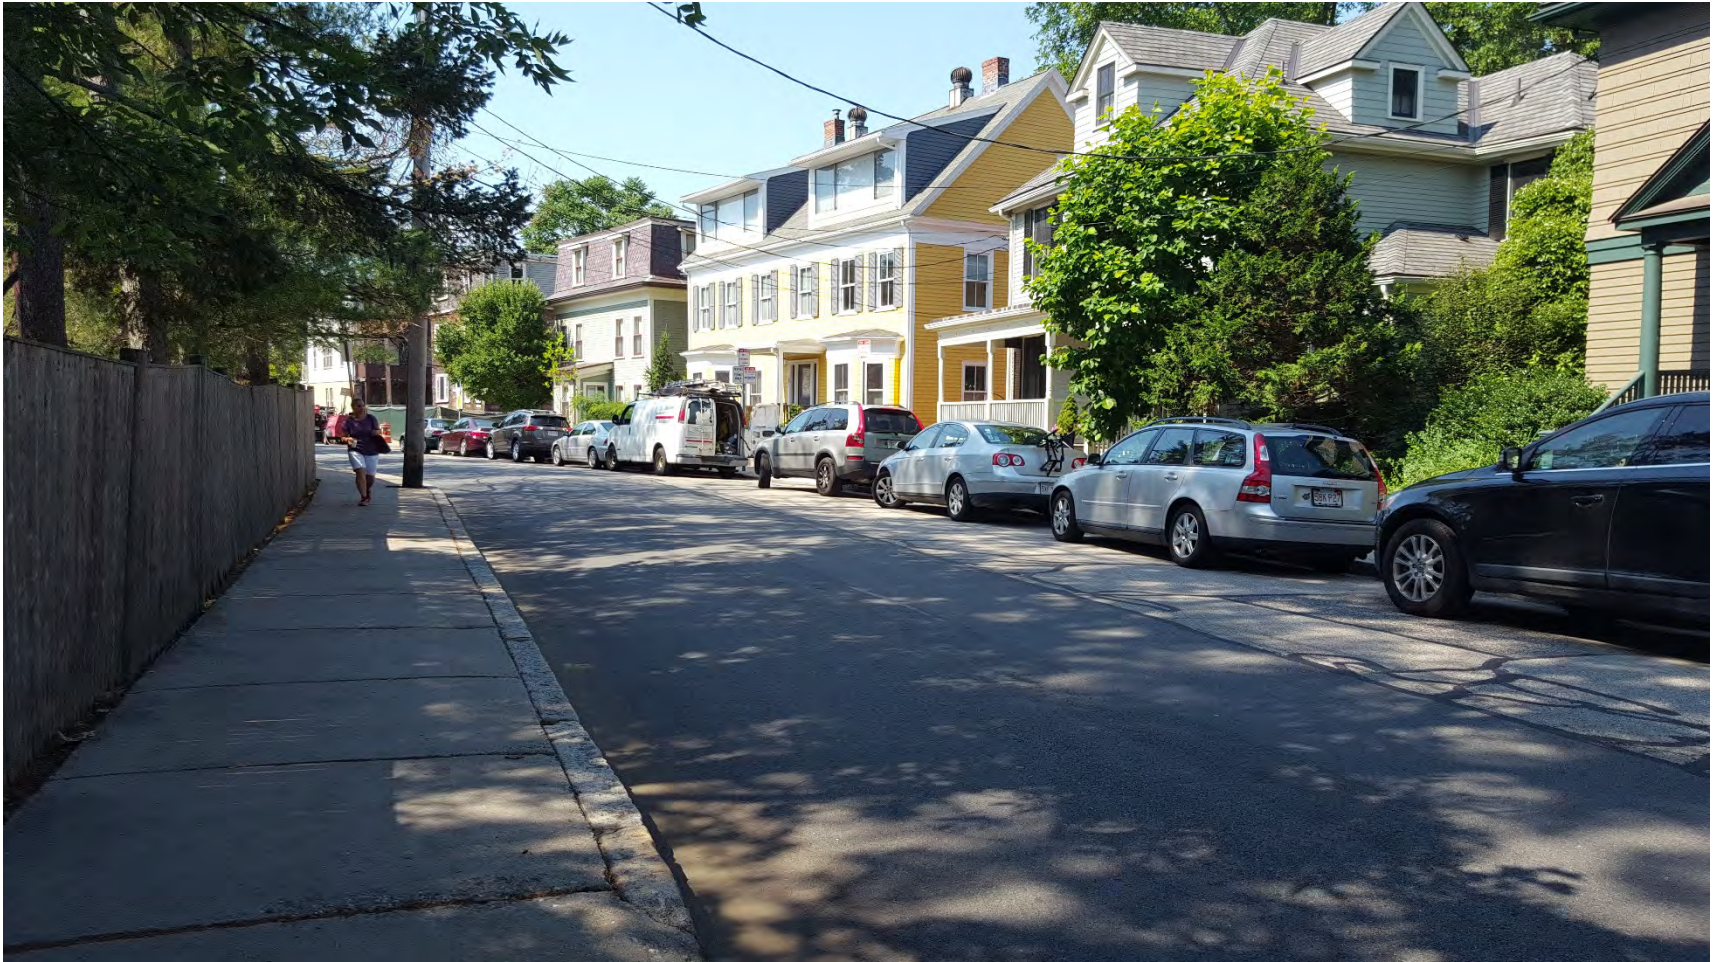
Current Conditions - Looking South (Skate Club/Foster)

- **Parking West Side**
- **10' Travel Lanes, both directions**
- **Narrow Sidewalks**

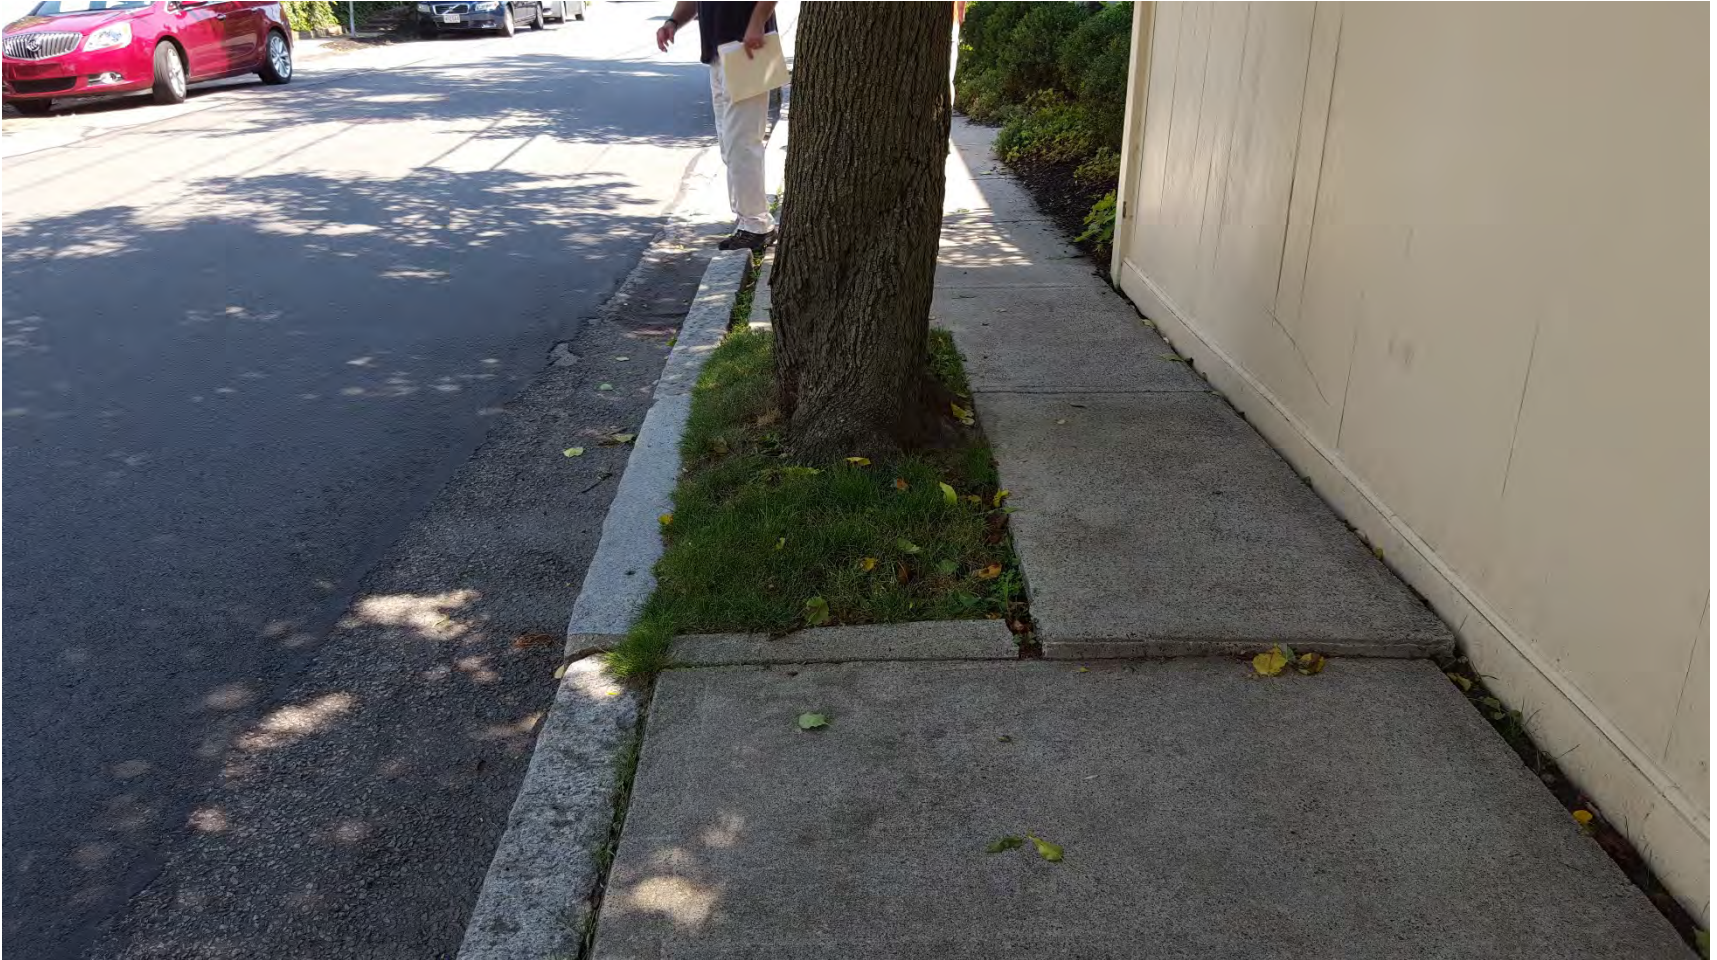
Current Conditions - Looking North (Skate Club)

- **Narrow/Obstructed Sidewalks**
- **Little opportunity for treatment enhancements**
- **Constrained Tree-pit zone and uplifted concrete**

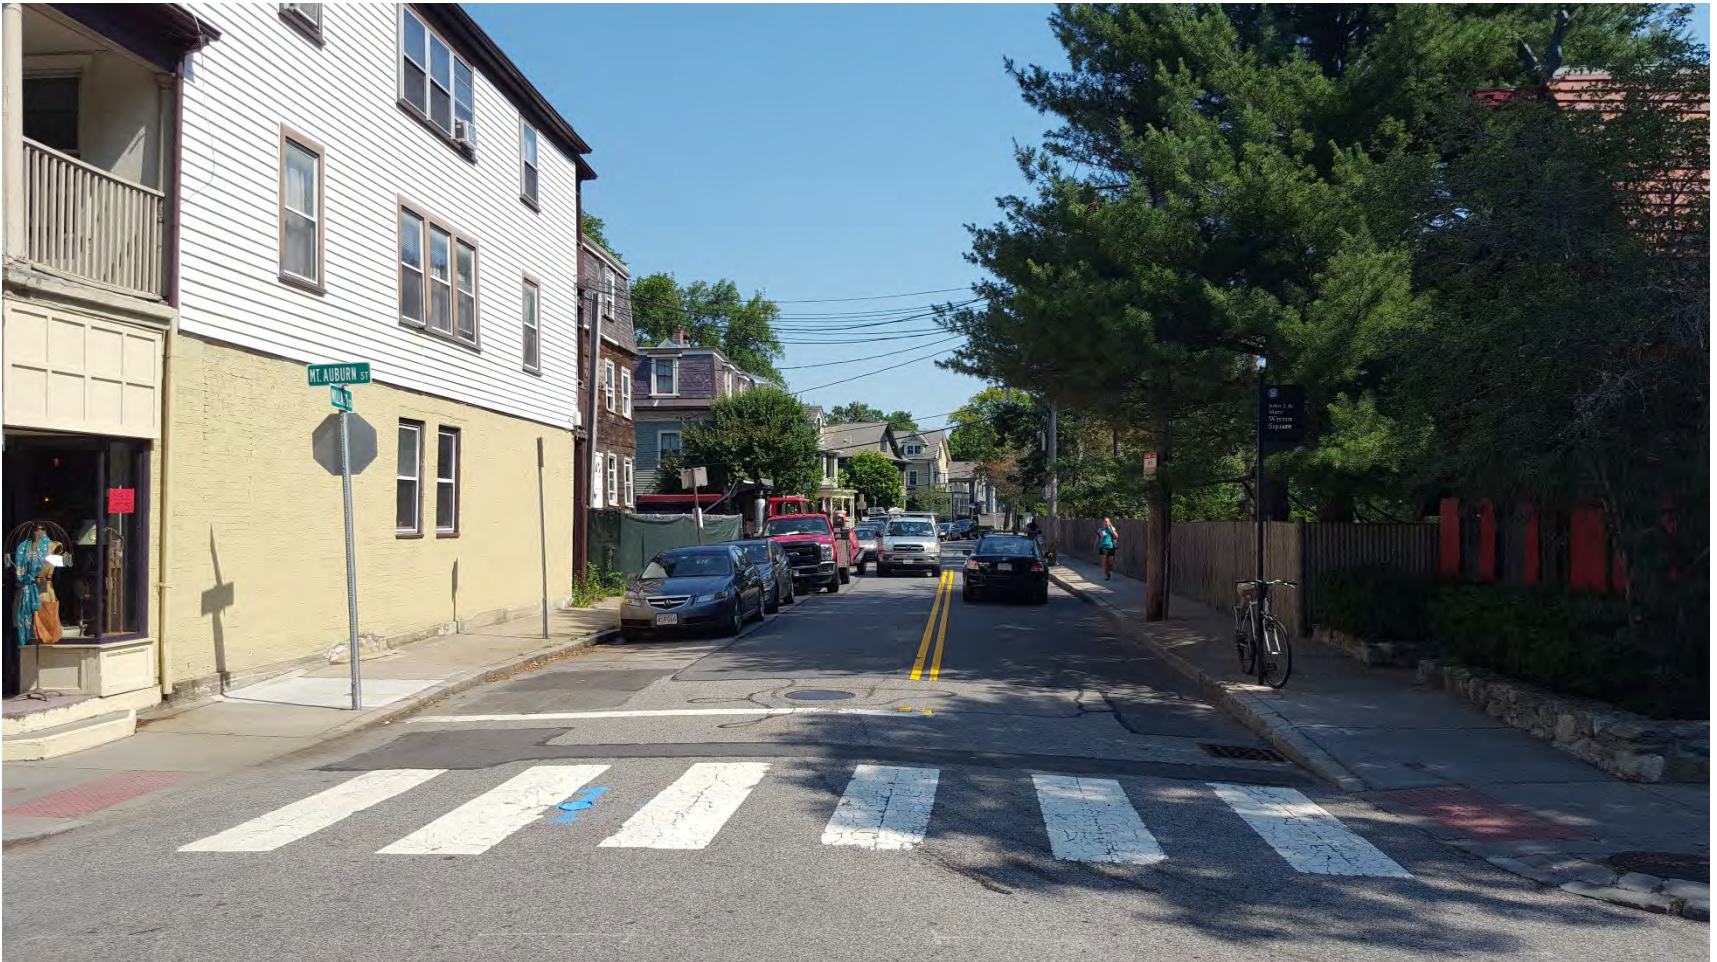
Current Conditions - Looking North (at Mt. Auburn St.)

- **Parking West Side**
- **10' Travel Lanes, both directions**
- **Narrow/Obstructed Sidewalks**
