OUT OF TOWN NEWS - Historic Restoration

PUBLIC WORKS: BUILDINGS - HARVARD SQUARE KIOSK AND PLAZA

FY18 PROJECT DESCRIPTION	CITY COUNCIL GOALS
<p>An allocation of \$2,000,000 will be used to start the construction of the Harvard Square Kiosk and Plaza project, which will open up the historic kiosk building for more public use, renovate and enhance the historic character of the building, and build on its iconic presence in Harvard Square. The surrounding plaza area will be reconstructed to make it more inviting, enhance pedestrian usage, and improve accessibility.</p> <p>The Harvard Square Kiosk Working Group is advising the City Manager on the vision, programming, operations, and governance of the Kiosk and developing a framework for the ongoing operation of the space that preserves the public nature of the kiosk and its surrounding plaza over time.</p>

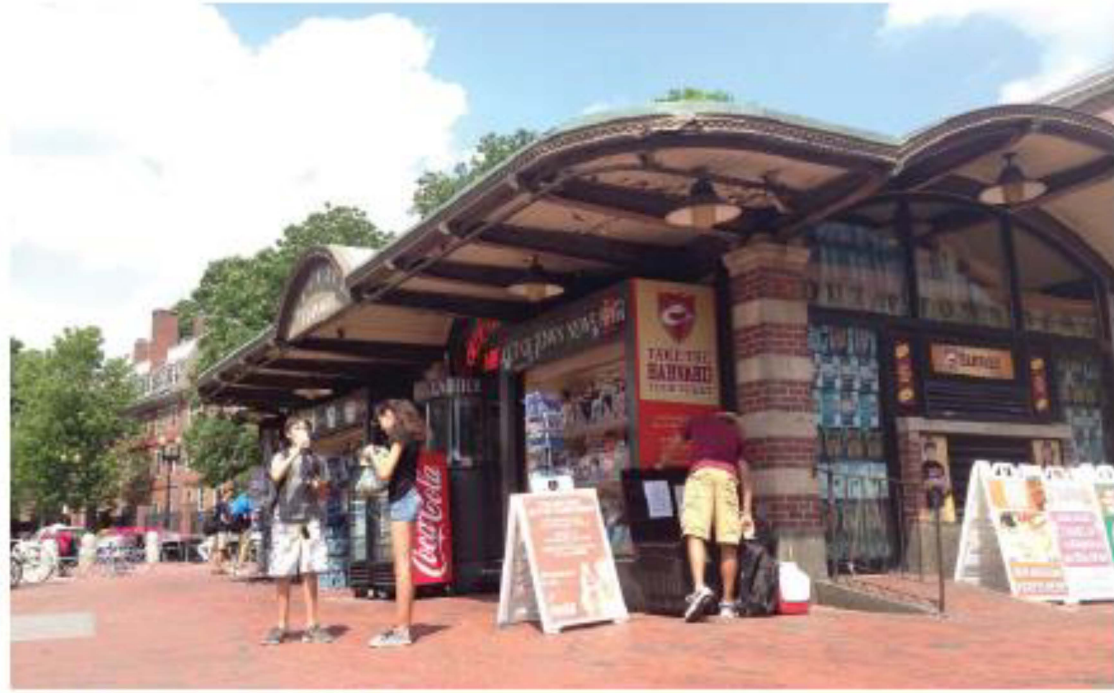
Brattle Street Facade - 2014

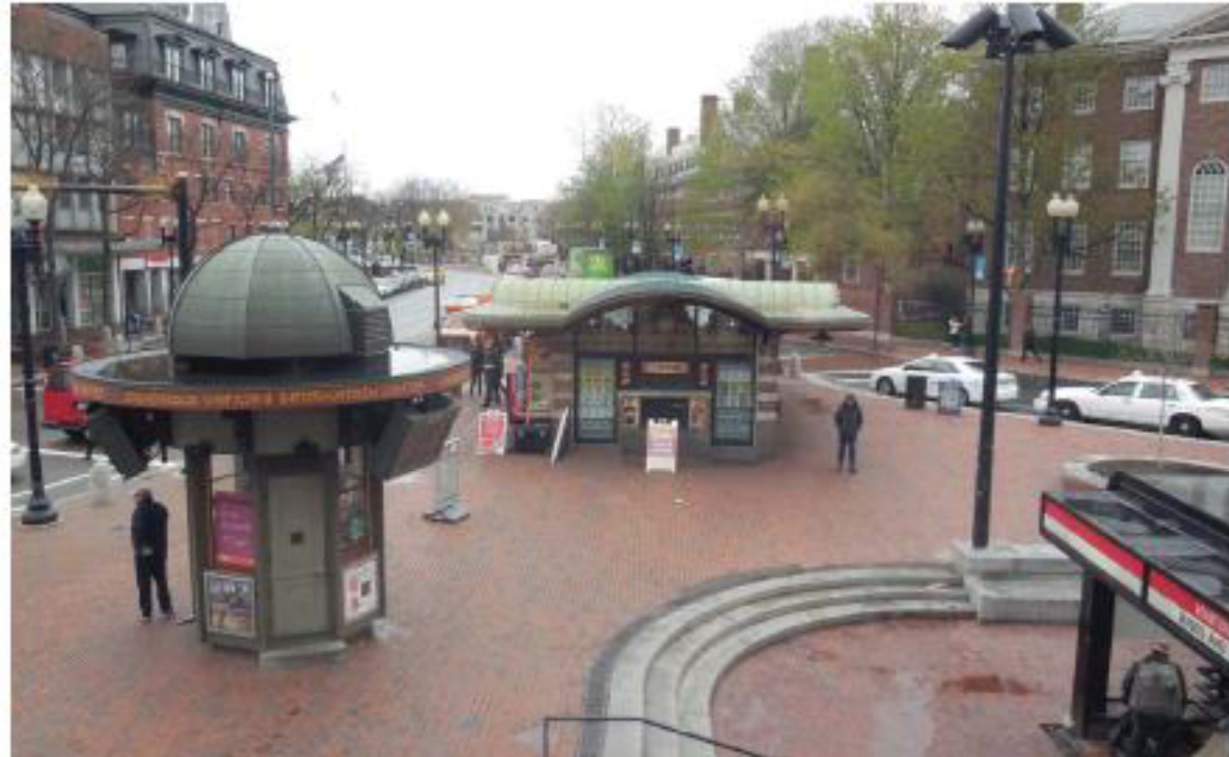
MBTA-Side Facade - 2014

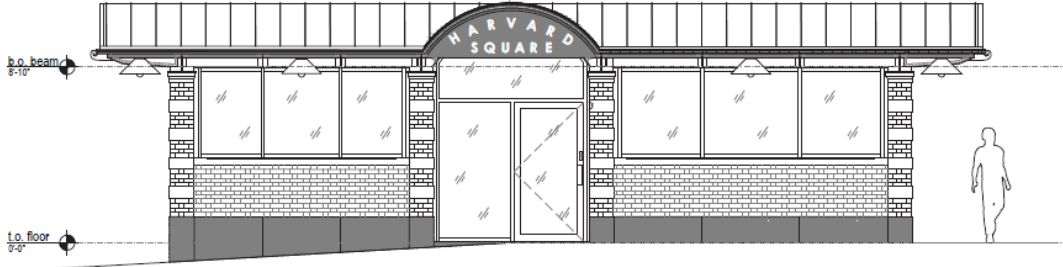
② Elevation - Massachusetts Avenue

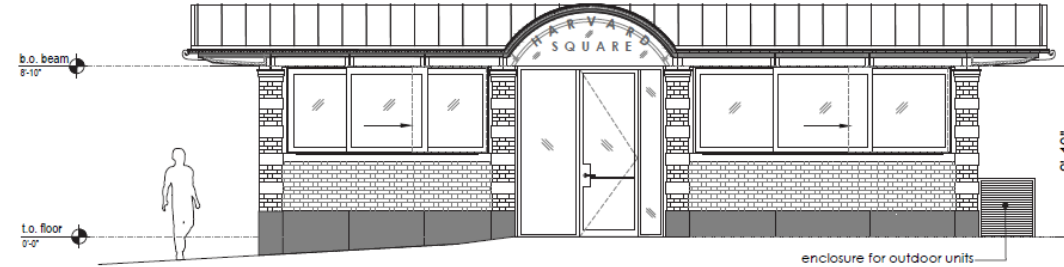
② Elevation - Massachusetts Avenue

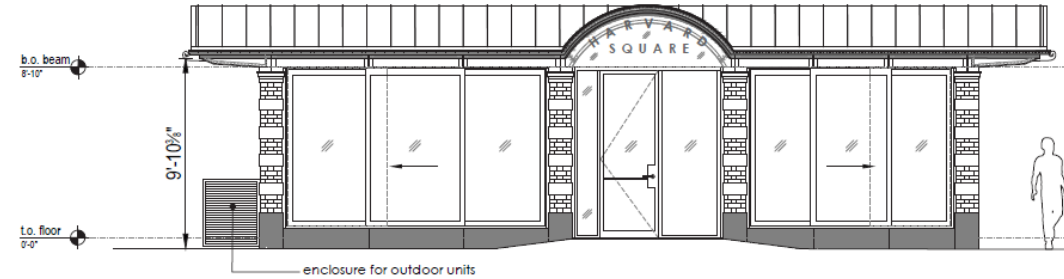
① Elevation - Brattle Street

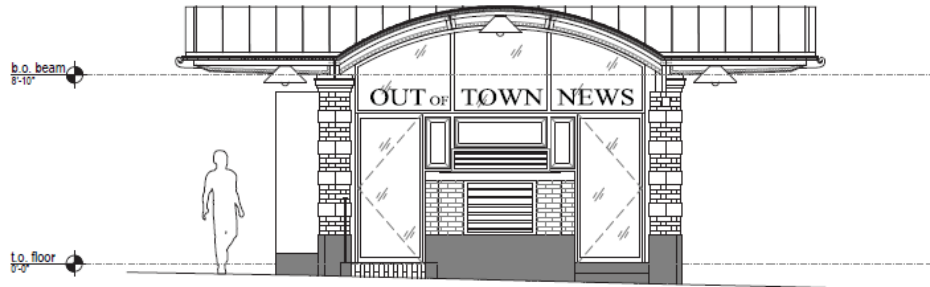
② Elevation - Facing Harvard Square MBTA Station

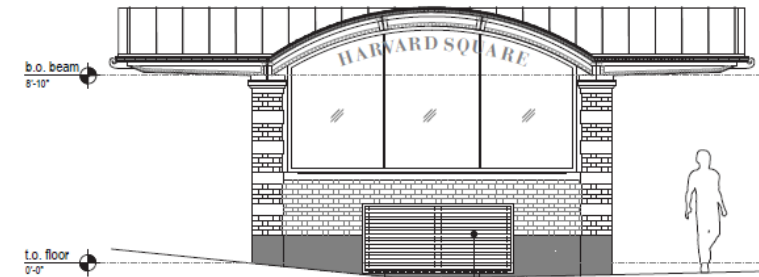
① Elevation - Facing Harvard University

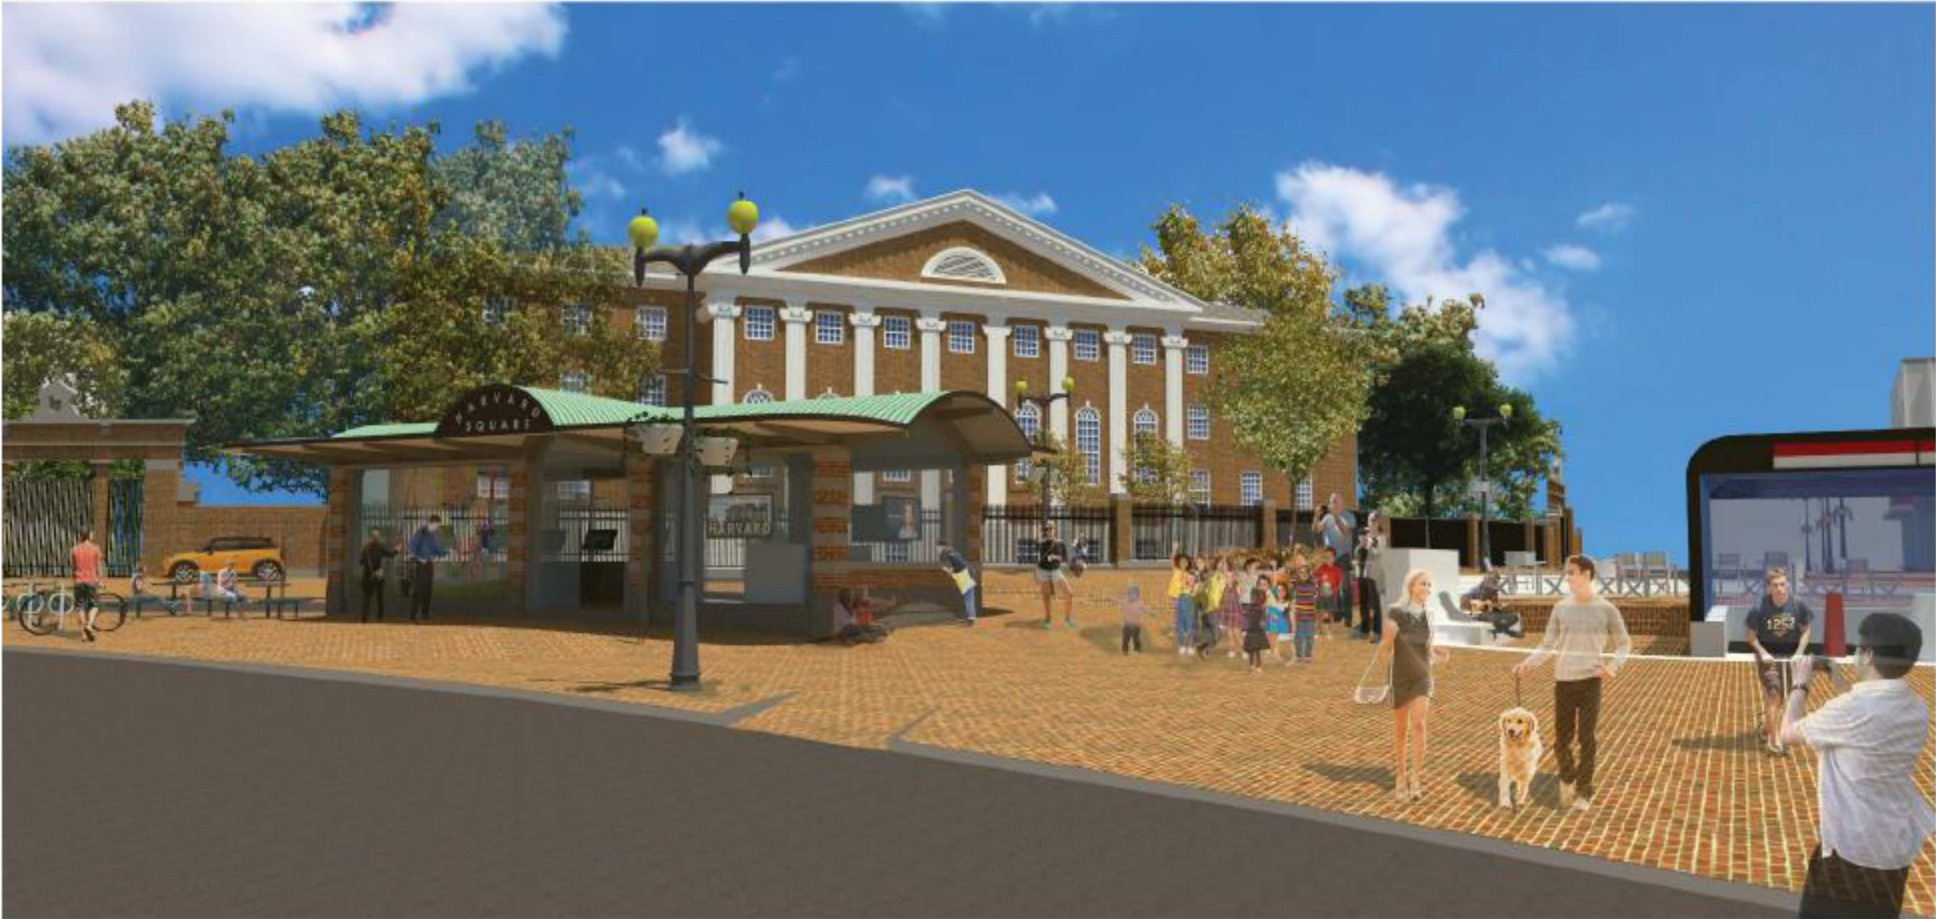
Rendering Brattle Street

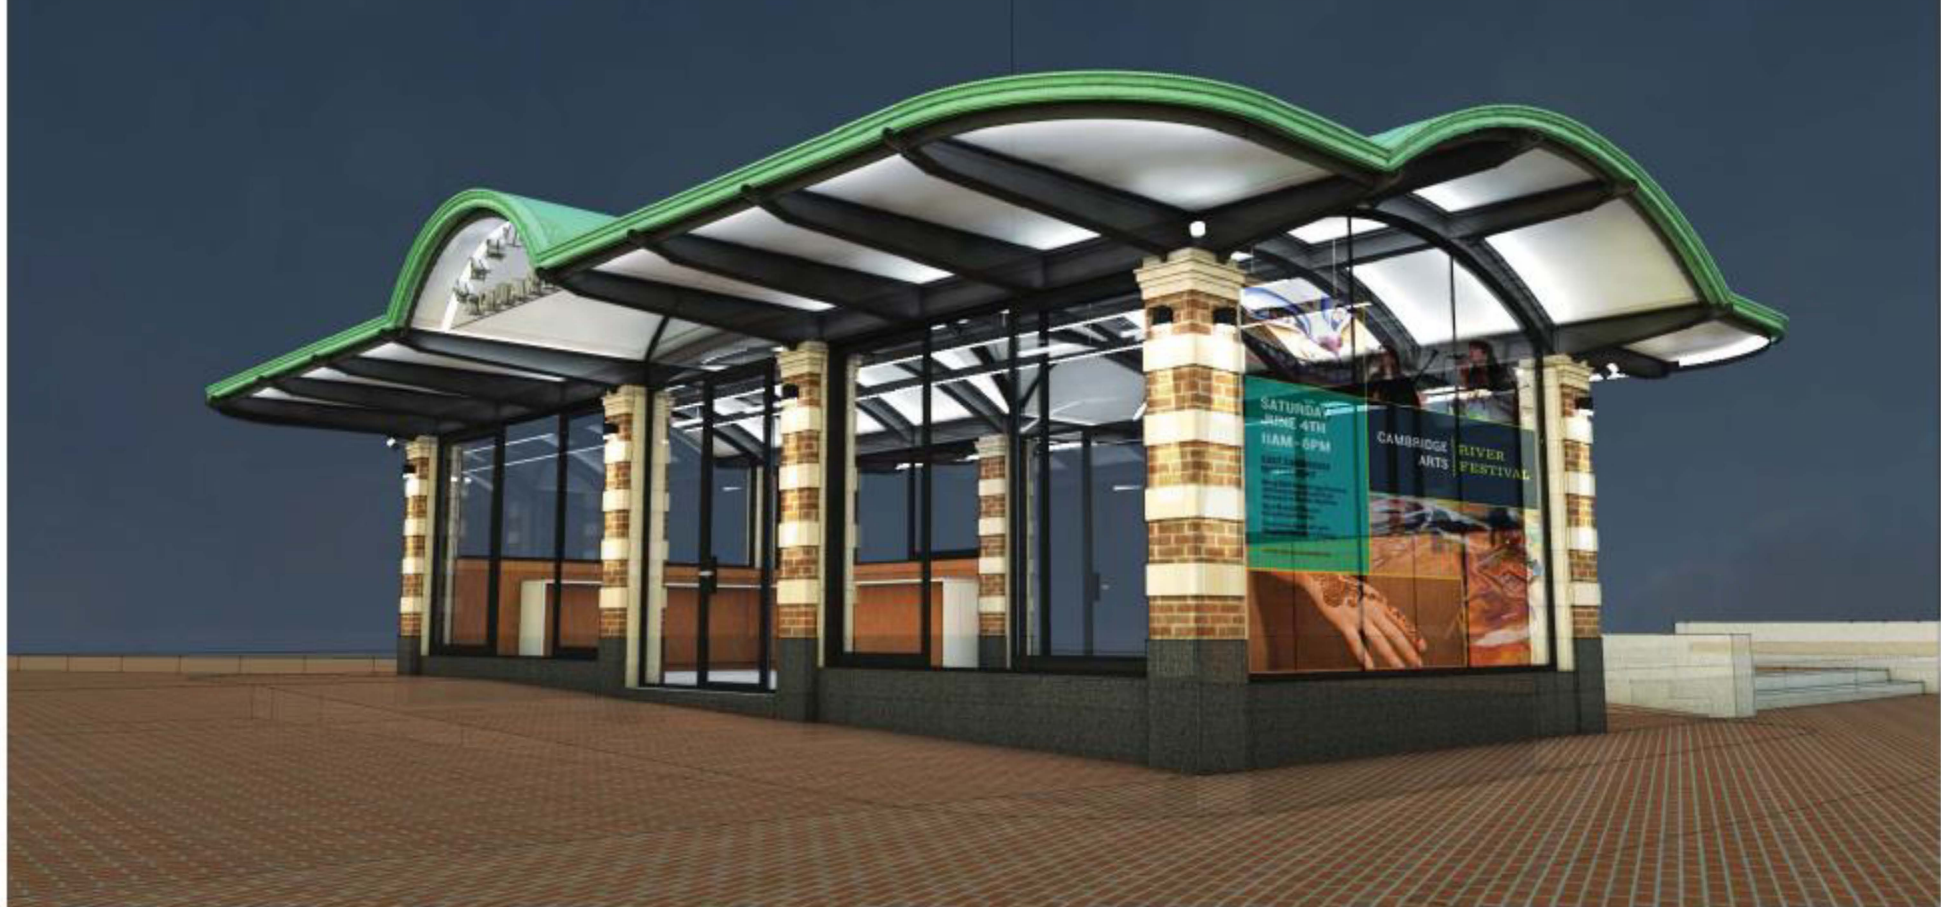
Rendering Brattle Street

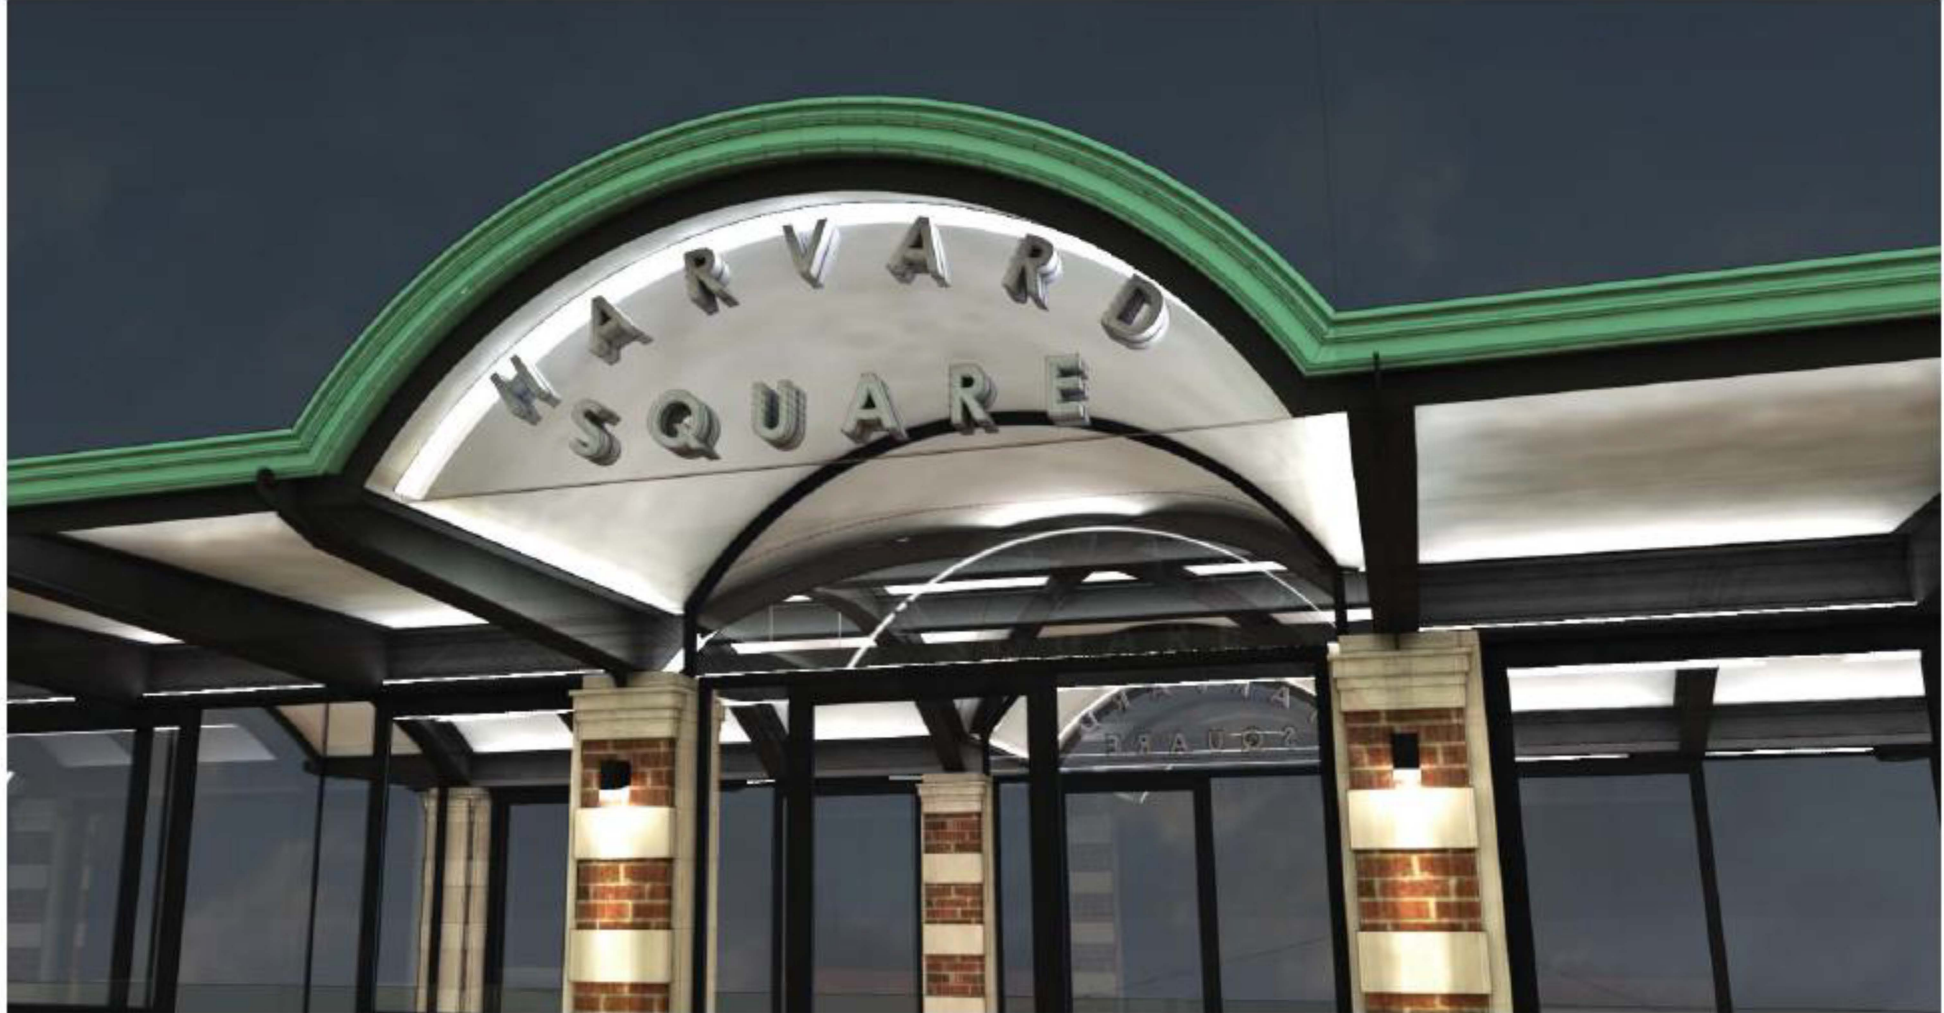
Integrated Building Signage

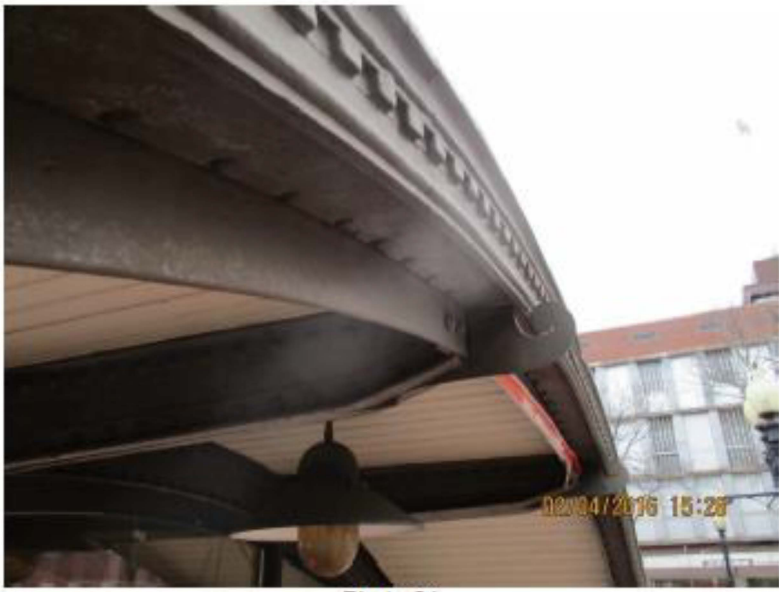
Photo 21
North elevation: Detail of decorative lead coated copper cornice and steel framing.

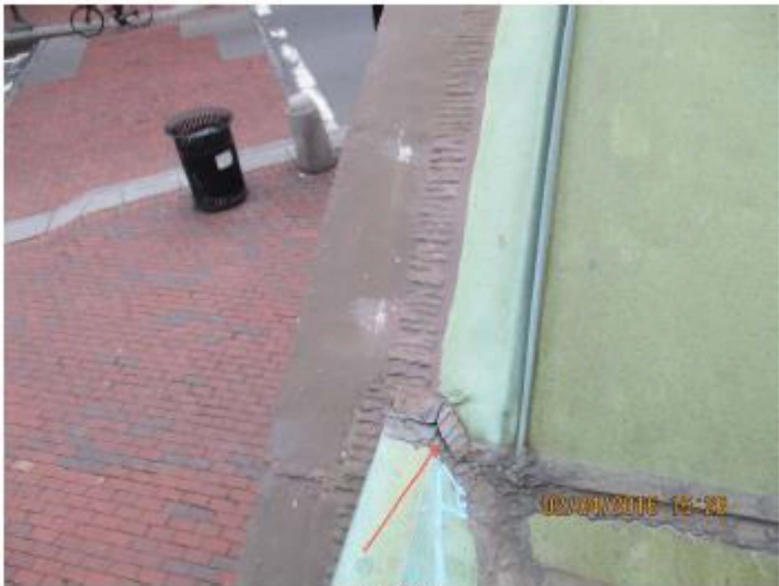
Photo 22
North elevation: Detail of transition between the standing seam copper roof and decorative cornice. Note failed solder joint.

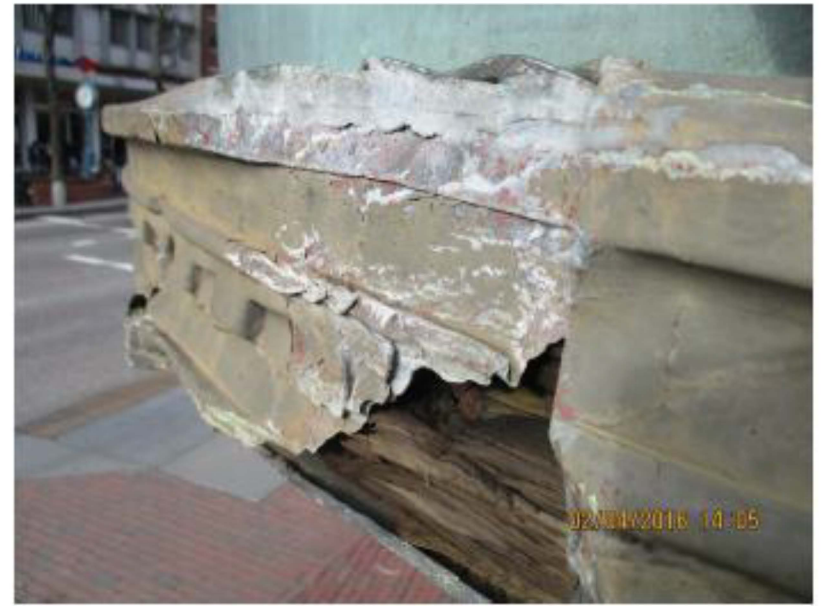
Photo 25
Southwest decorative cornice damage and wood blocking.

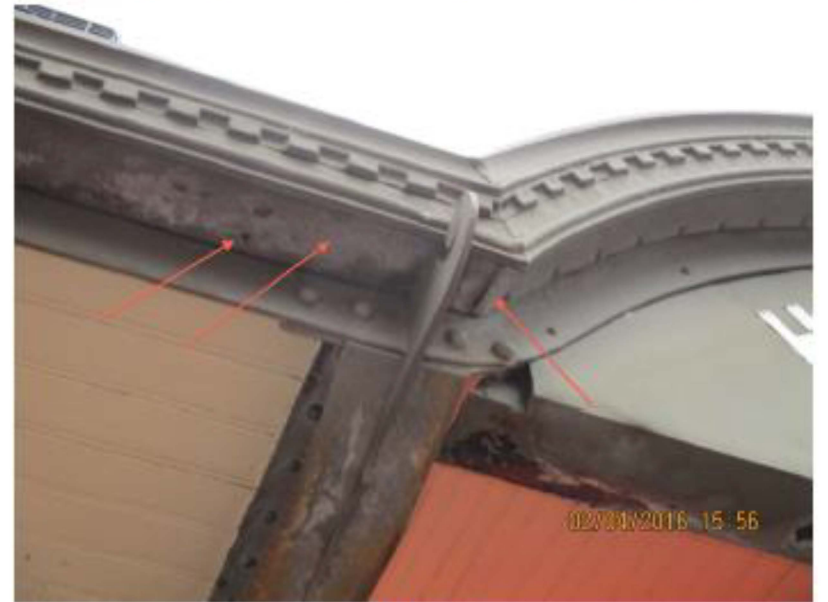
Photo 26
West elevation: Decorative cornice detail. Note accelerated oxidization of the lead coating.

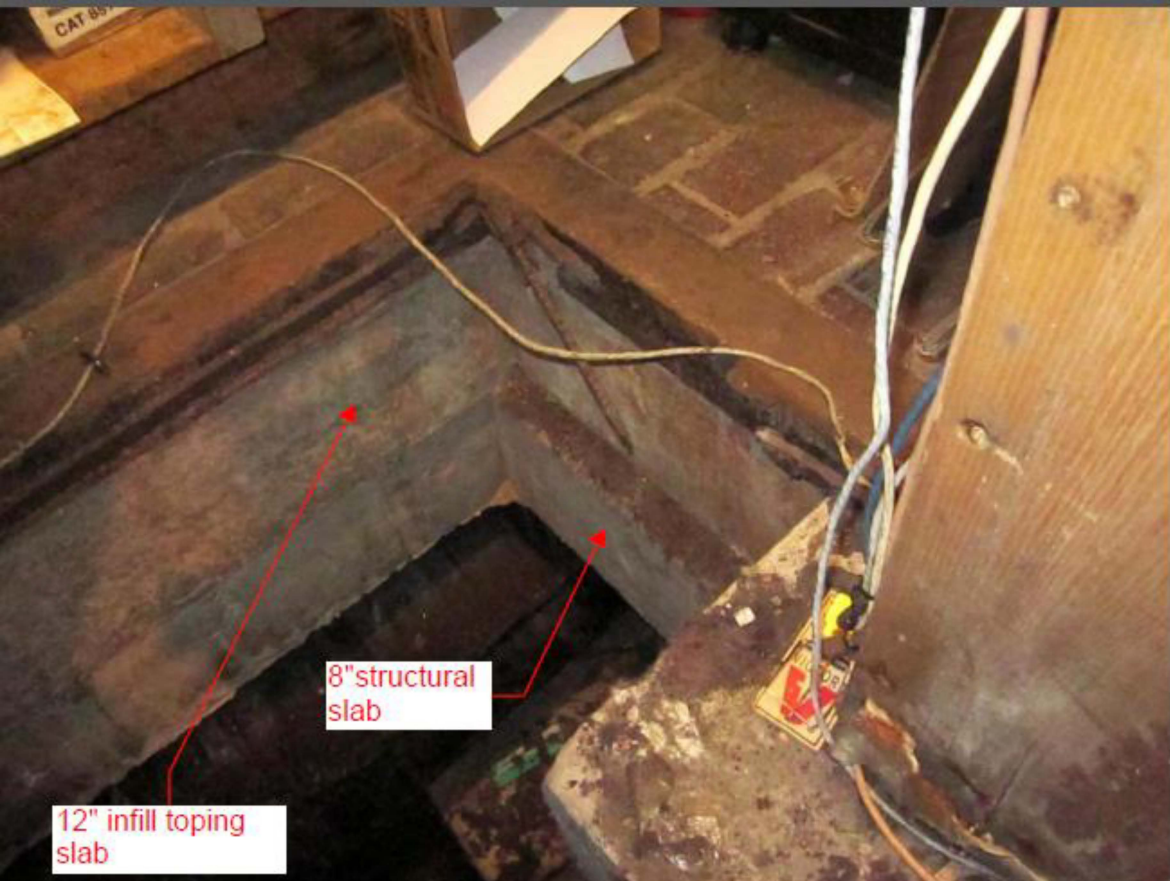
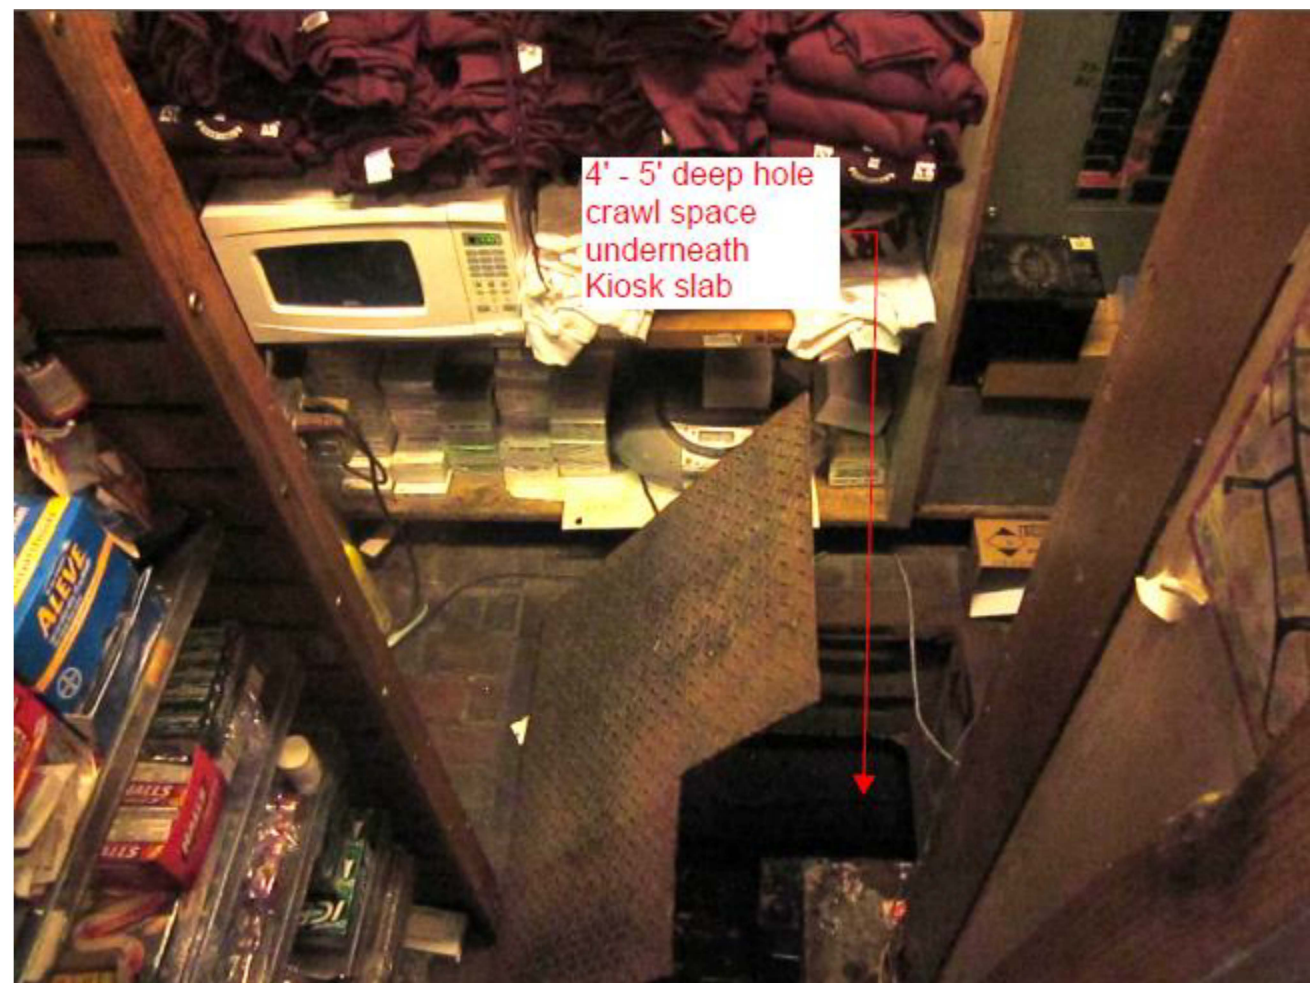
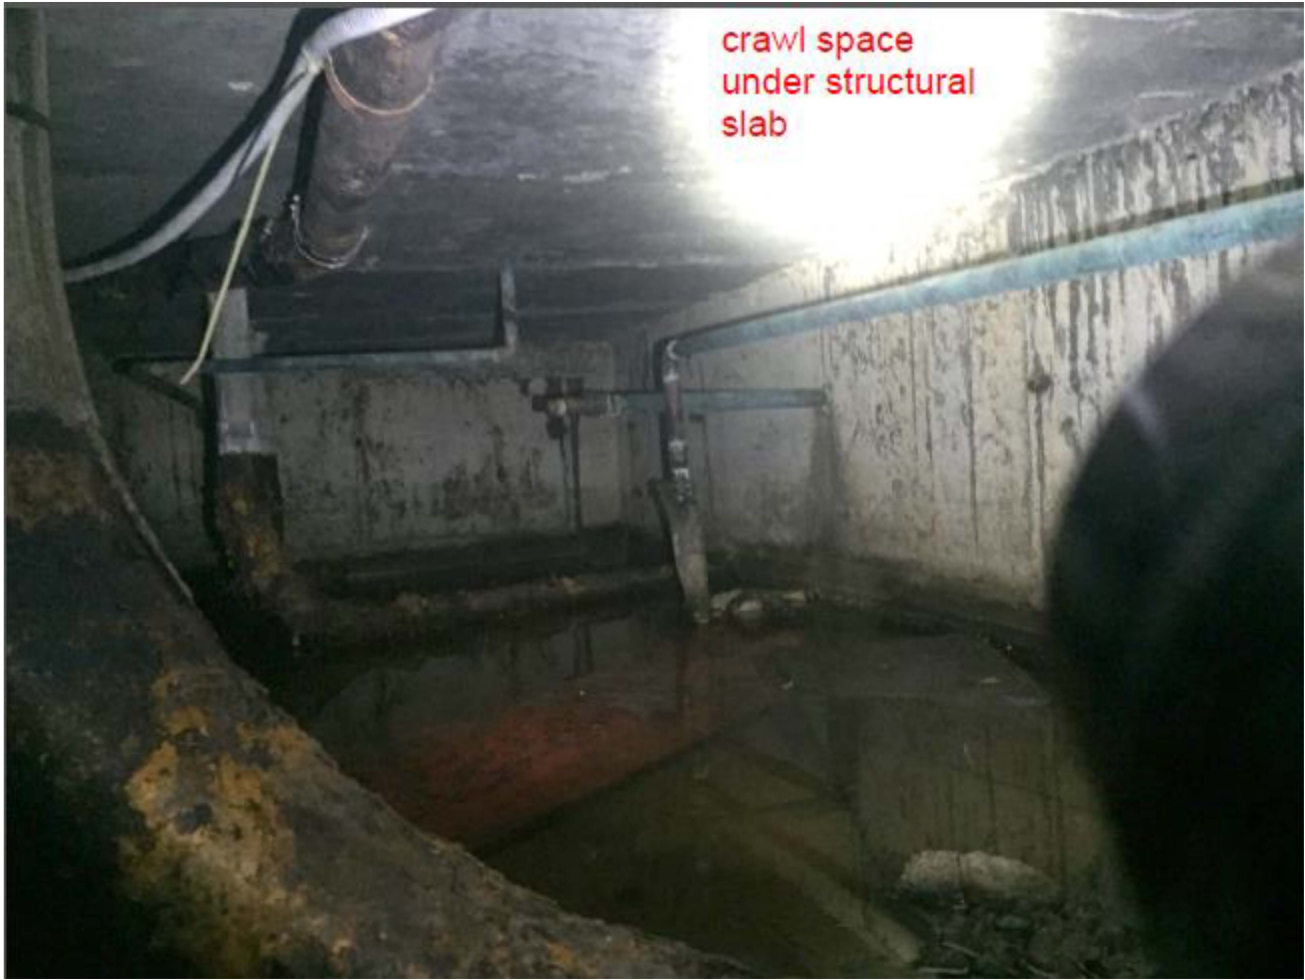
crawl space
under structural
slab

- NOTES:
1. INITIAL SUBSURFACE INVESTIGATIONS DEPICT EXISTING GROUND CONDITIONS FOR THE OUT OF TOWN NEWS AS THE FOLLOWING FROM SURFACE DOWN (SEE ATTACHED PHOTOS):
 - 2.5" BRICK LAYER
 - 10-12" CONCRETE FILL
 - 8-10" CONCRETE STRUCTURAL SLAB
 - 4' ANNUALR SPACE
 - STATION ROOF
 2. GPR INVESTIGATION LIMITS AROUND OOTN BUILDING TO DETERMIN EXACT LIMITS OF STRUCTURAL SLAB.
 3. GPR INVESTIGATION LIMITS TO DETERMIN LIMITS AND DEPTI OF UNKNOWN SLAB DISCOVERED DURING PREVIOUS SUBSURFACE INVESTIGATIONS

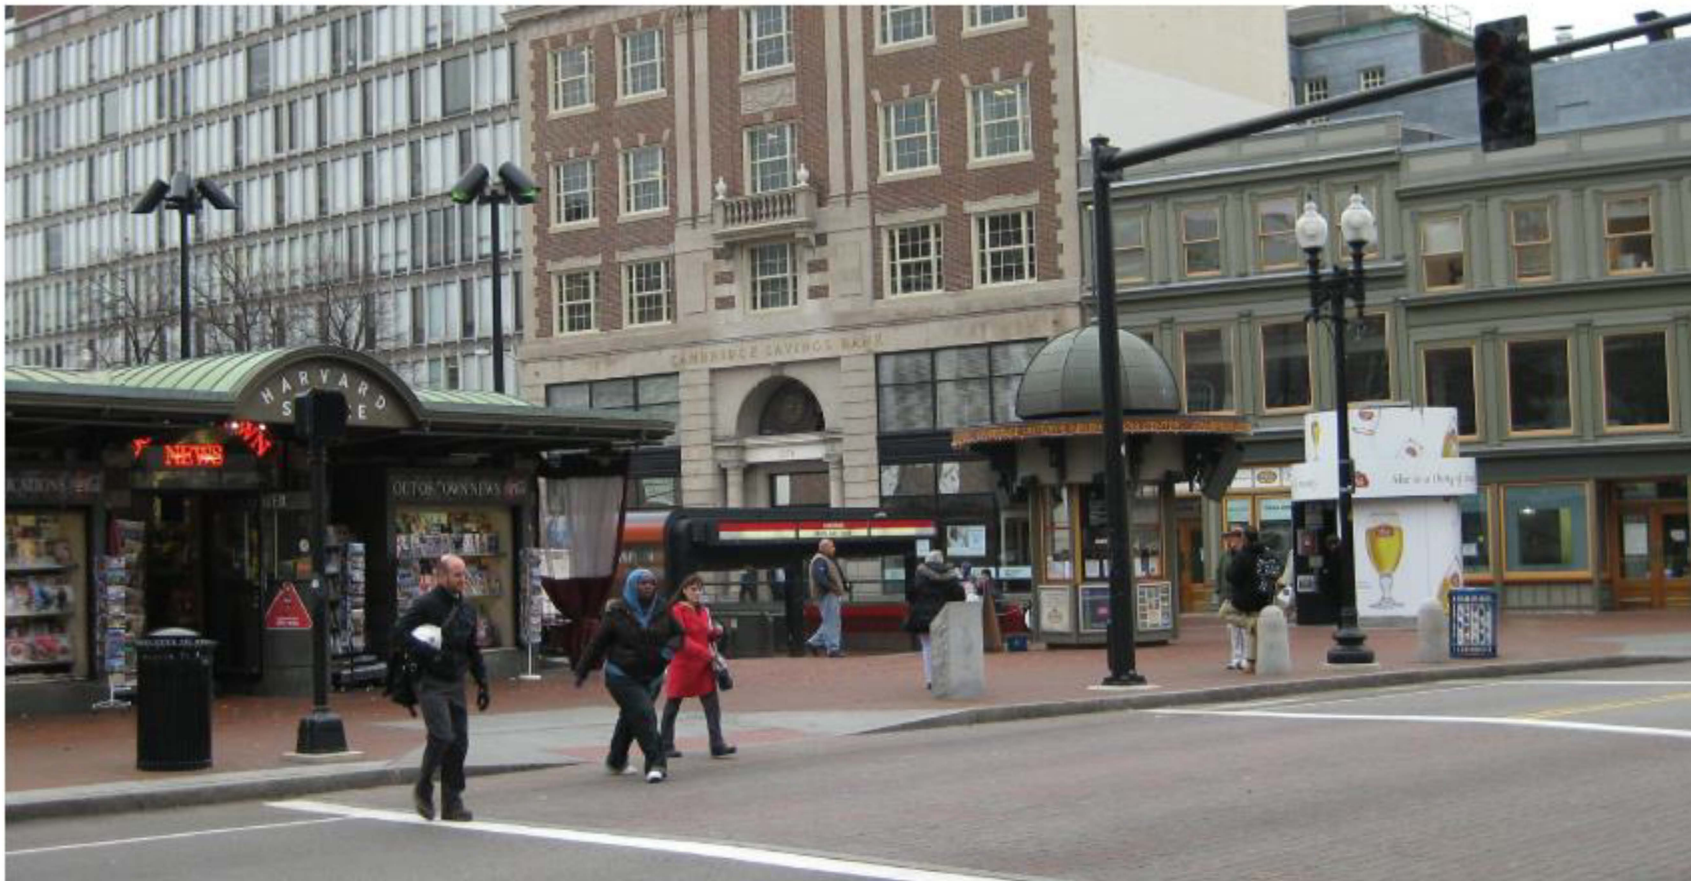
Harvard Square Station
Existing Plaza Level
January 2013

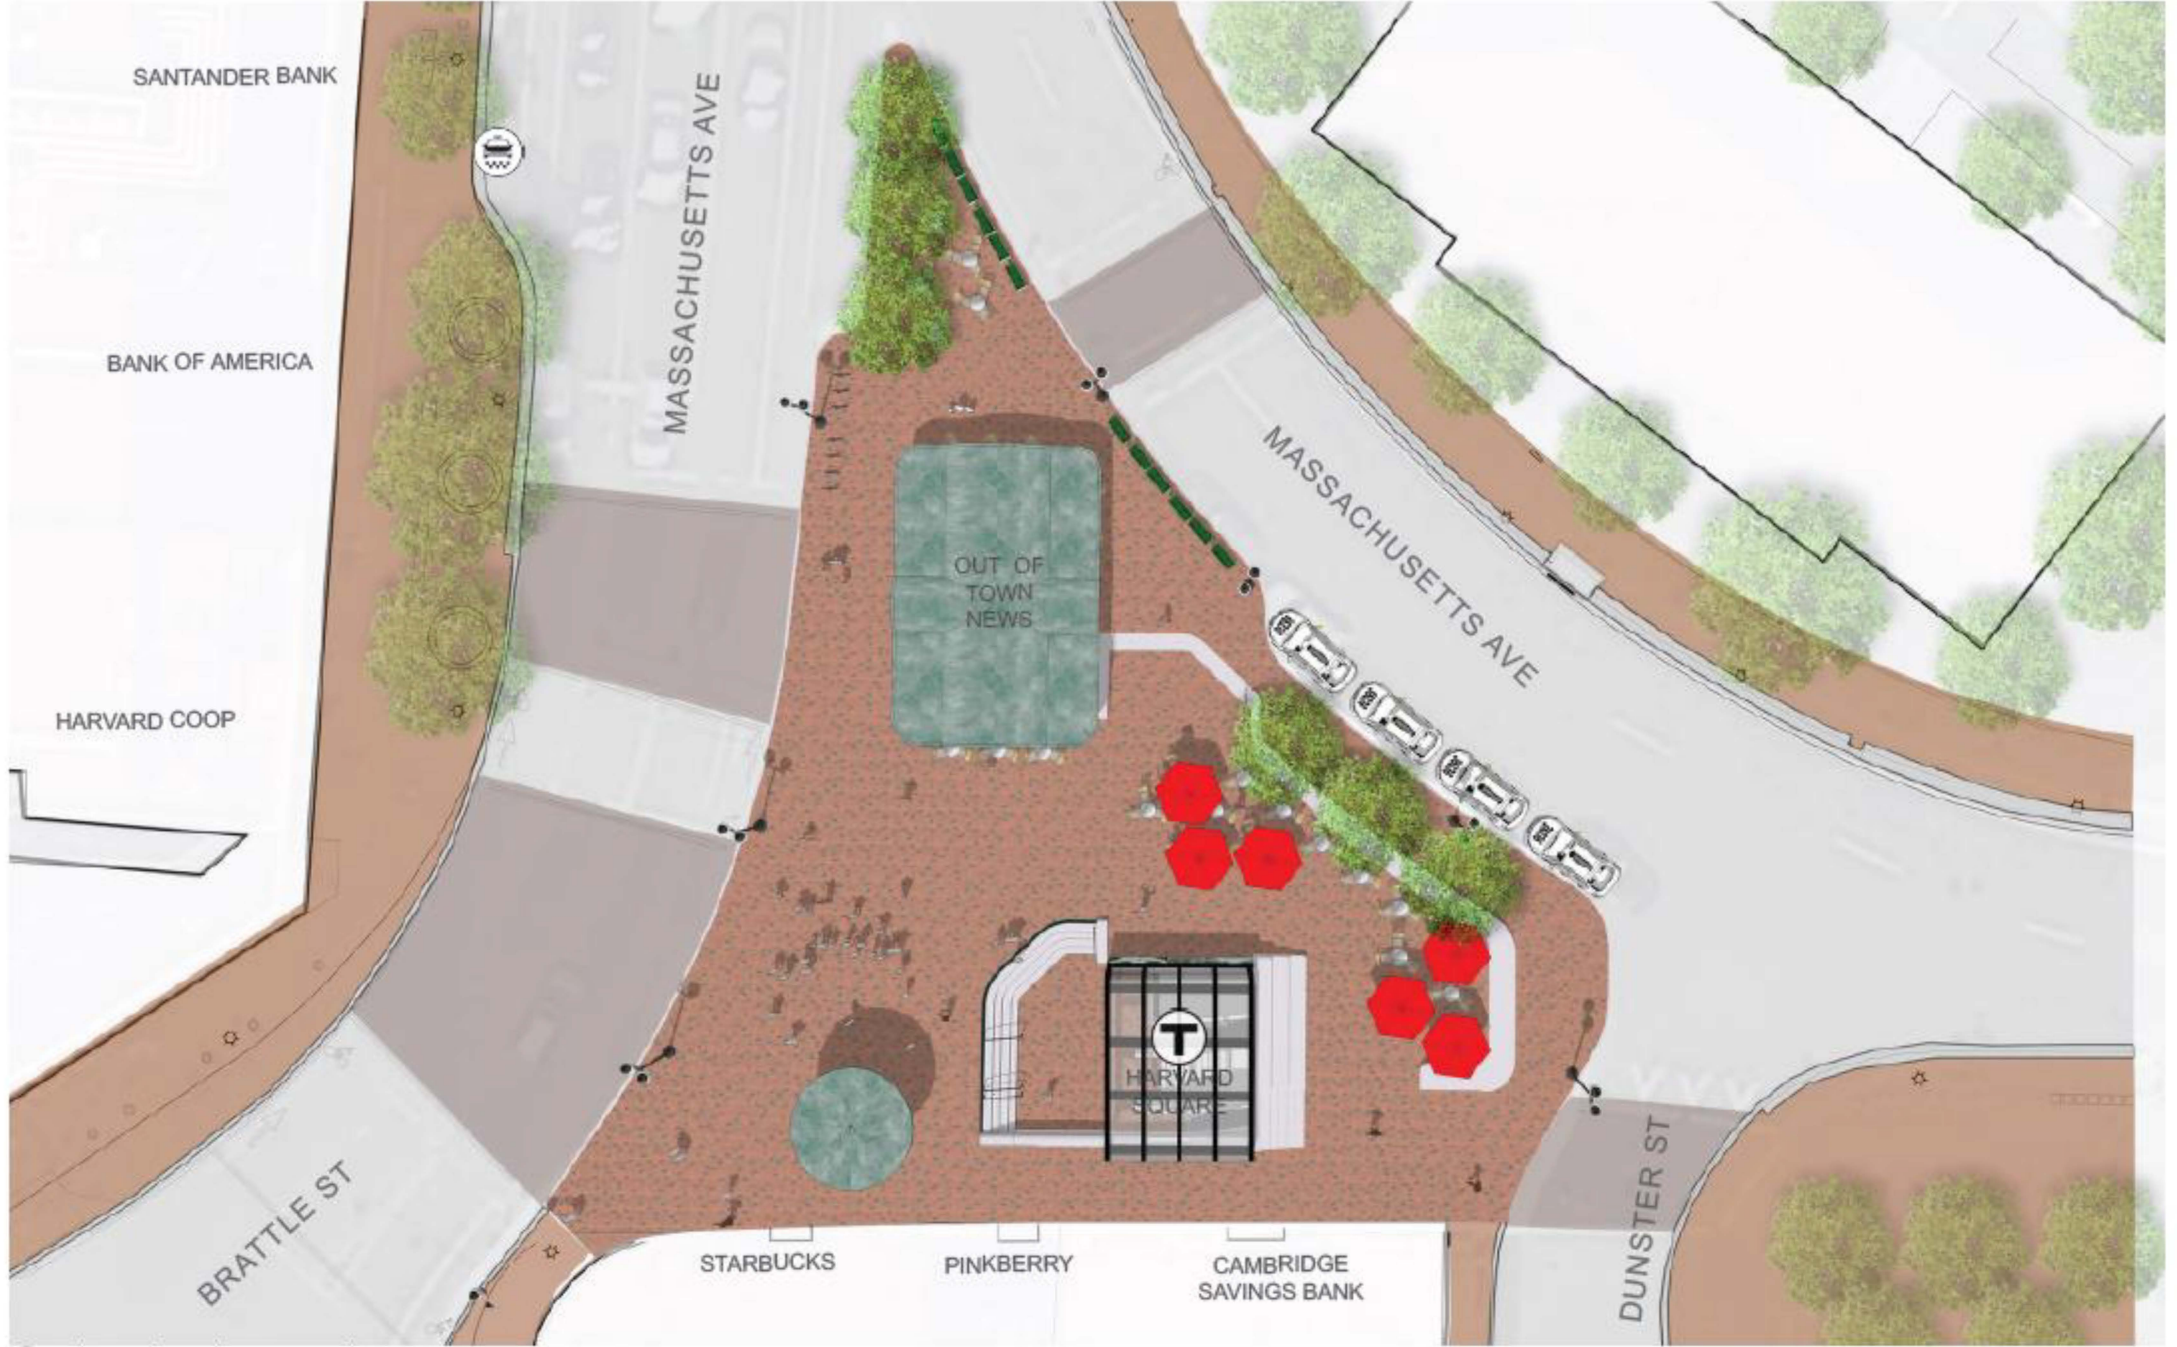
PREFERRED DIRECTION
