Glacken Slope Restoration

Fresh Pond Reservation

Presentation to the Fresh Pond Advisory Board

15 October 2009

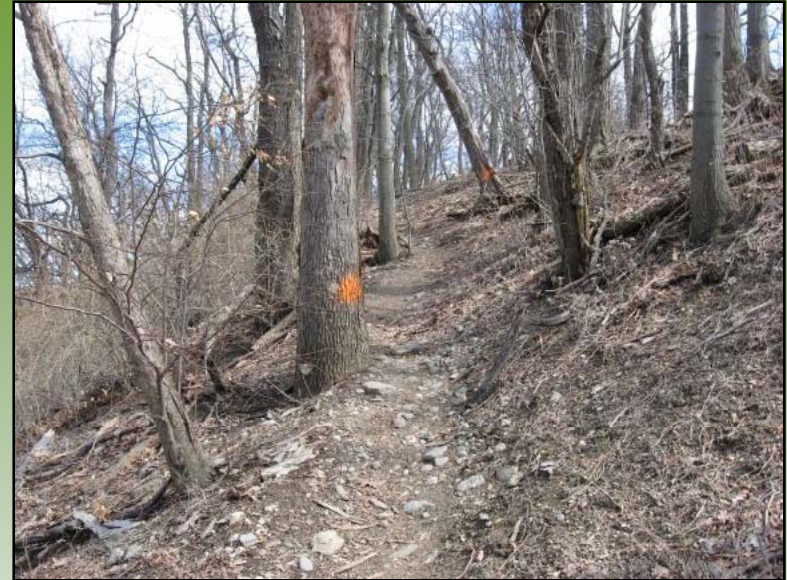
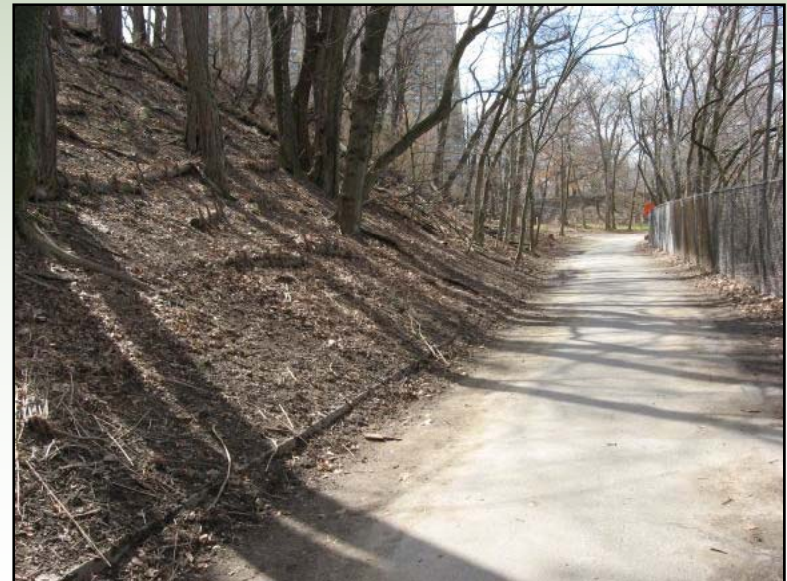
Soil Erosion

- Ongoing Erosion from steep, unprotected slopes
- Limited litter/duff layer
- Soil accumulates at toe of slope
- Dogs/humans on steep slopes exacerbating erosion
- Severe compaction and poor nutrient composition

Stormwater/Runoff

- Lack of control and infiltration of runoff at top of slope

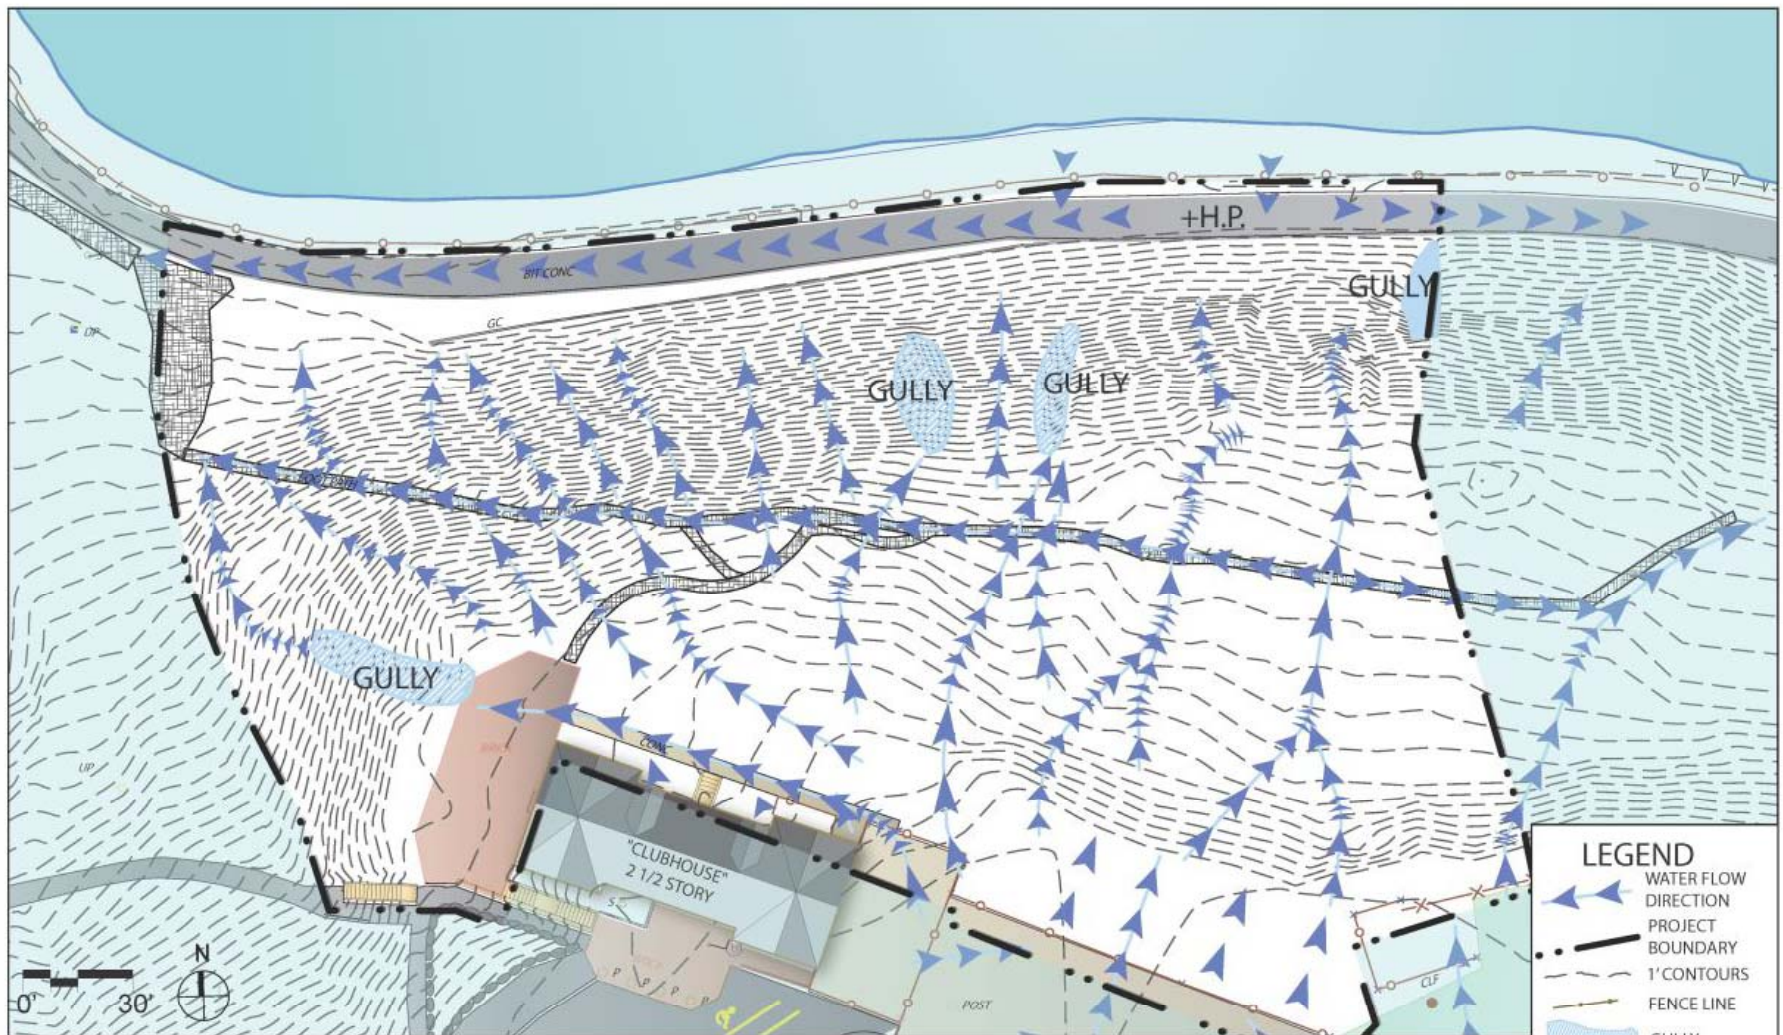
Surface Hydrologic Analysis

SURFACE HYDROLOGIC ANALYSIS
FRESH POND SLOPE RESTORATION
 INVENTORY + ANALYSIS | JANUARY 2009

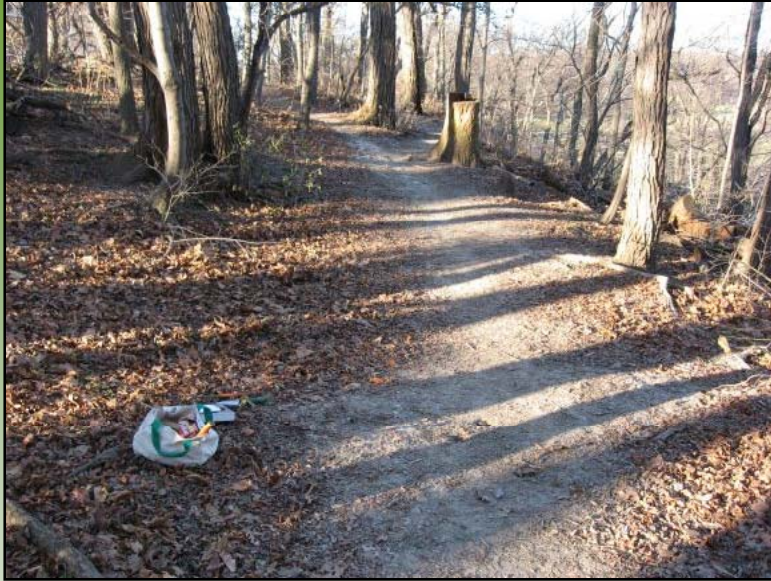
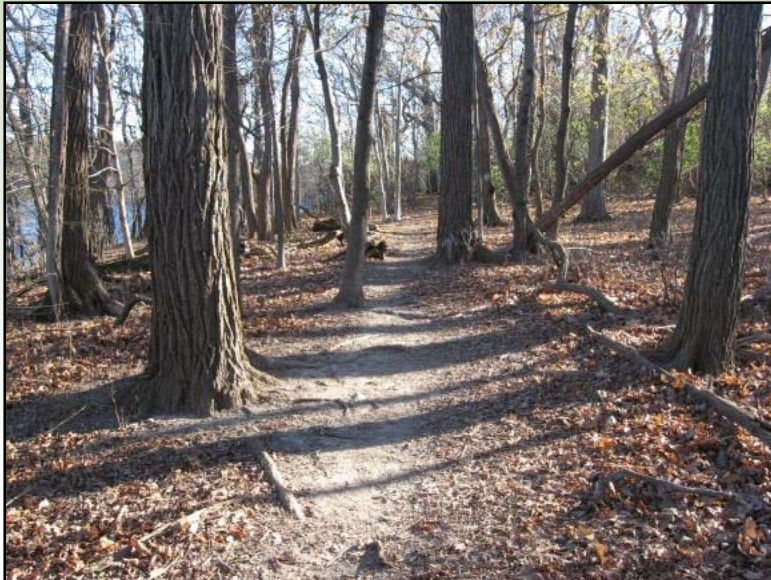
- Lack of established understory vegetation
- Existing Tree Canopy = 80% non-native species
- Low ecologic diversity
- Invasive monoculture contributes minimal habitat value
- Limited long-term ecological viability

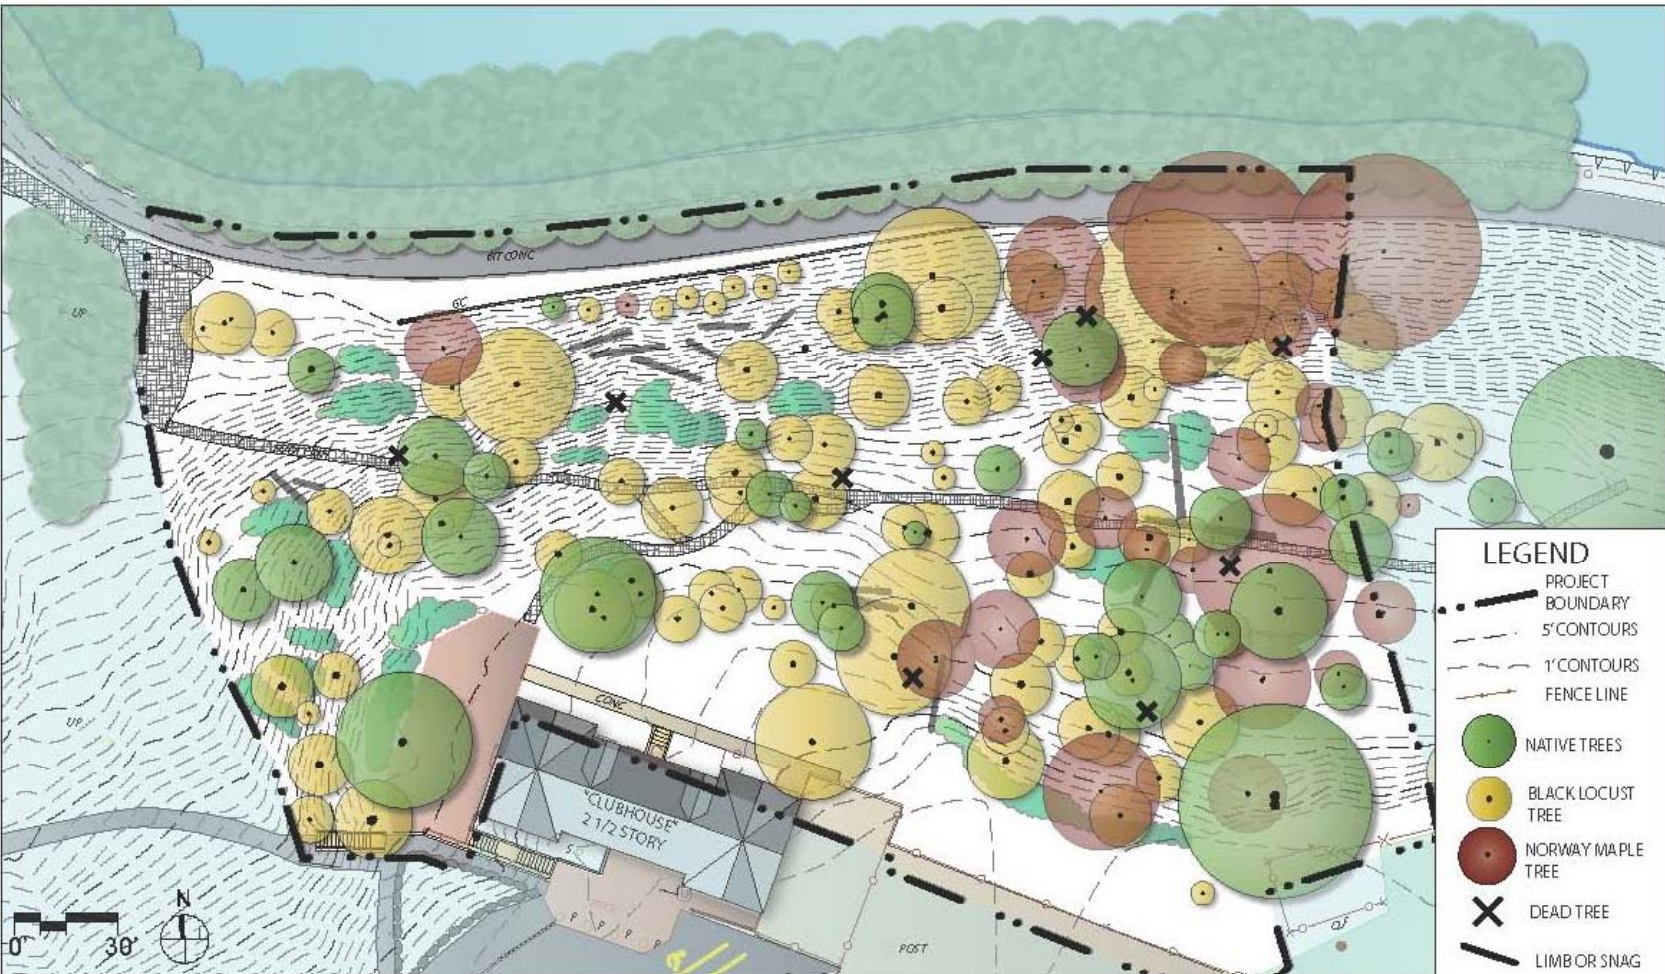
Existing Conditions: Tree Canopy

TREE CANOPY INVENTORY
FRESH POND SLOPE RESTORATION
 INVENTORY + ANALYSIS | JANUARY 2009

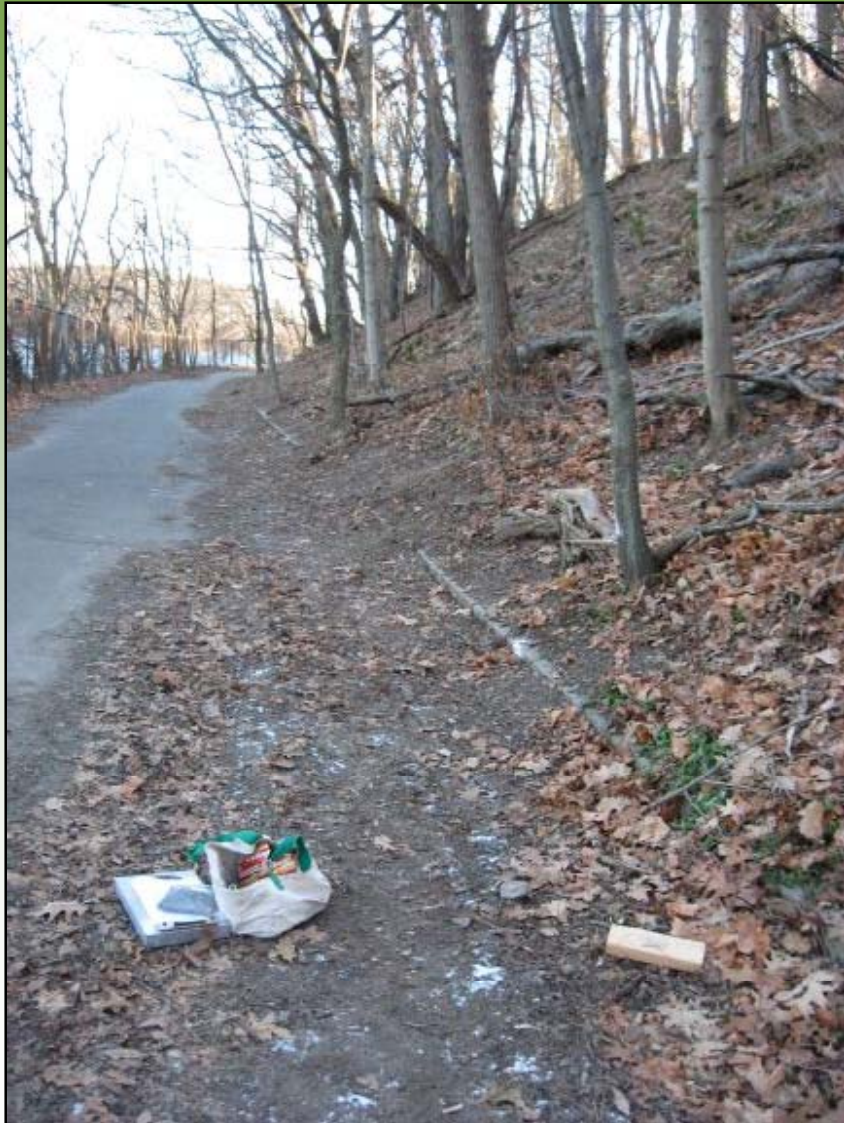
Site Inventory – User Experience

- Limited overlooks/views during growing season
- Numerous secondary trails - desire lines (especially at western extent)
- Very steep and unstable trail conditions
- Poor drainage on Perimeter Road

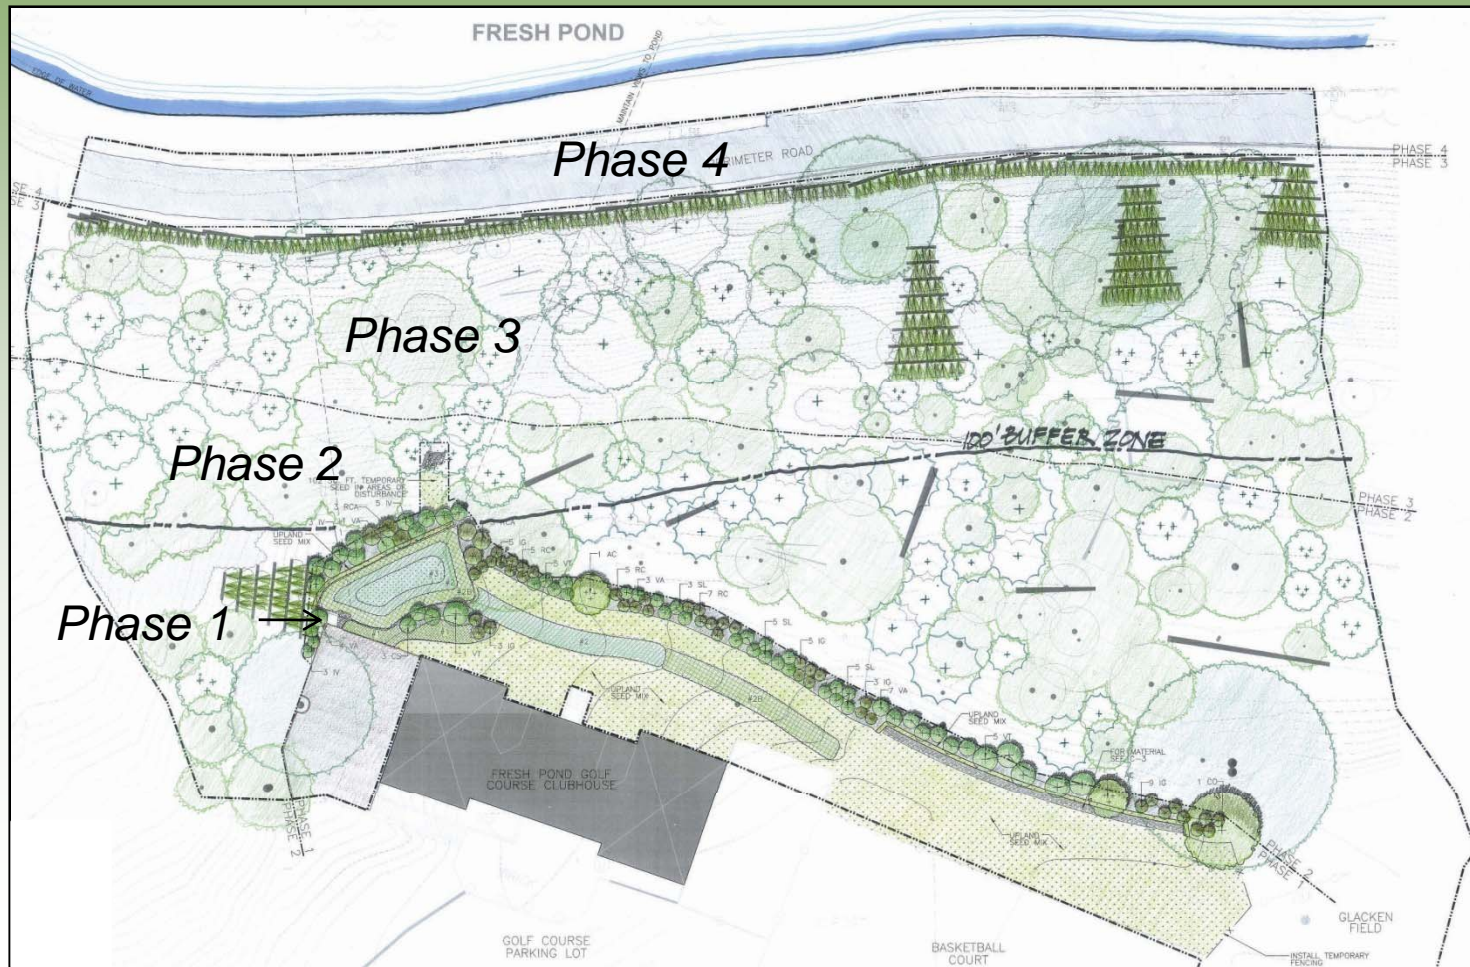
Phased Plan

Phase 1: Top of Slope Drainage improvements

Phase 2: Restoration and Reforestation

Phase 3: Restoration and Reforestation

Phase 4: Perimeter Road Improvements

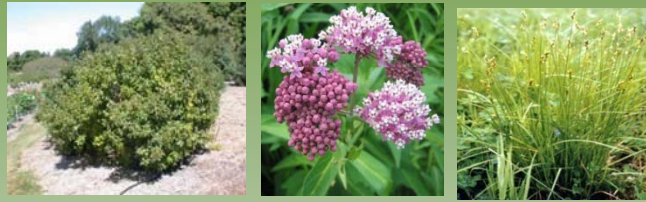
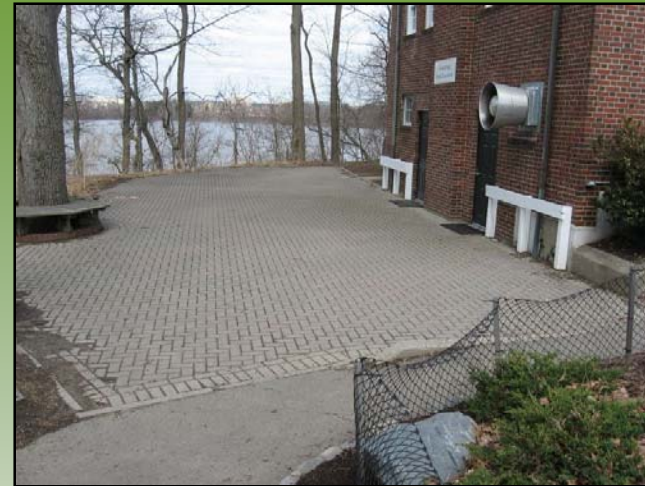
Phase 1: Rain Garden

- Rain Garden – 36” Engineered Soil with Underdrain and Level Spreader
- Underdrain Outlet Energy Dissipater – Recycled Black Locust Log Level Spreader and Gravel
- Capacity = 47% of 10-YR Storm Event

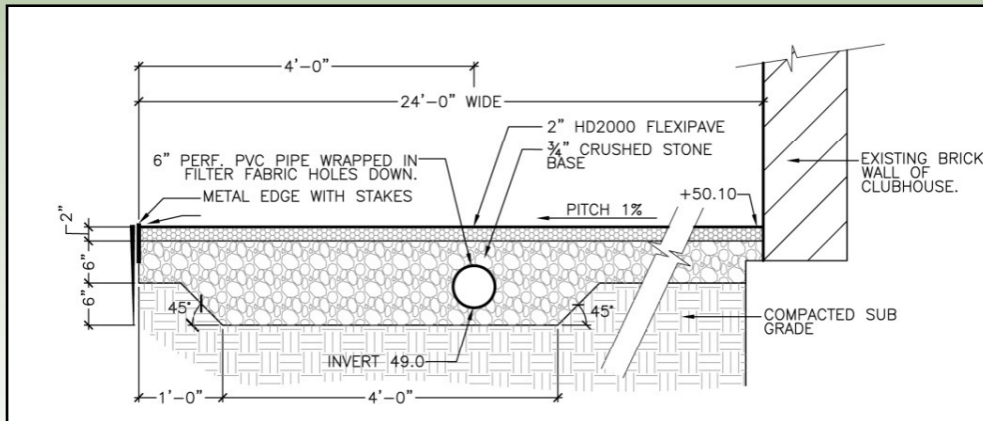
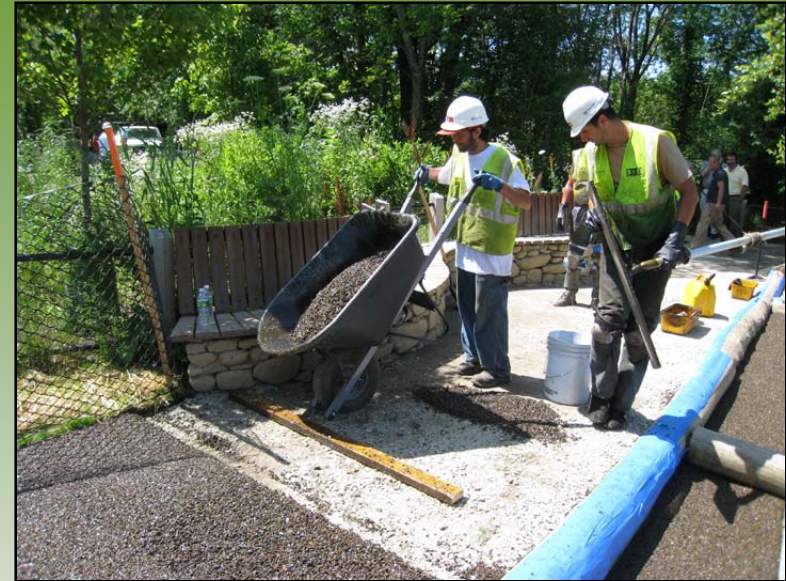
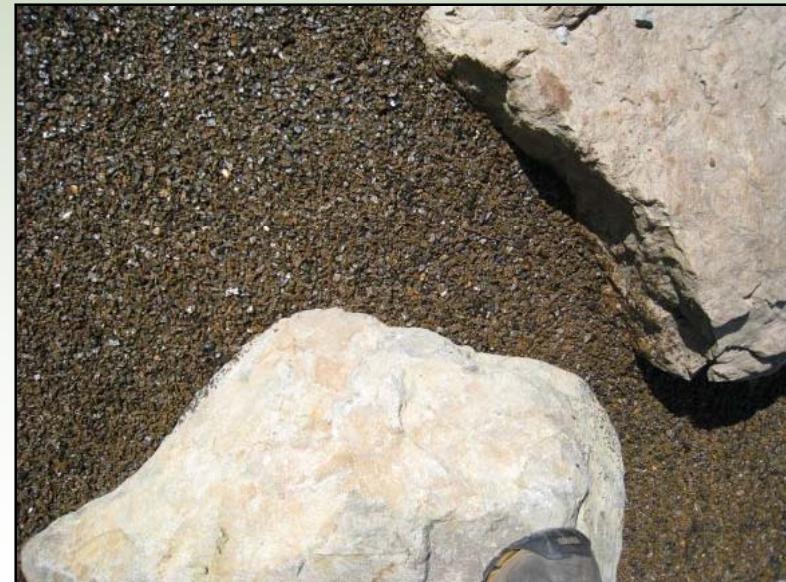
Phase 1: Resurface Patio

- Permeable Flexipave surface
- Underdrain outfalls to rain garden

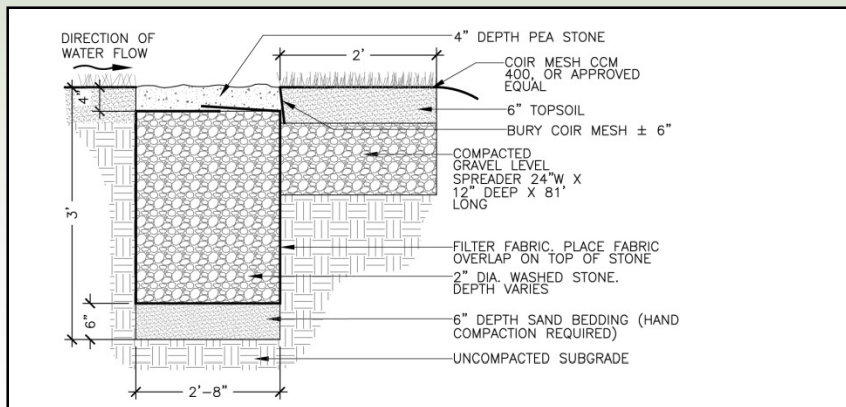
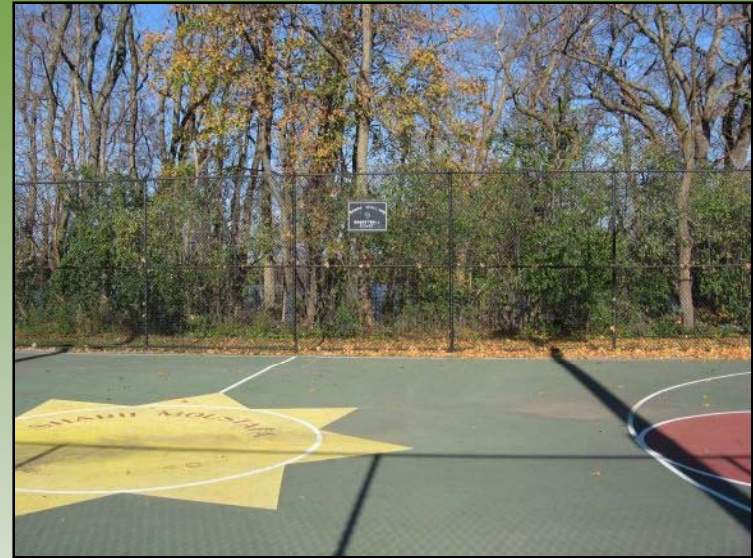
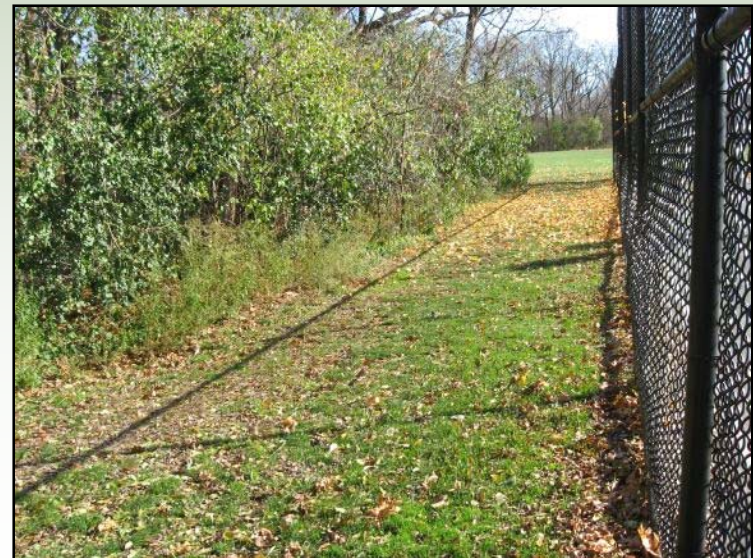
Phase 1: Infiltration Trench

- Twenty (20) foot-wide low turf buffer pre-treatment
- Will overflow after the first 5.5 hours of a 10-year storm
- Level spreader evenly distributes flow

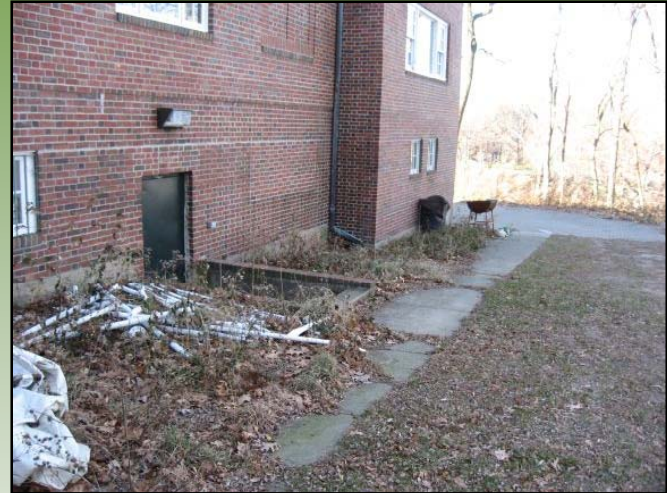
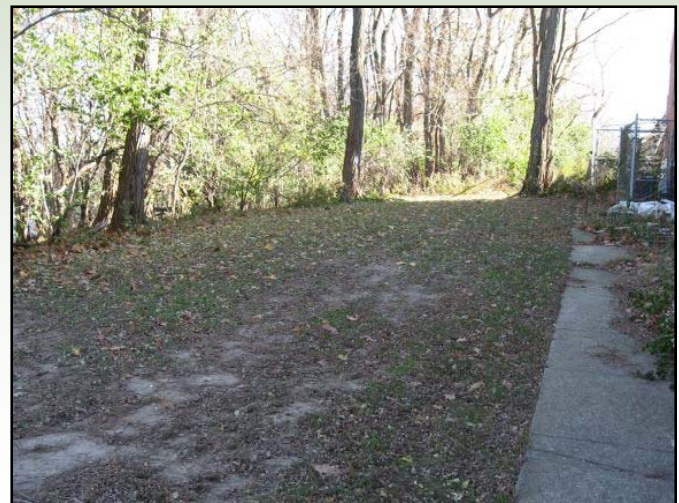
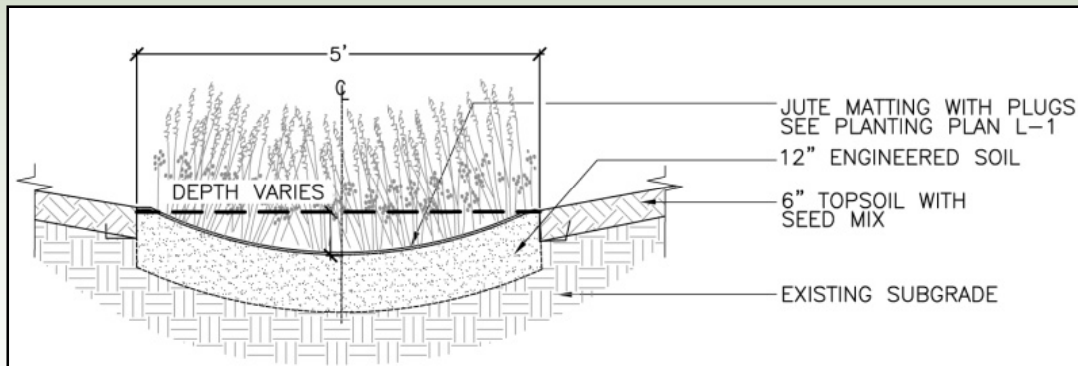
Phase 1: Water Quality Swale/Concrete Walk Removal

- Remove concrete walk to reduce uncontrolled conveyance
- Shallow swale directs runoff from golf cart parking area and downspouts into rain garden

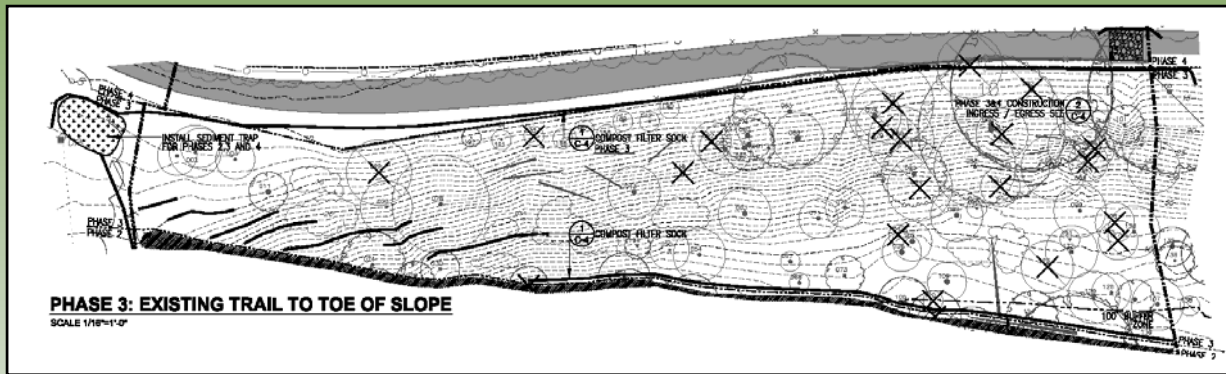
Phases 2/3: Slope Stabilization and Woodland Restoration

- Invasive Plant Removal
 - Black Locust
 - Norway Maple
- Smooth our Rills
- Eliminate dirt trail
- Gully Repair
- Soil Scarification and Enhancements
- Native Plant Installation
- Install brush layering supported by recycled Black Locus logs at toe of slope to impeded foot/dog traffic up slope

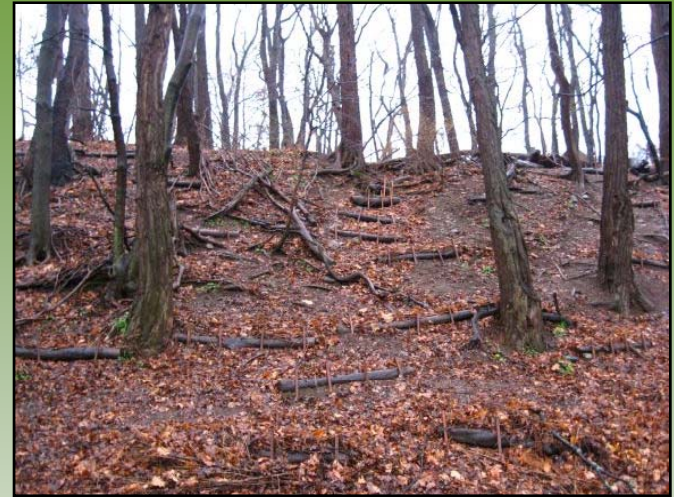
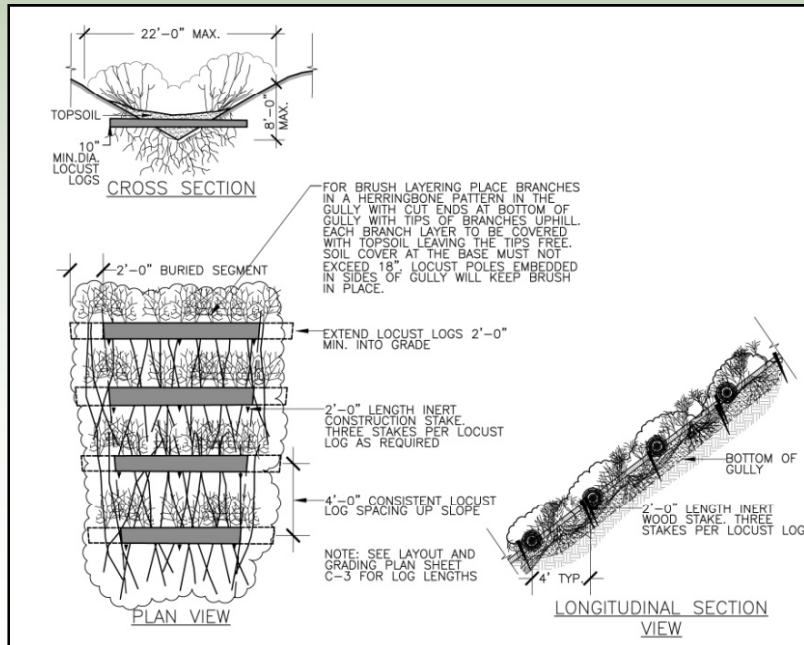
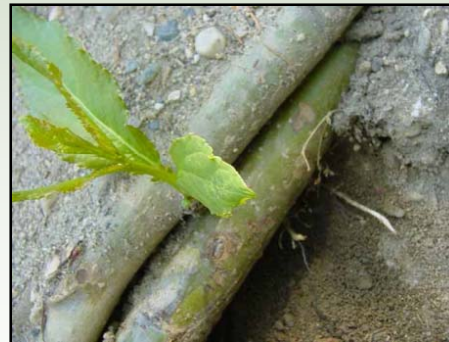
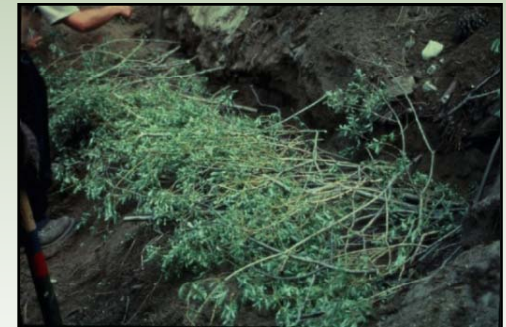
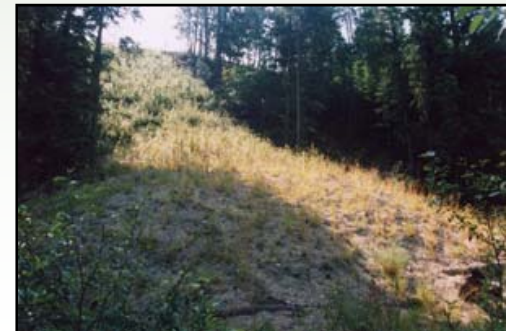
Phases 2/3: Gully Repair

Log Terracing with Branch Packing

- Recycled Black Locust logs
- Plant selection:
 - Gray Birch
 - Silky Dogwood
 - Quaking Aspen

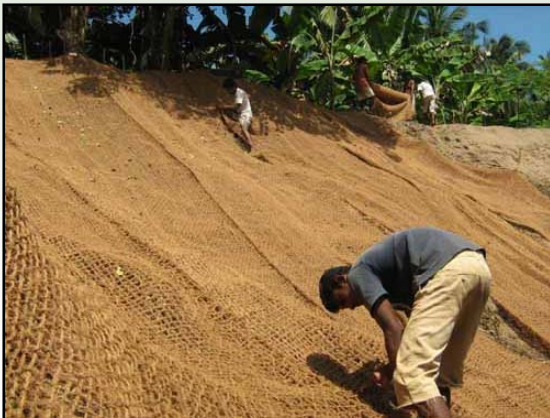
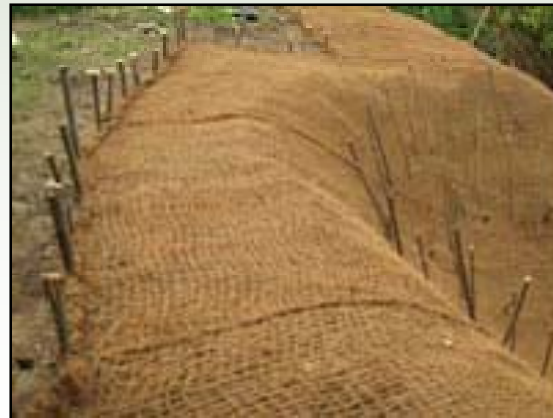
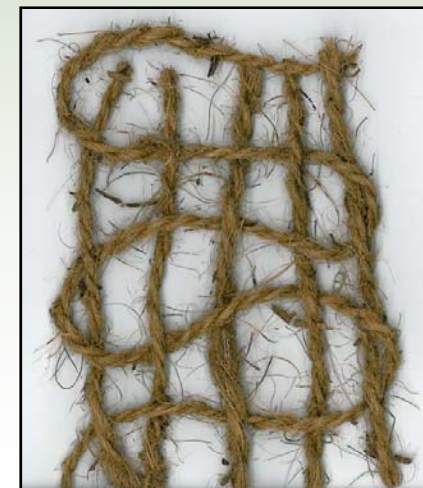
Phases 2/3: Temporary Slope Stabilization

Coir Mesh with Inert Stakes

- Maintains good contact on uneven slopes
- Absorbs moisture and helps keep juvenile plantings well-hydrated
- Promotes duff accumulation and A-Horizon formation
- 100% biodegradable

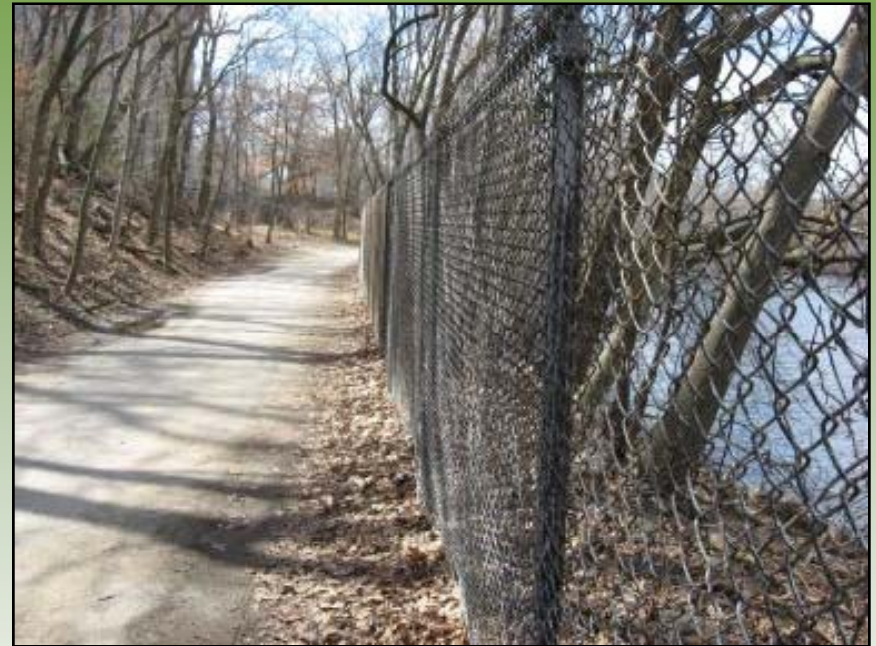
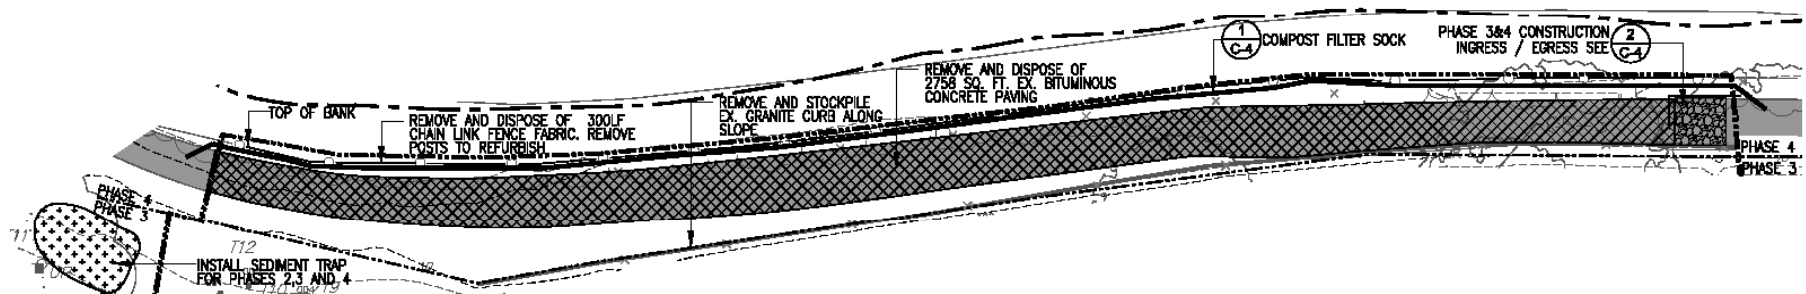
PHASE 4: PERIMETER ROAD

- Remove existing pavement and re-grade to drain away from Fresh Pond
- Adjust Perimeter Road to uniform 12 foot width
- Resurface with bituminous concrete and stabilized aggregate paving
- Refurbish existing chain link fence

SCALE 1/16"=1'-0"

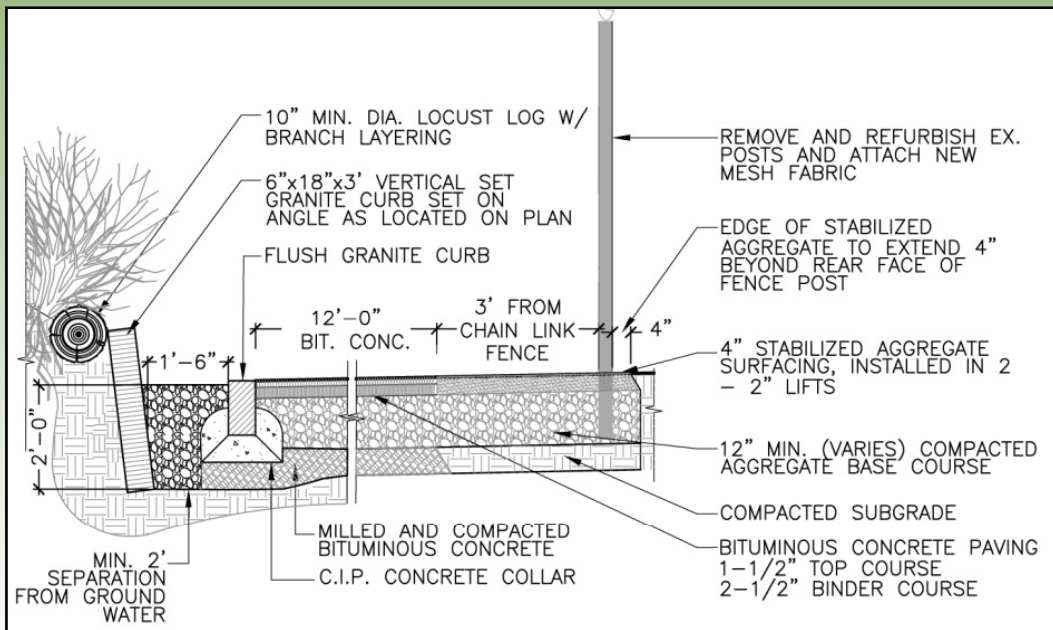
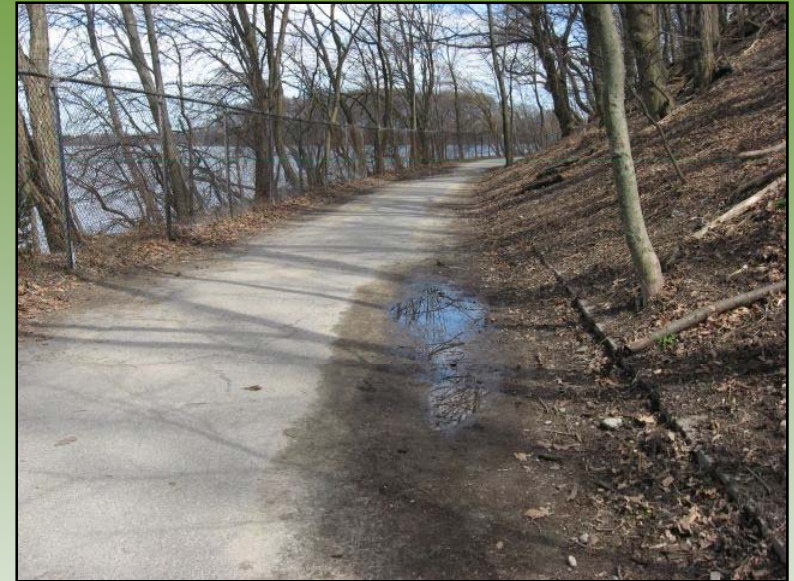
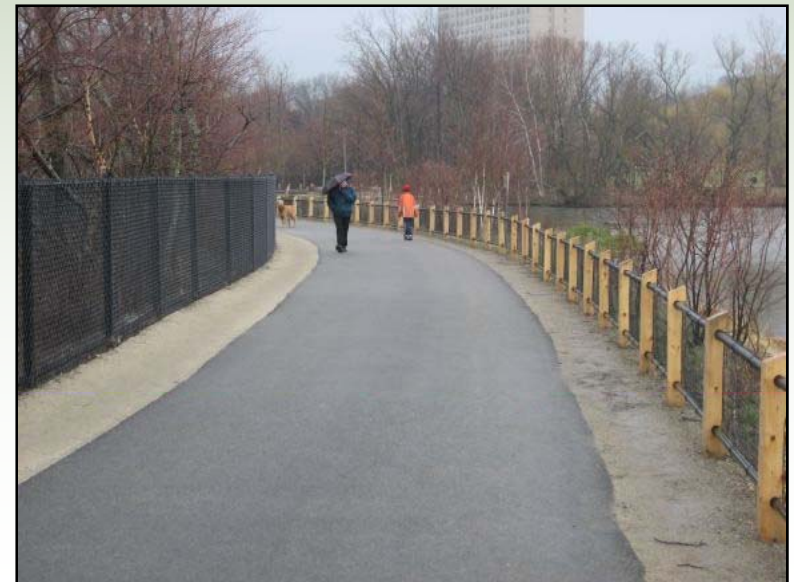
Phase 4: Perimeter Road Improvements

- Infiltration swale drains Perimeter Road runoff
