CAMBRIDGE HISTORICAL COMMISSION

APPLICATION FOR CERTIFICATE

2. Address of property: 15 Harvard Yard (Holden Chapel), Cambridge, Massachusetts

Holden Chapel – West Pediment Repair and Restoration

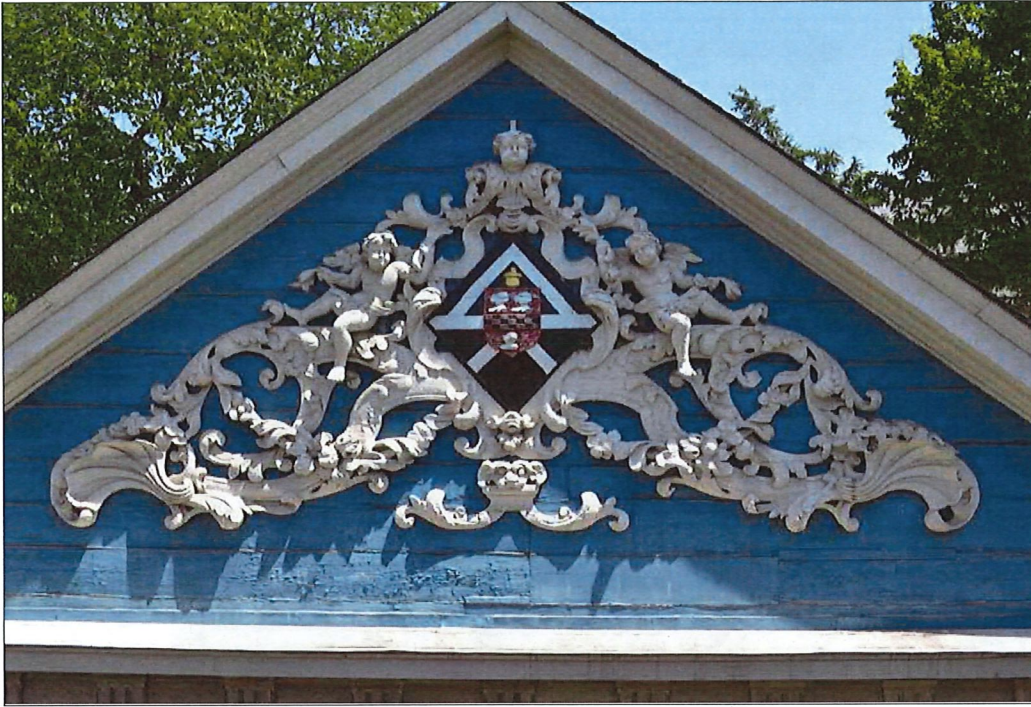
West

The wood-plank backboards at each location show evidence of extensive deterioration. To appropriately repair these elements, and ensure the long-term structural integrity of the building, the wood sculptures are proposed to be carefully disassembled, removed and the backboards replaced.

- In preparation for removal, the condition of the sculpture will be further assessed and stabilized as needed. Harvard will coordinate with CHC staff on any issues that arise during this assessment. After stabilizing the sculpture, the component sections will be removed from the pediment, packed, and taken off-site for treatment. Any new openings in the backboards created by the removal process will be repaired and secured as needed.

- The surface will be repaired using reversible repair materials and are likely to include the use of carved wood dutchman, and traditional wood repair techniques such as dowels and adhesives mixed with wood shavings.

- A new mounting system will be fabricated (likely using a stainless-steel framework with accessible screws) which will permit the removal of separate sculpture sections facilitating future maintenance and repair activities. The project team will review the specifications of the new mounting system and its installation with the CHC staff.

- The backboards will be surveyed, repaired, and re-painted on-site using the same methods and materials as the sculpted sections. This work will include repairing losses at the seams between the boards, filling the gaps between the boards and repairs at the connection points for the sculpture. It will also include removal of a few small boards to permit architectural team access for inspecting the support system. The need for the replacement of damaged and deteriorated backboards will be determined by the project team and reviewed with CHC staff.
