# Cambridge Historical Commission Review

February 2, 2023

## City Hall Façade Restoration Project

Anticipated Construction  
June 2023 through August 2024

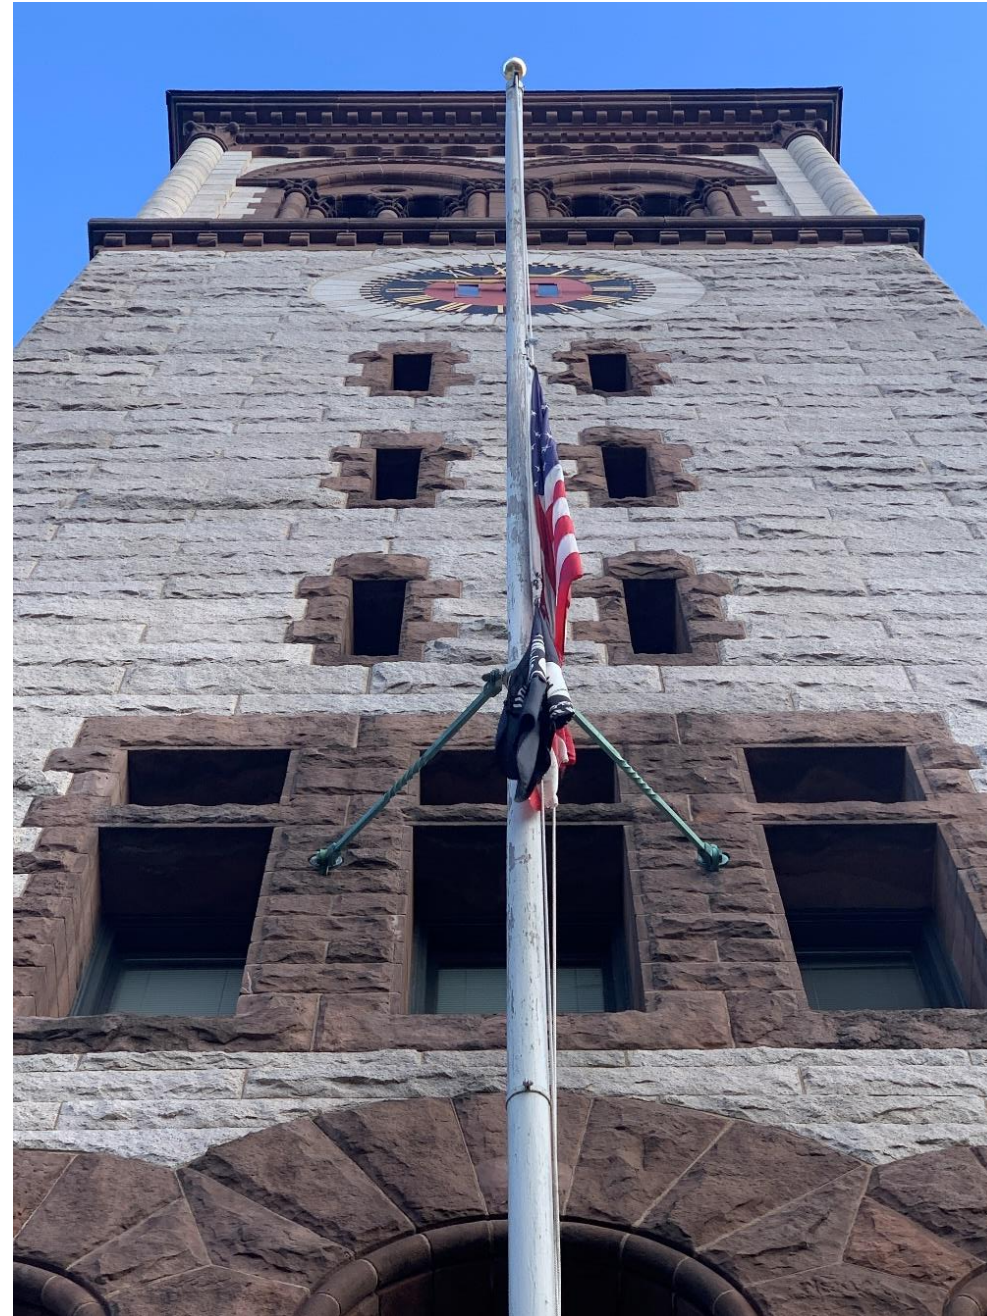
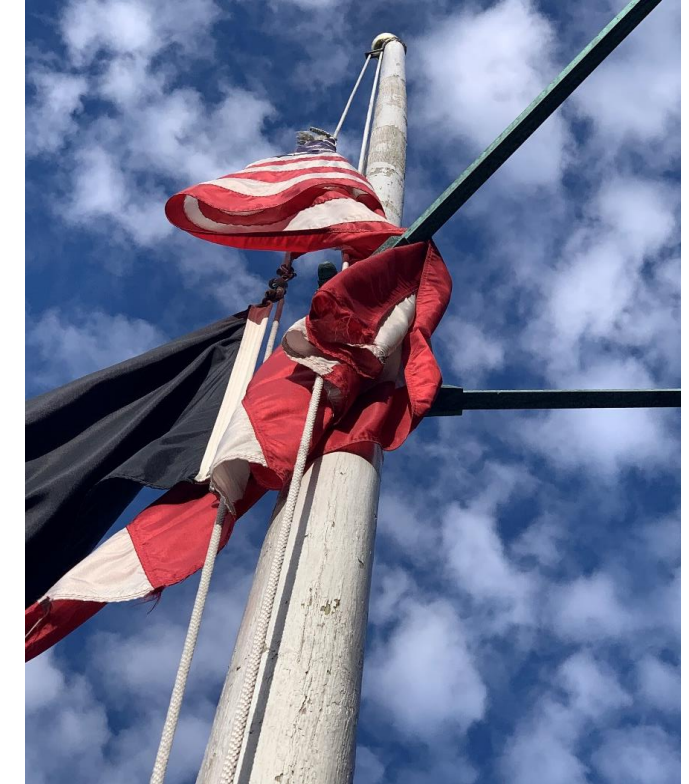
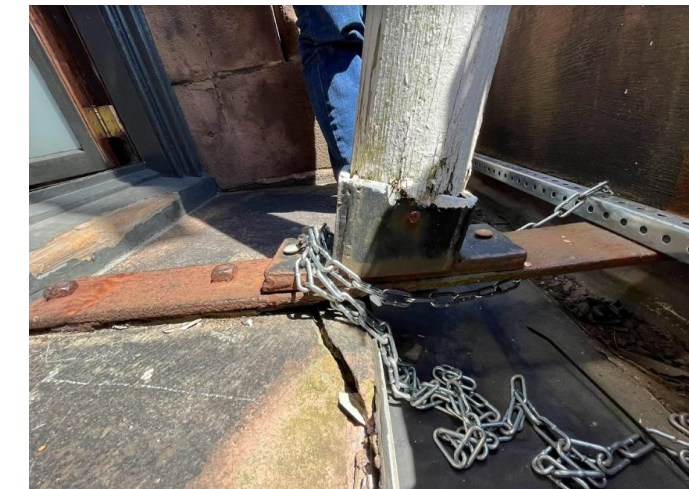
The existing wood flagpole will be replaced to address issues with the supporting base detail, the finial, and the flag tangling.

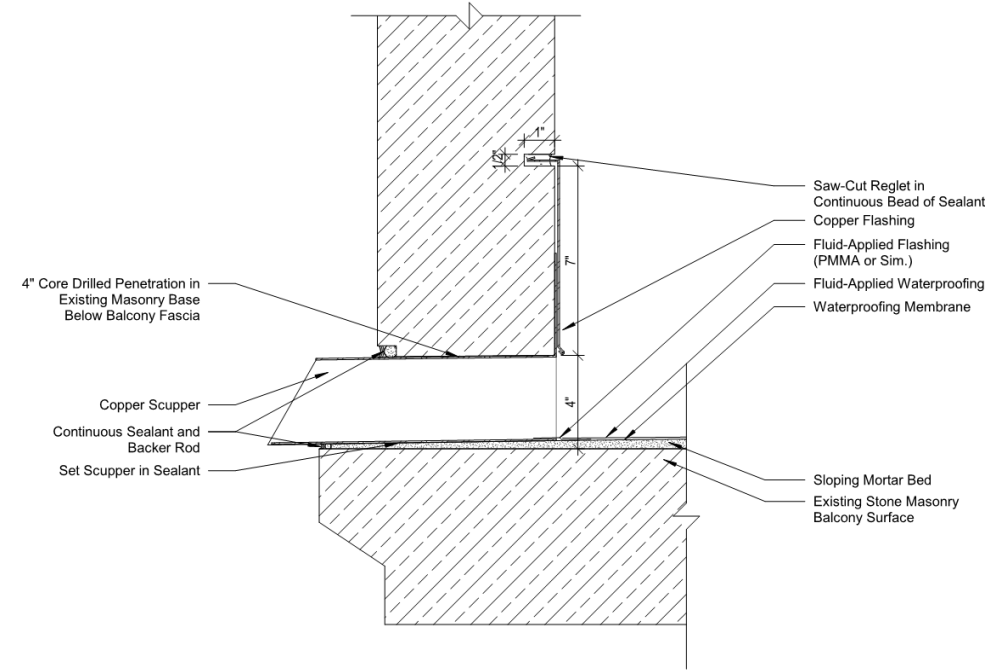
6 Section at New Balcony Scupper  
3" = 1'-0"

The balcony drainage is insufficient and frequently clogs. A new scupper will be added in the same location as the existing outlet to address the issue.

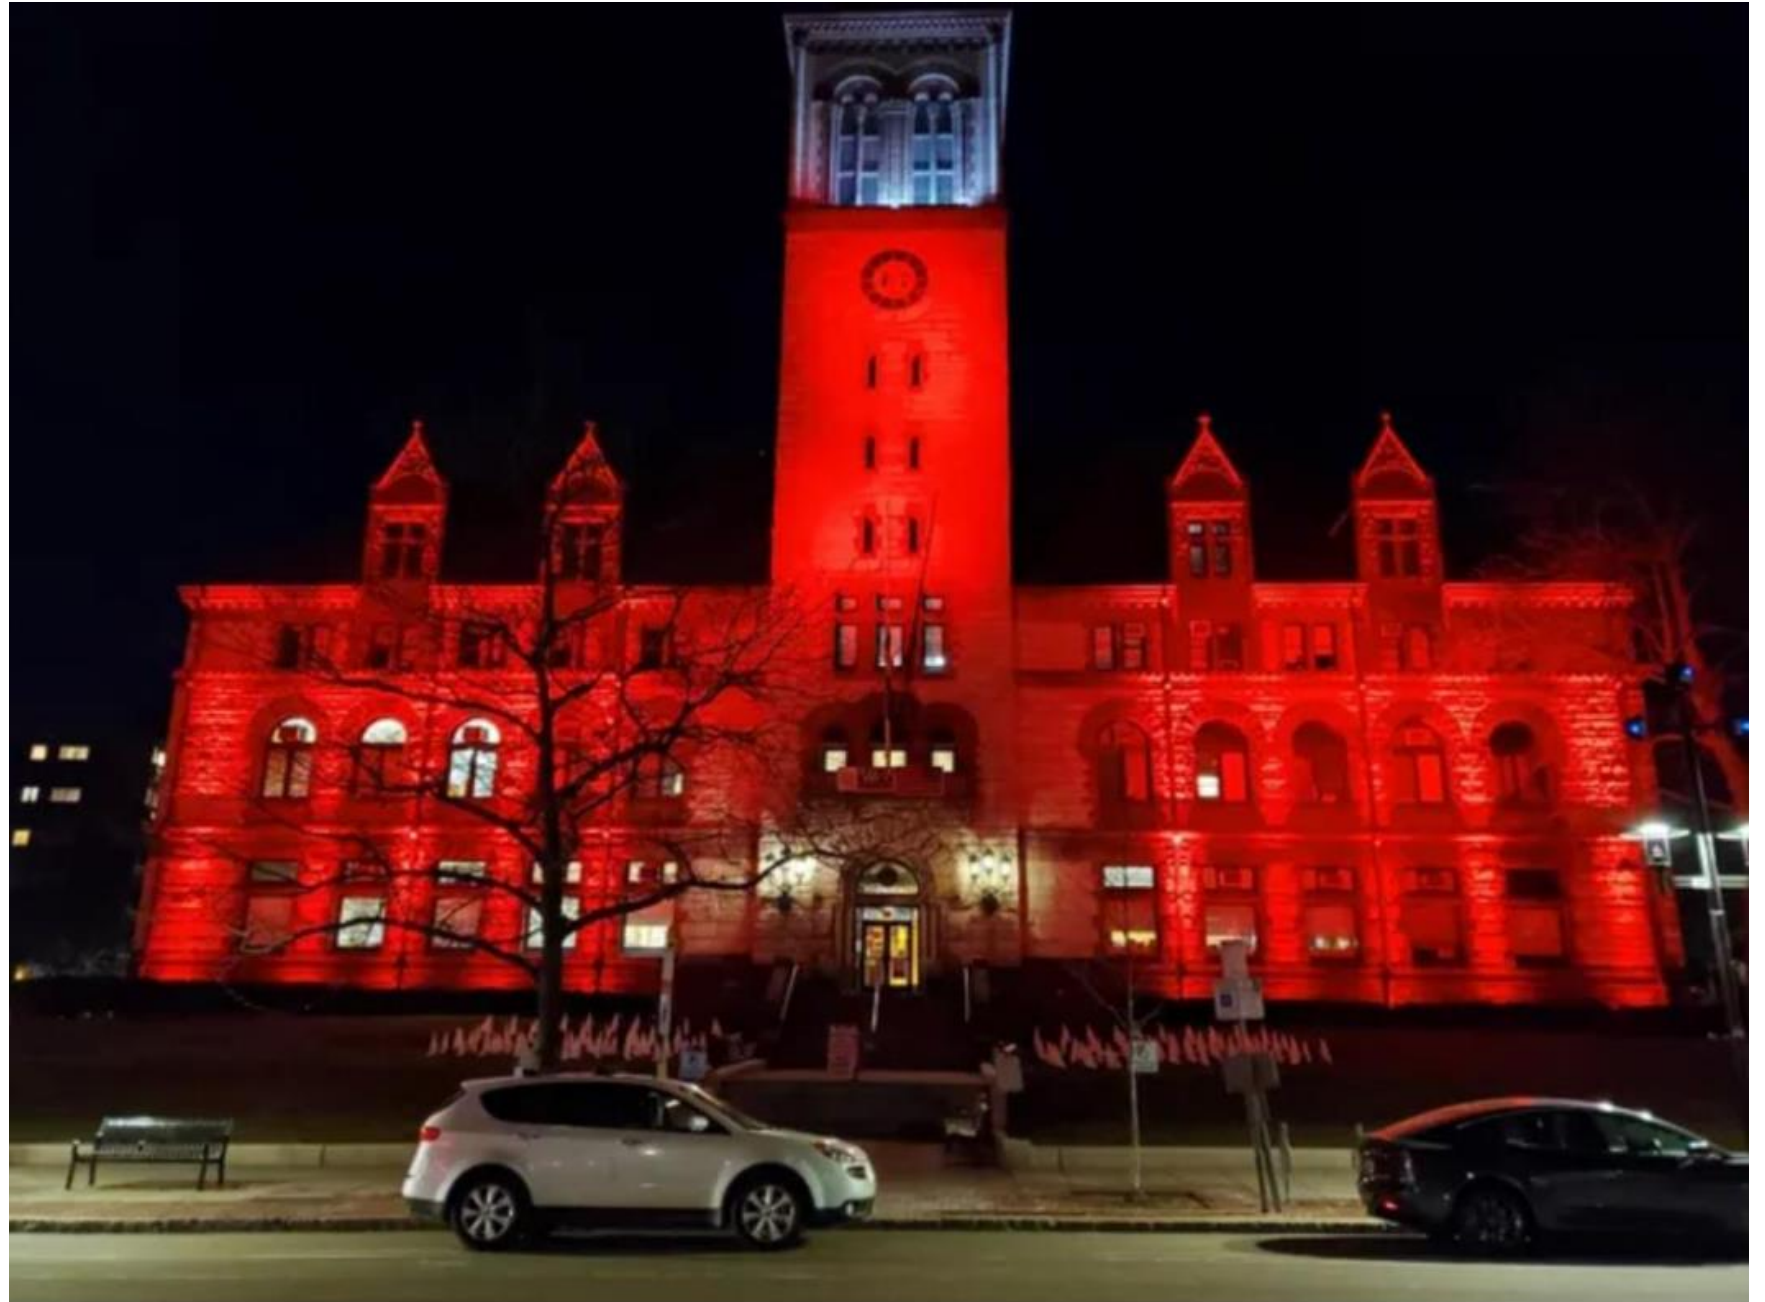
Existing Lighting at Tower

The existing tower lighting fixtures were at one time retrofitted with LED fixtures, but the system was not upgraded to match the remainder of the façade lighting. The current tower lighting provides uneven illumination, with noticeable hot spots and dark spots.

**The main objective is to upgrade the lighting system into a full functioning system that is connected to the rest of the façade.**
