Willard Street Drainage Improvements Project

Community Meeting #1

March 30, 2017

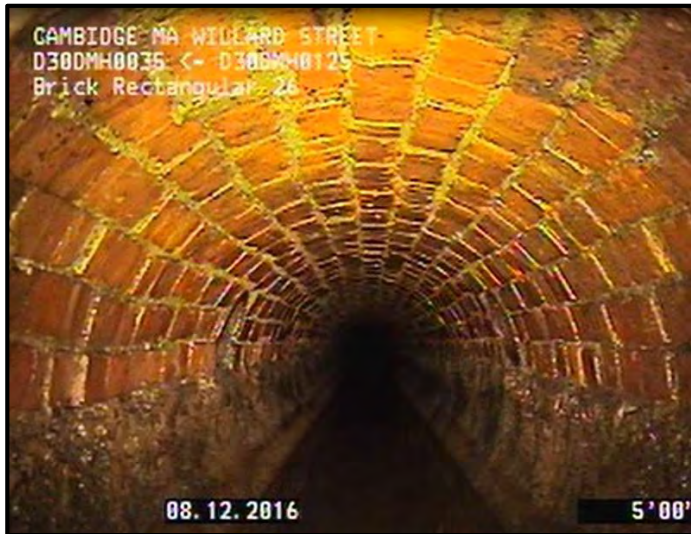
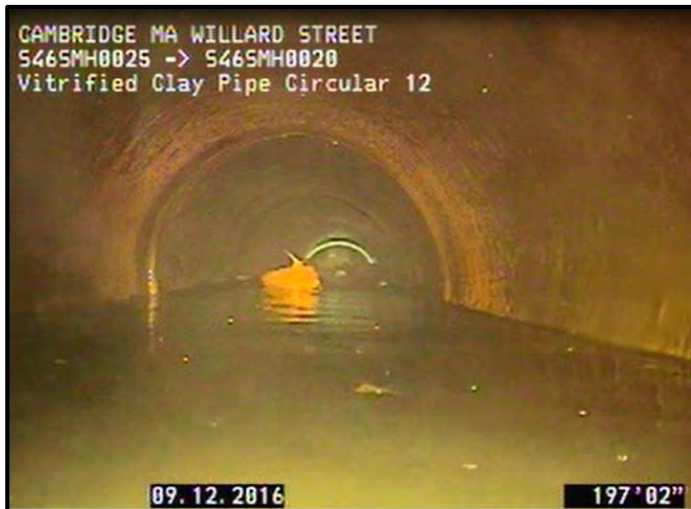
Current Conditions – Subsurface Infrastructure

- In December 2016 and March 2017, National Water Main completed cleaning and inspections of:
 - 1,000 ft of storm drain pipe, 8 drain manholes and 9 catch basins
 - 1,300 ft of sanitary sewer pipe, including laterals on Dinsmore Court, and 6 sewer manholes
- HW conducted manhole and catch basin inspections and reviewed drainage area to Willard Street
- Review of Cambridge Skating Club drainage and Willard Street improper connection inspections (dye testing) to be completed in April 2017

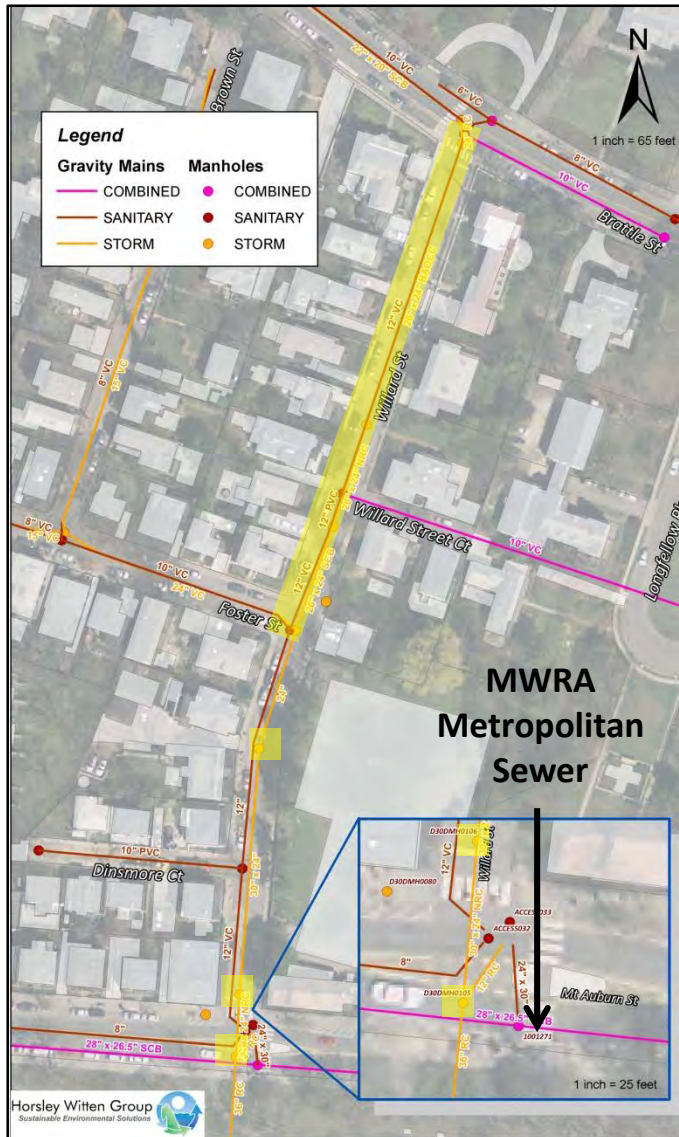
Current Conditions – Storm Drain Inspections

- **Materials:** brick and concrete
- **Condition:** good (minor holes)
- **Initial findings:**
 - Bulkhead at manhole near Dinsmore Court redirects flow to downstream structure
 - Hydraulic capacity issues observed
 - Higher flows than expected in MWRA’s Met Sewer (under review by MWRA)

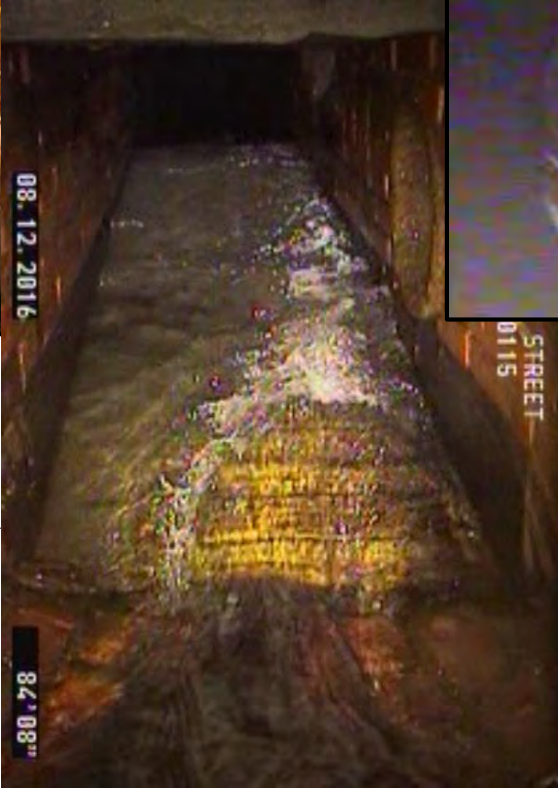
↖
Bulkhead and pipe redirecting flow to access structure (from 2013 inspection)

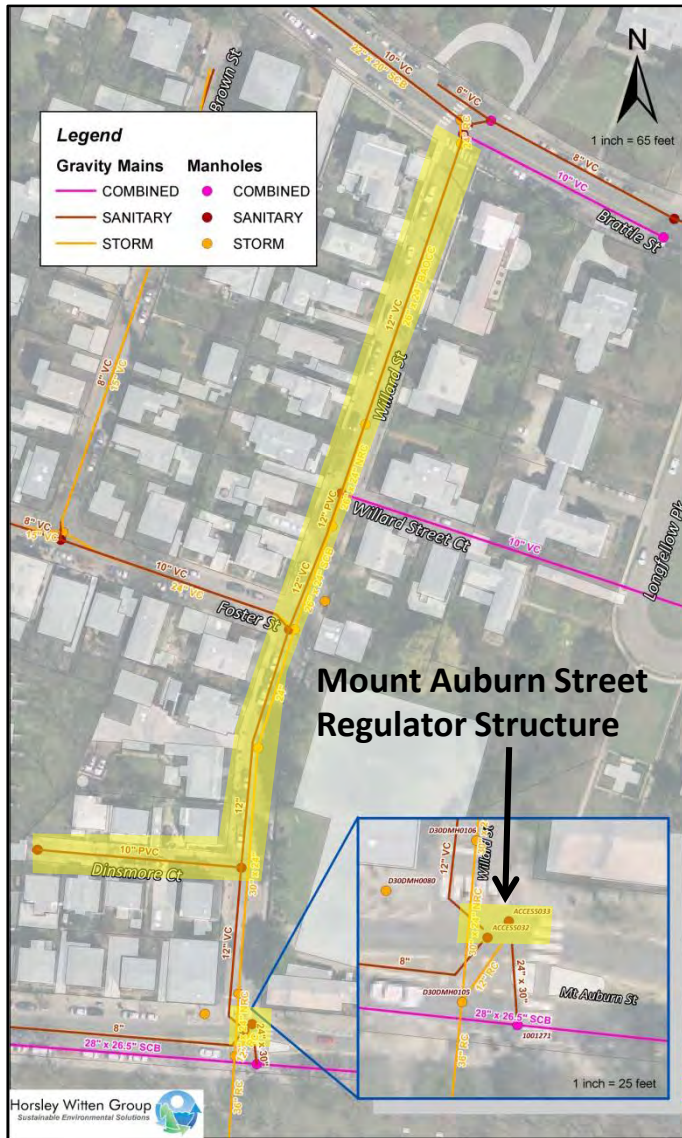
Current Conditions – Sanitary Sewer Inspections

- **Materials:**
 - PVC and vitrified clay pipe
- **Condition:**
 - minor to major defects (cracks, infiltration, roots, joint offsets)
- **Initial findings:**
 - Hydraulic capacity issues observed
 - Higher flows than expected in MWRA's Met Sewer (under review by MWRA)

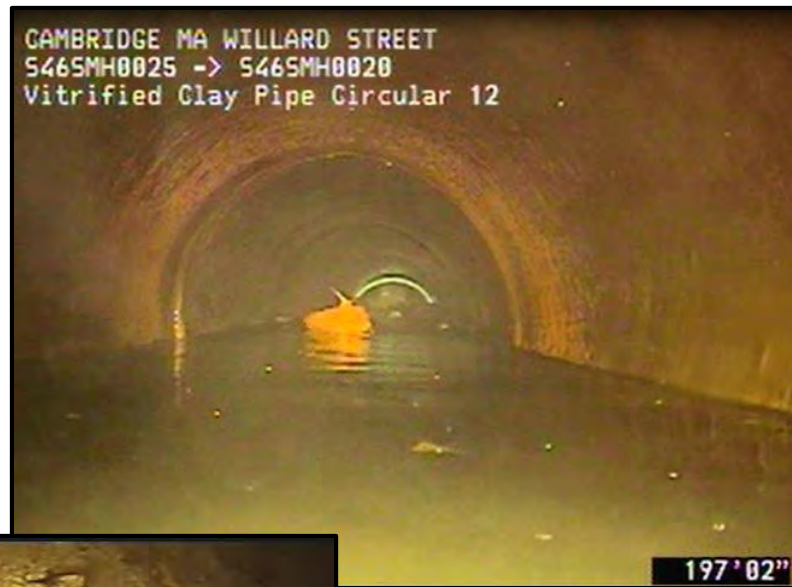
Sewer pipe on Willard Street

Example of infiltration (at joint)

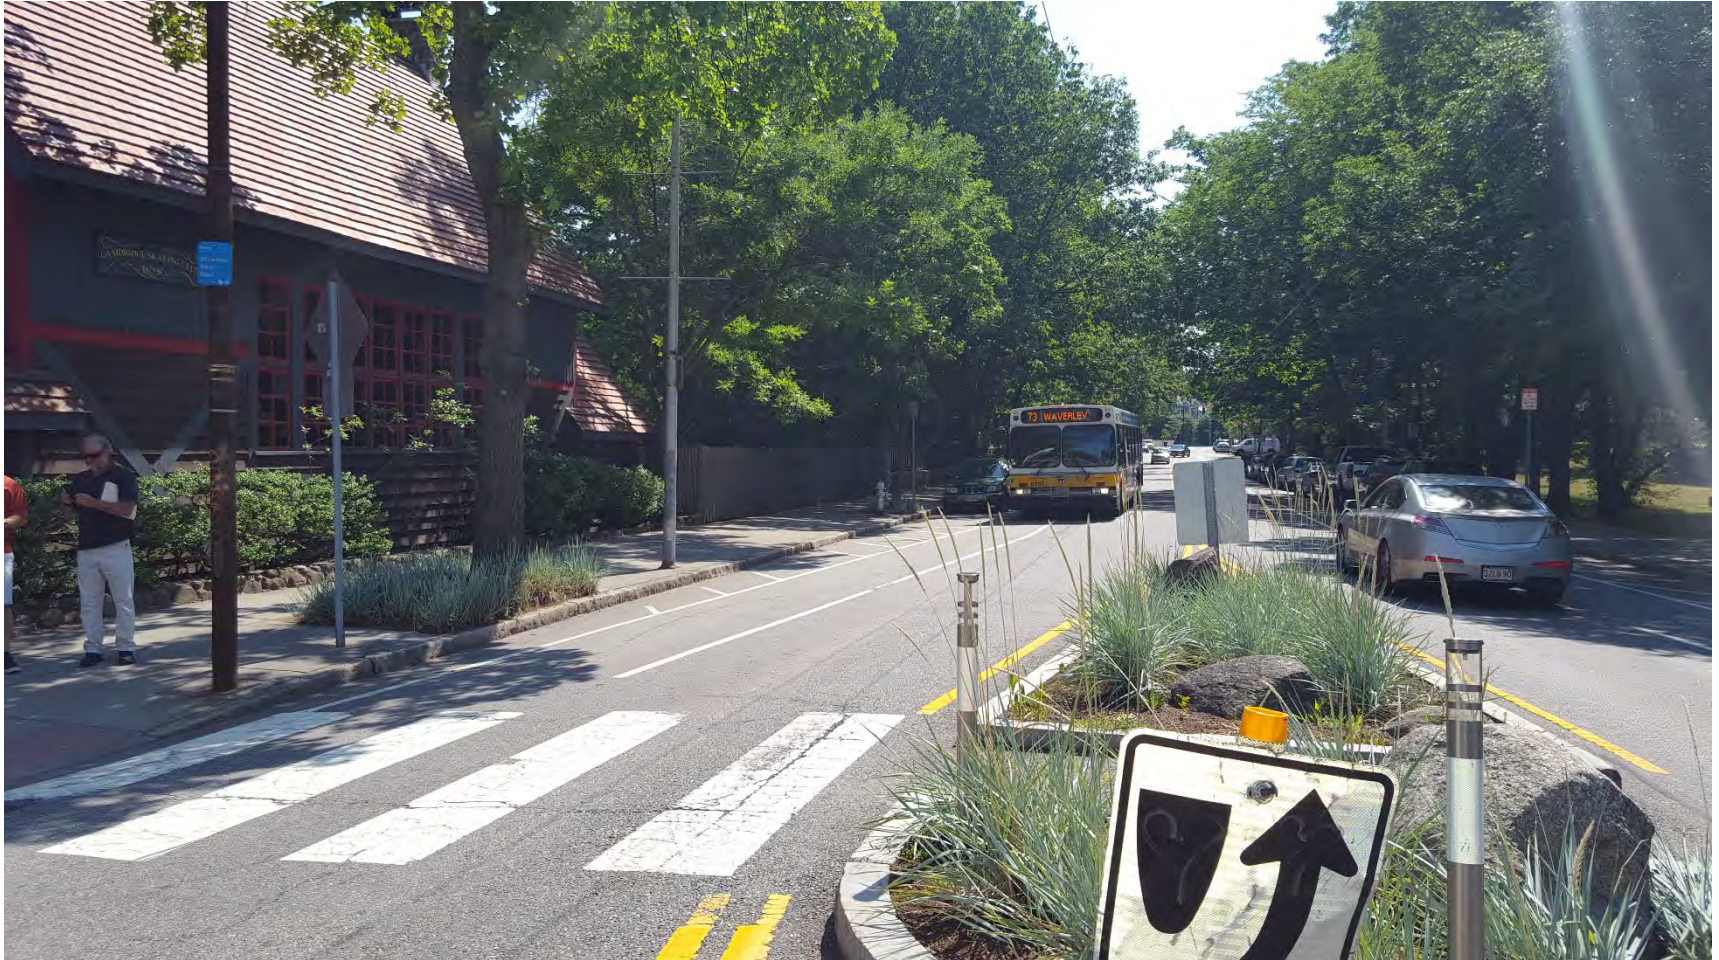
Current Conditions – Mt. Auburn / Willard Street intersection Looking East (on Mt. Auburn St.)

- **Important Multi-Modal Portal (Mt. Auburn Street)**
- **Bike Lanes/Pedestrian Crossing**
- **Transit Oriented (bus stop both sides)**

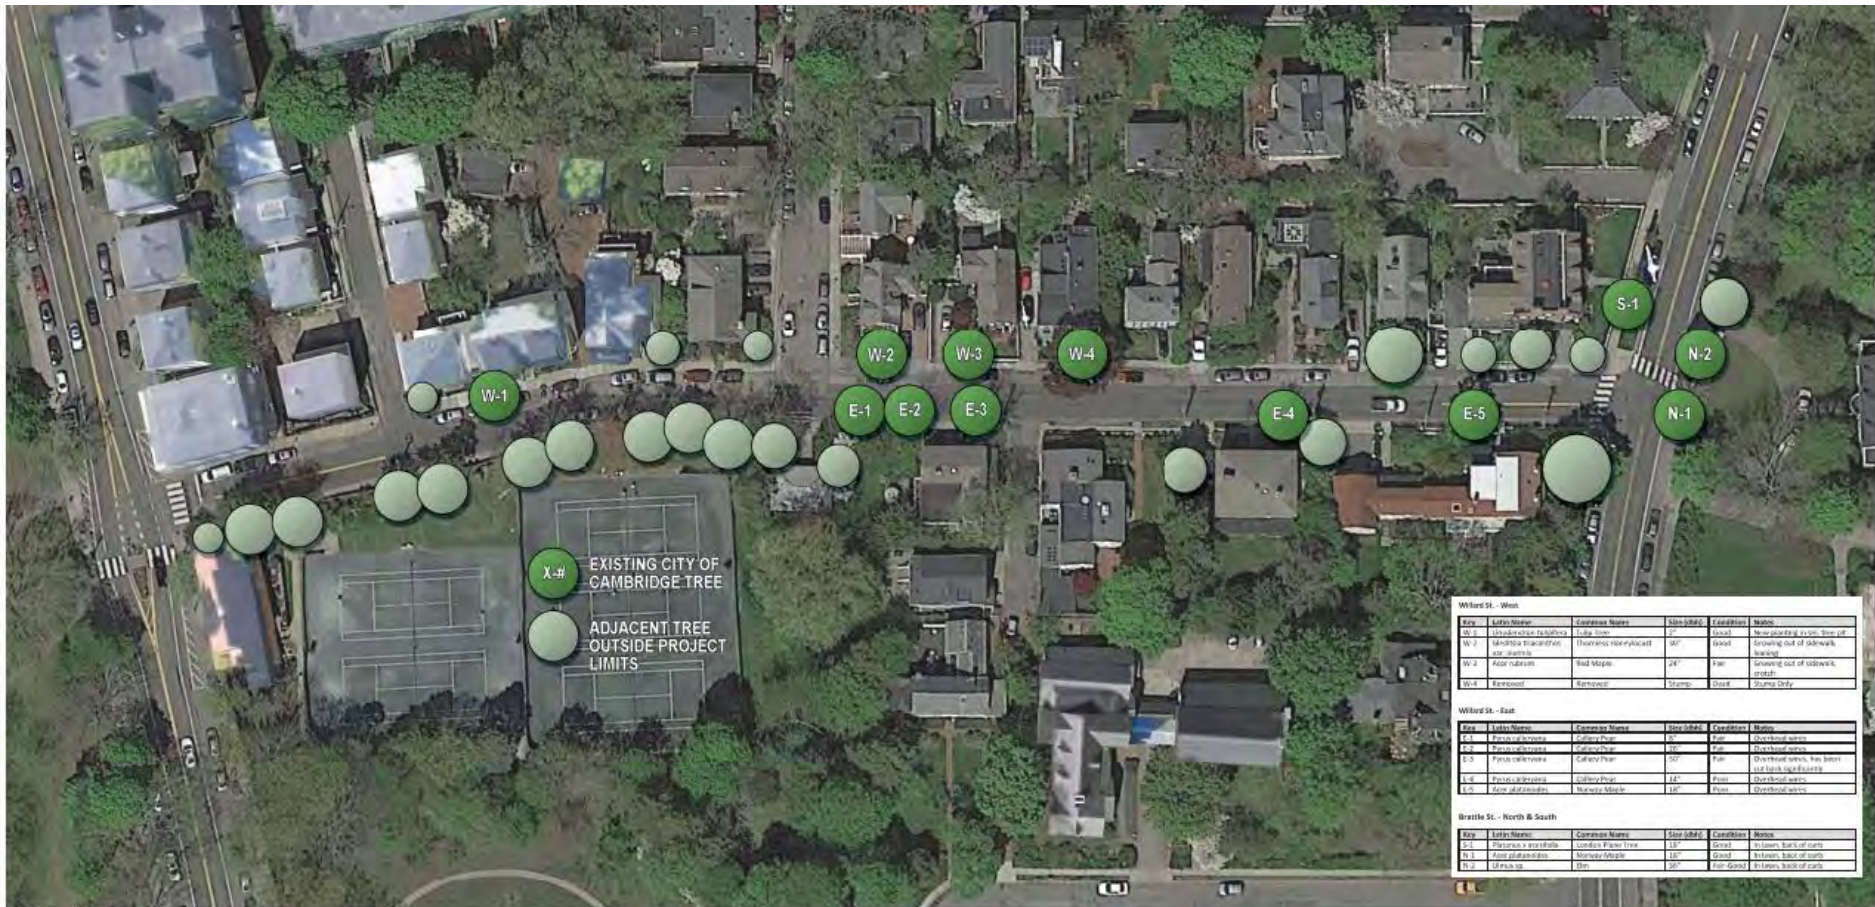
TREE INVENTORY

Tag	Latin Name	Common Name	Size (DBH)	Condition	Notes
W-5	Ulmus americana	White Elm	27"	Good	Non-planting to curb, line of
W-2	Malus baccata	Thornless rose-hawthorn	40"	Good	Growing out of sidewalk, hanging
W-3	Ailanthus altissima	Tree of Heaven	24"	Fair	Growing out of sidewalk, trash
W-4	Fraxinus americana	White Ash	Stump	Dead	Stump only

Tag	Latin Name	Common Name	Size (DBH)	Condition	Notes
E-1	Prunella americana	Black Cherry	26"	Fair	Overhead wires
E-2	Prunella americana	Black Cherry	20"	Fair	Overhead wires
E-3	Prunella americana	Black Cherry	20"	Fair	Overhead wires, low branch
E-4	Prunella americana	Black Cherry	22"	Fair	Overhead wires
E-5	Prunella americana	Black Cherry	18"	Fair	Overhead wires

Tag	Latin Name	Common Name	Size (DBH)	Condition	Notes
N-1	Prunella americana	Black Cherry	18"	Good	In lawn, back of yard
N-2	Prunella americana	Black Cherry	20"	Fair-Good	In lawn, back of yard

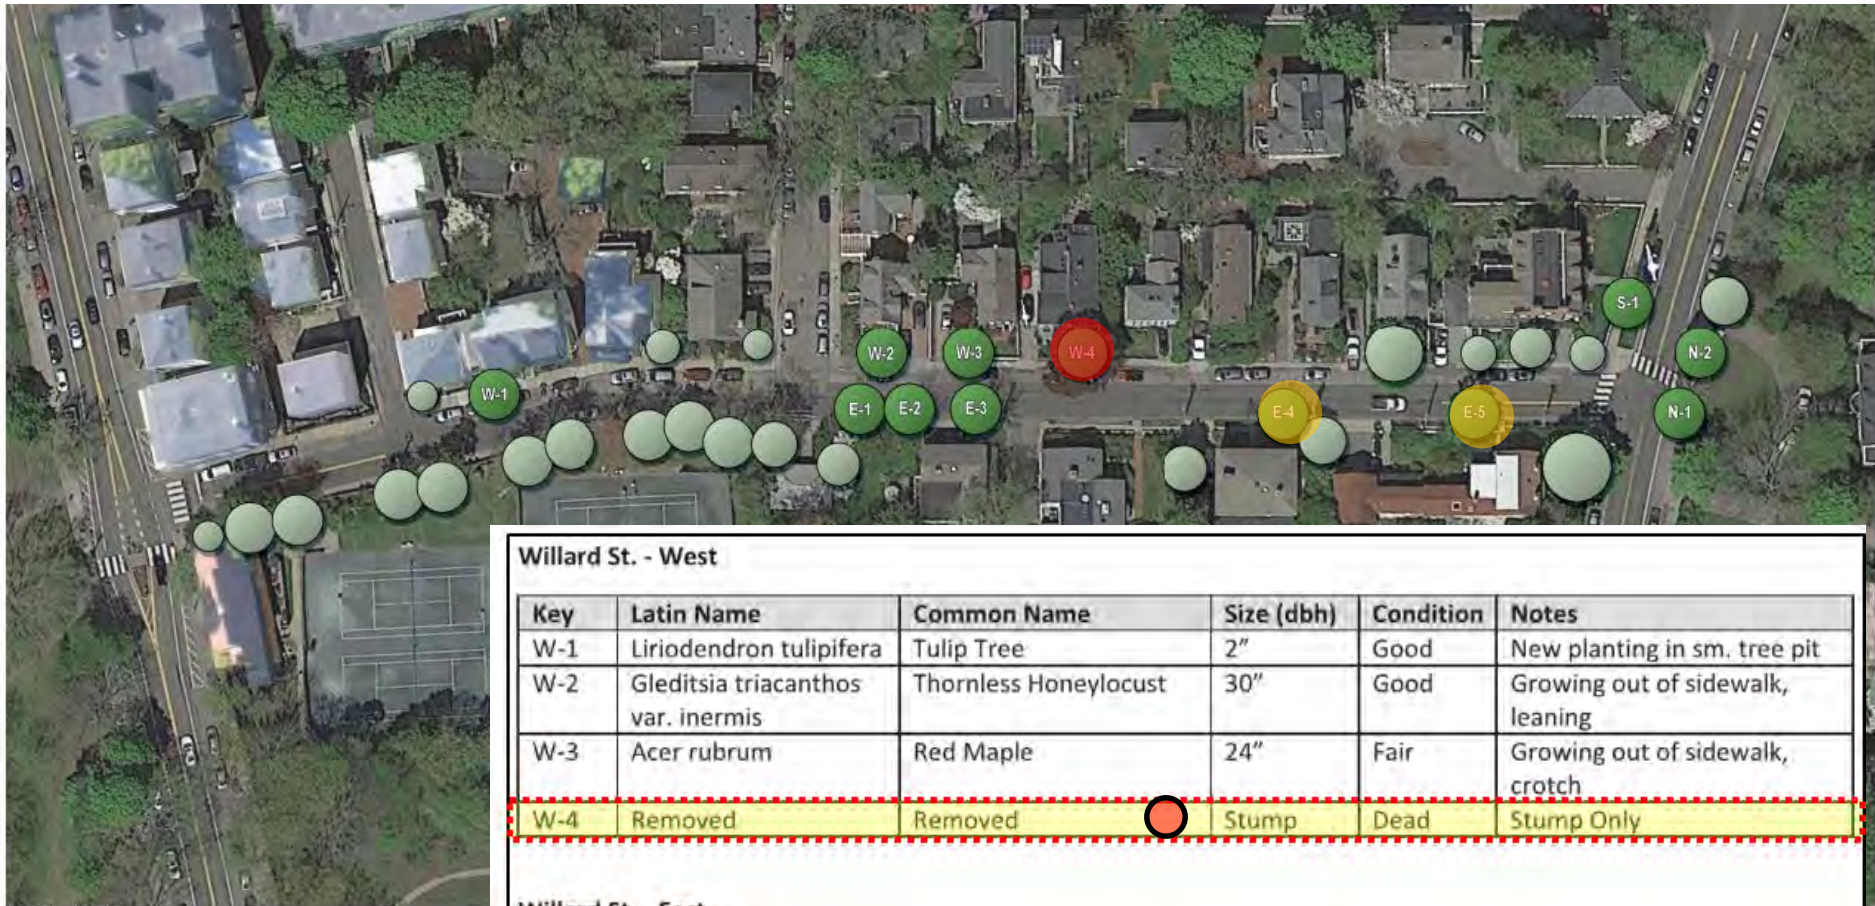
Key	Latin Name	Common Name	Size (dbh)	Condition	Notes
W-1	<i>Liriodendron tulipifera</i>	Tulip Tree	2"	Good	New planting in sm. tree pit
W-2	<i>Gleditsia triacanthos</i> var. <i>inermis</i>	Thornless Honeylocust	30"	Good	Growing out of sidewalk, leaning
W-3	<i>Acer rubrum</i>	Red Maple	24"	Fair	Growing out of sidewalk, crotch
W-4	Removed	Removed	Stump	Dead	Stump Only

Key	Latin Name	Common Name	Size (dbh)	Condition	Notes
E-1	<i>Pyrus calleryana</i>	Callery Pear	8"	Fair	Overhead wires
E-2	<i>Pyrus calleryana</i>	Callery Pear	26"	Fair	Overhead wires
E-3	<i>Pyrus calleryana</i>	Callery Pear	30"	Fair	Overhead wires, has been cut back significantly
E-4	<i>Pyrus calleryana</i>	Callery Pear	14"	Poor	Overhead wires
E-5	<i>Acer platanoides</i>	Norway Maple	18"	Poor	Overhead wires
