Tobin Montessori/Vassal Lane Upper Schools Project Public Meeting

February 6, 2019

Project Approach

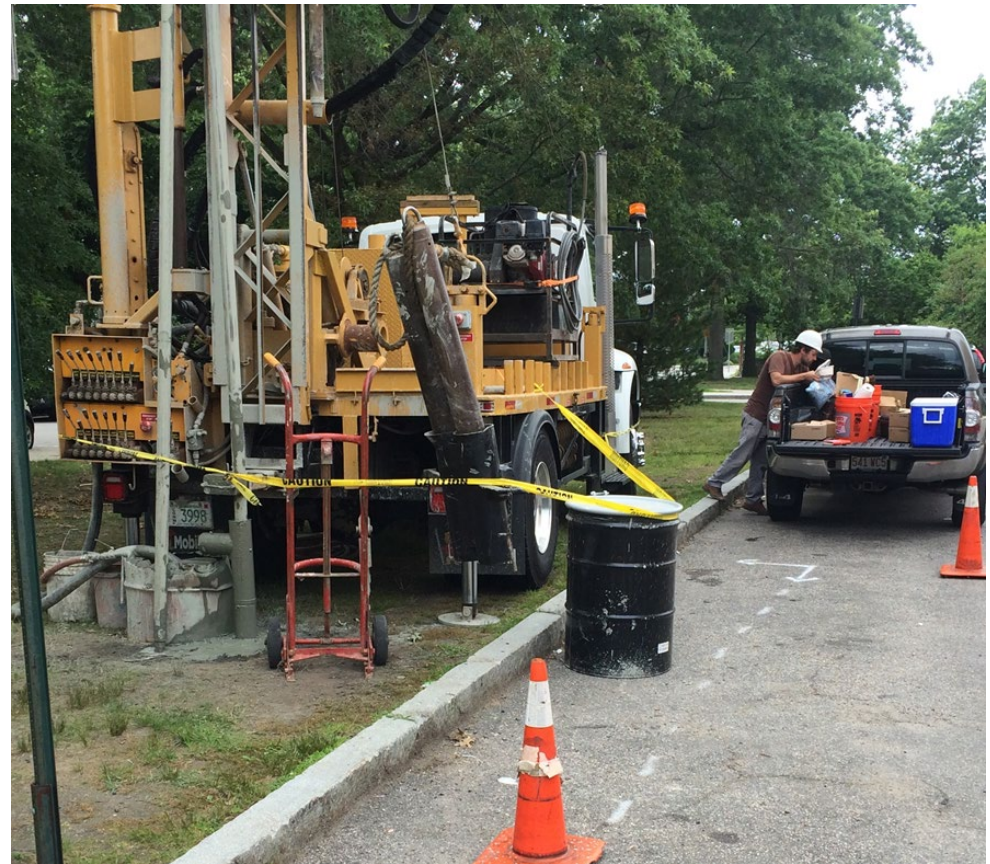
Geotechnical Assessment (2016-2018)

- Soil borings (overburden and bedrock) to characterize subsurface materials
- Test Pits to visually assess materials
- Monitoring wells to assess groundwater
- Laboratory testing of physical and engineering properties of subsurface material

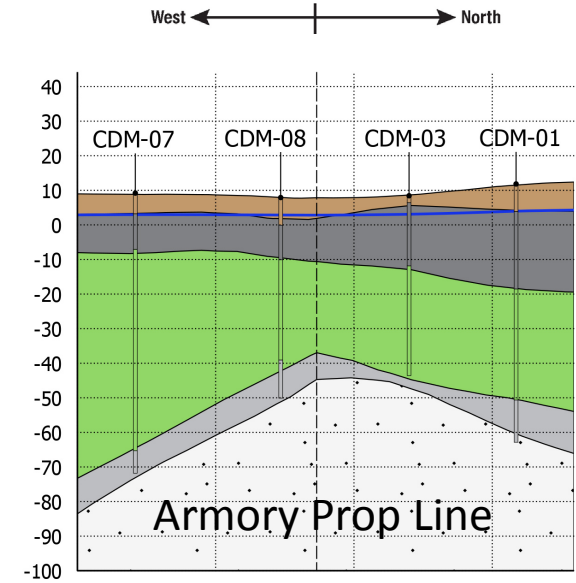
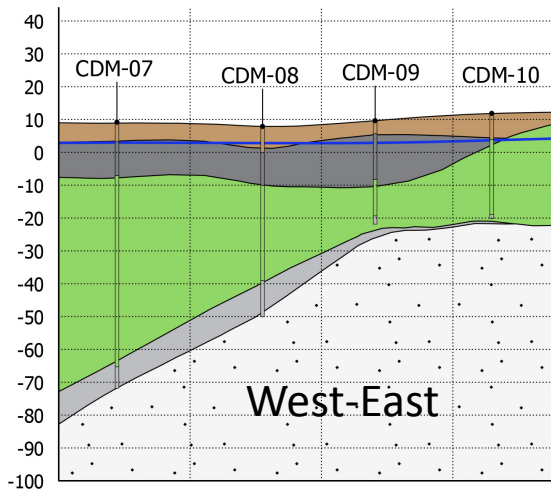
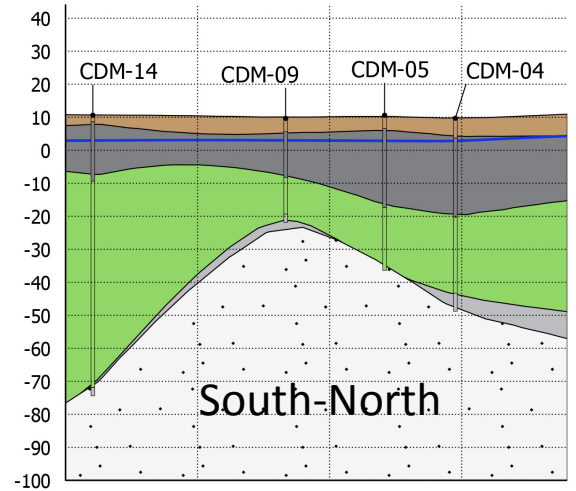
Subsurface Conditions - Strata Cross Section

Water Table
-

Granular Fill
-

Waste (Misc. Fill)
-

Clay and Silt
-

Glacial Till
-

Bedrock

Subsurface Conditions – Soil/Waste Fill/Rock

Layer	Thickness	Comments
Pavement or Topsoil	Surface to 18 in.	
Granular or Waste Fill	Varies from not present to 30 ft thick	Varying amounts of gravel, silt, brick, concrete, coal, ash, cinders, slag, metal, glass, wood, leaves, granite blocks, and other miscellaneous material
Clay and Silt	6.5 to 75 ft.	Boston Blue Clay; some miscellaneous fill materials
Glacial Till	0.5 to 13 ft.	
Bedrock		Significant variation in the elevation of top of bedrock across the site

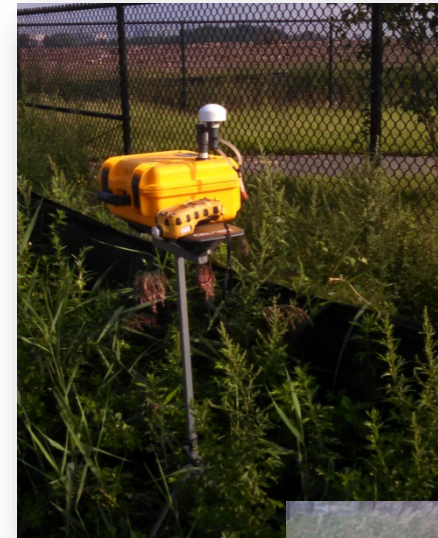
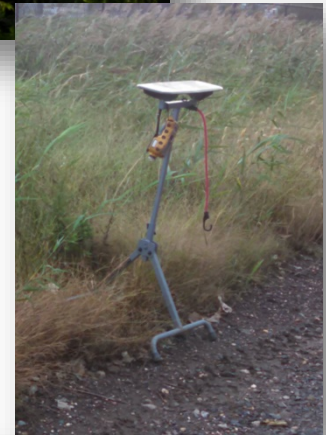
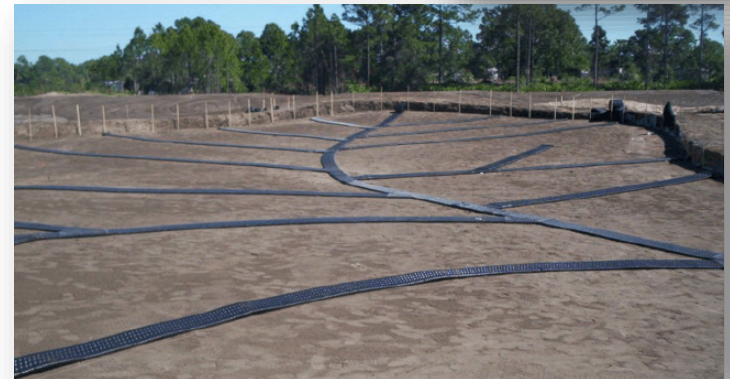
1. Management of Landfill Gases

- Control of landfill gases during excavation of waste for the health and safety of on-site workers and the surrounding community
 - Health & Safety Plan
 - Personal protective equipment
 - Air monitoring units
 - Gas collection system

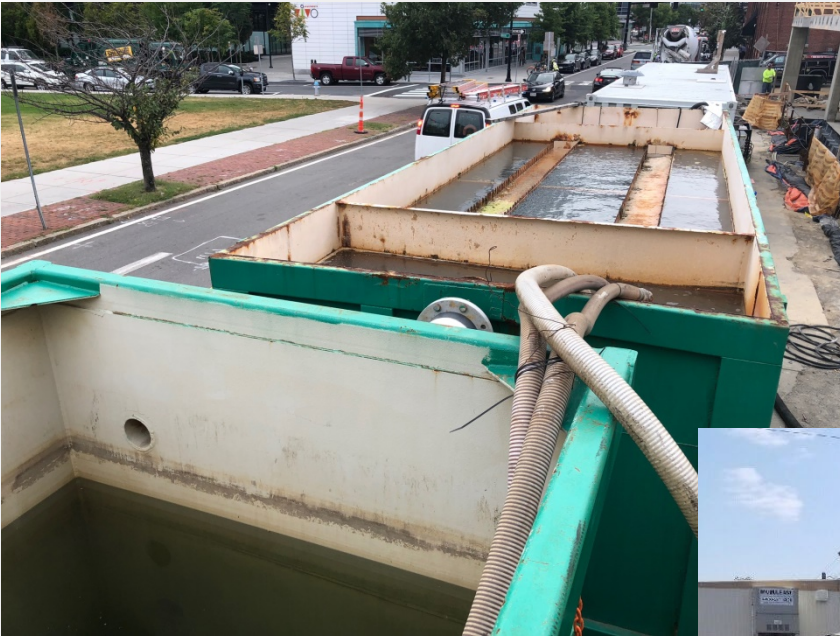
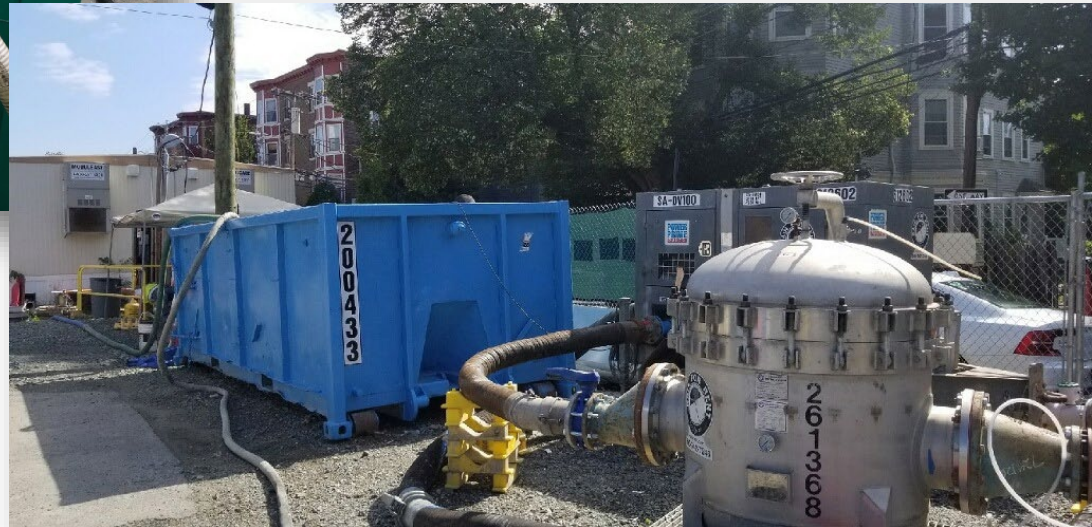
2. Dewatering with Treatment Prior to Discharge

- To allow for excavation below groundwater (4.5 to 12 ft BGS)
- Discharge treated to be protective of the environment

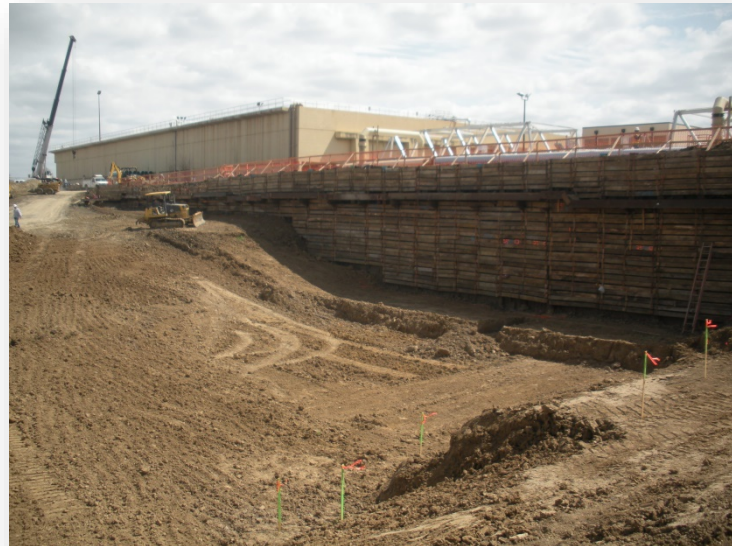
3. Excavation Support System

- Allows removal of deep waste materials
- Limits extent of excavation (keep within property lines, reduce total volume)
- Protects nearby facilities (residences, Armory, roads, utilities, trees)
- May also provide groundwater/landfill gas cutoff

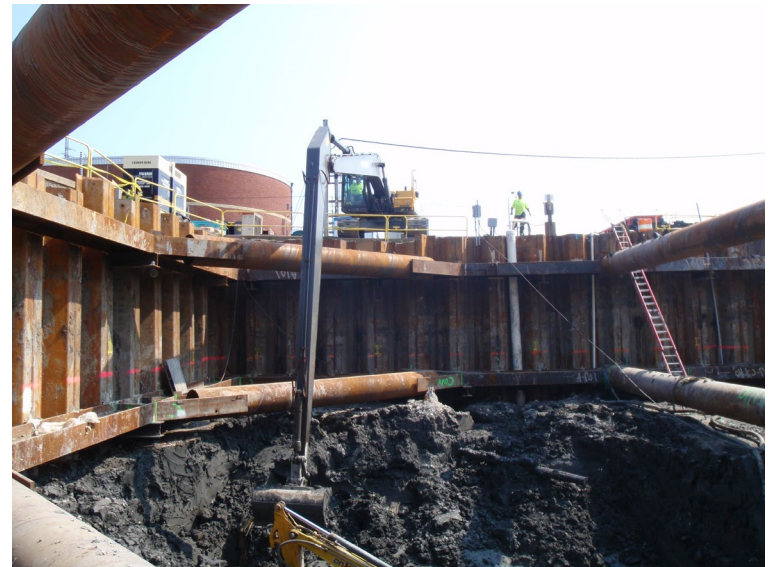
4. Excavated Soil Management

- Managed in accordance with the MCP
- Approximately 260,000 cubic yards of waste/soil
- Feasibility Study will determine waste removal vs. stabilization
- Excavated soil will be shipped to disposal facilities
- Excavations backfilled with clean material

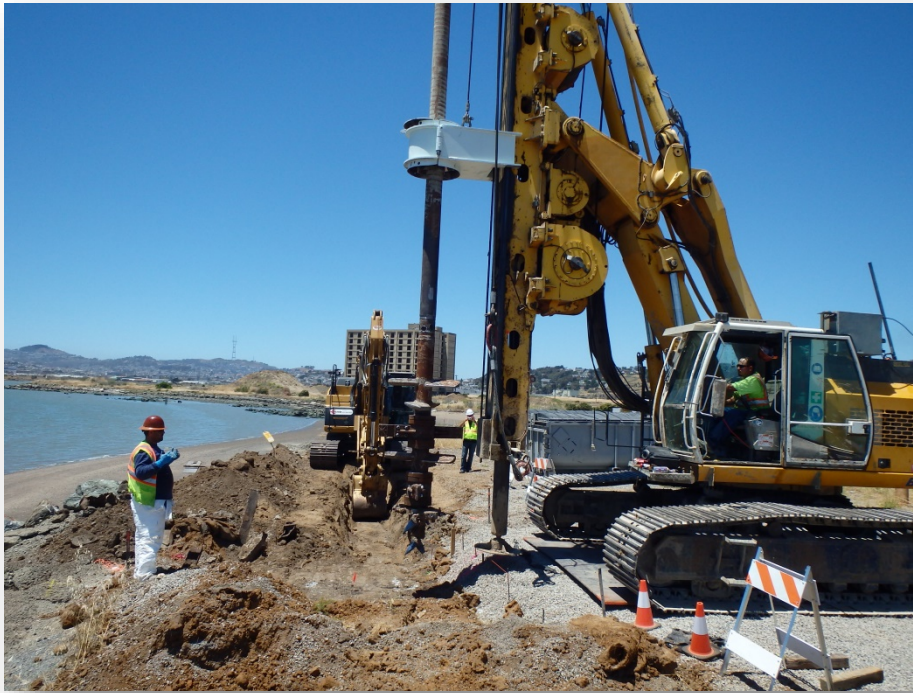
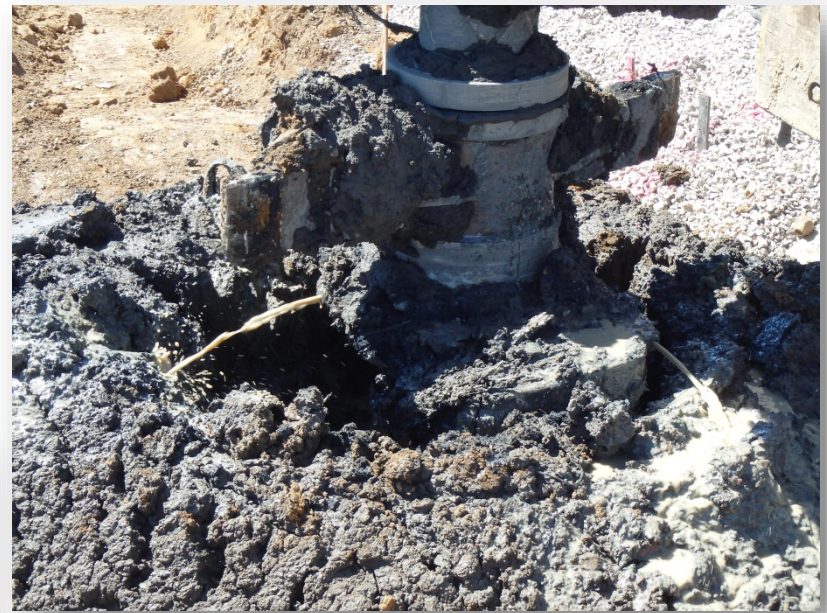
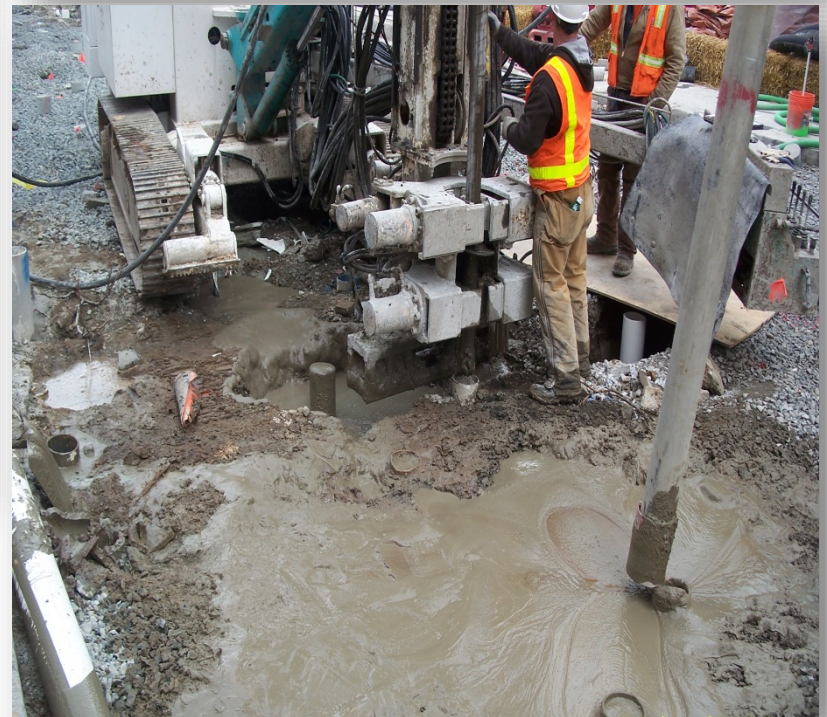
5. In-Situ Stabilization

- Soil Mixing
- Jet Grouting
